# Salinas River Lagoon Marsh Plain Condition Assessment

## *Summary Report*

**November, 2015**

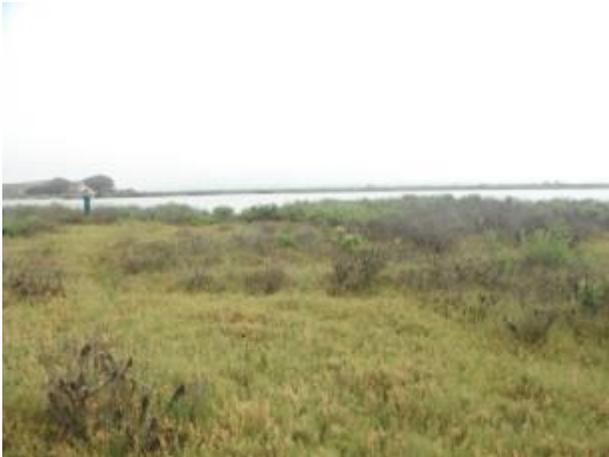
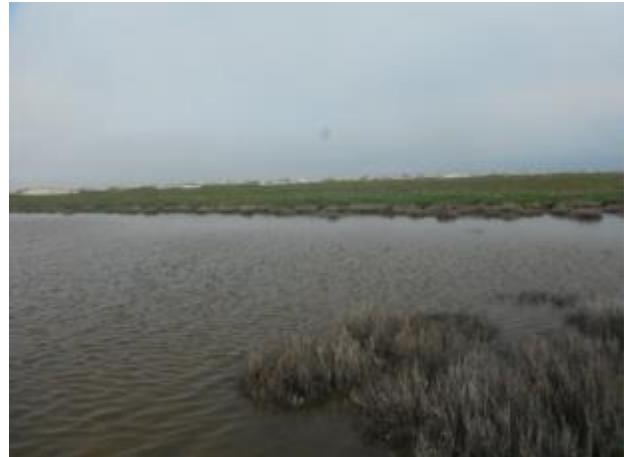
Several stressors were identified on the site during the assessments. While not factored into the CRAM scores, stressors can provide more detailed insight about what may be adversely affecting the ecological condition of the river, stream or creek. Stressors that were consistently observed on the site include:

- Non-point sources from agricultural areas
- Nutrients and Pesticides
- Dikes and levees along the river

Photos from the Salinas River Lagoon CRAM assessments.

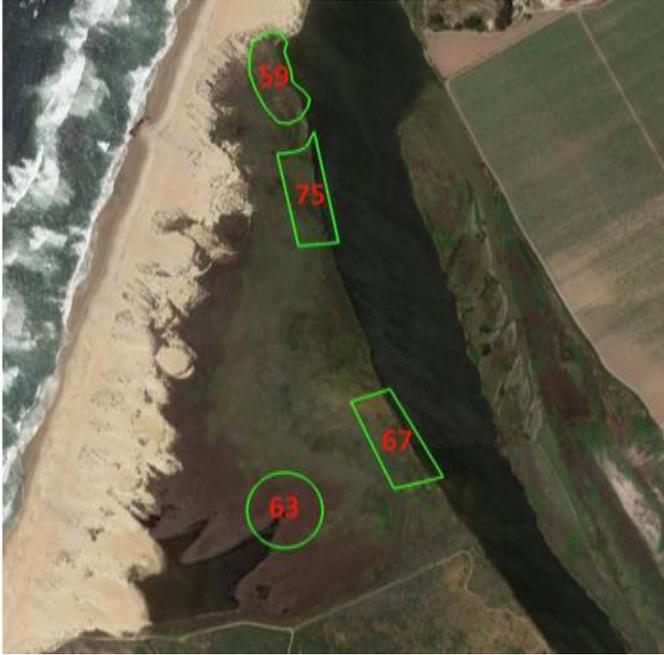
The Bar-built Estuary CRAM assessment of the Salinas River lagoon showed an average condition score of 66 (Figure 2, Table 2). The Index Scores ranged from 59 to 75, with the higher scores along the main channel in the more established areas of the marsh, away from the natural disturbance of the mouth and dunes. Three of the sites scored in the “good” category and one site scored in the “fair” category.

**Figure 2.** CRAM Index scores for each Assessment Area in the Salinas River lagoon. Site 1 scored in the “fair” category, while the remaining sites scored in the “good” category.

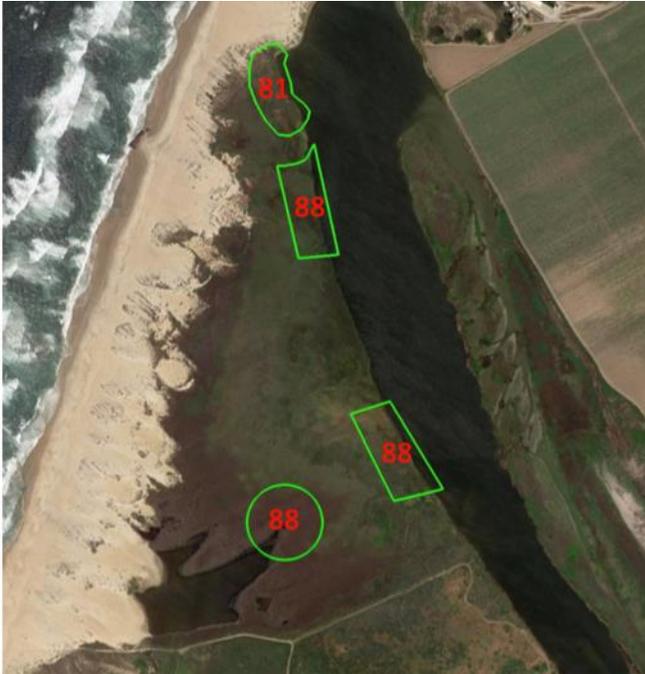
The average Buffer and Landscape Context Attribute score showed an excellent condition score of 86, ranging from 81 to 88 (Figure 3). This was due to the Salinas Lagoon and marsh plain being very large in size, allowing for the assessment areas to have wide buffers of wetland and upland habitat surrounding them. In addition, there is good connectivity with the marine environment, without any impediments to mouth migration or sand transport. This attribute did however score very low for stream corridor continuity due to the lack of a wide riparian corridor upstream of the transition from an estuarine environment to a riverine environment.

**Figure 3.** Buffer and Landscape Attribute scores for each Assessment Area for the Salinas River lagoon.

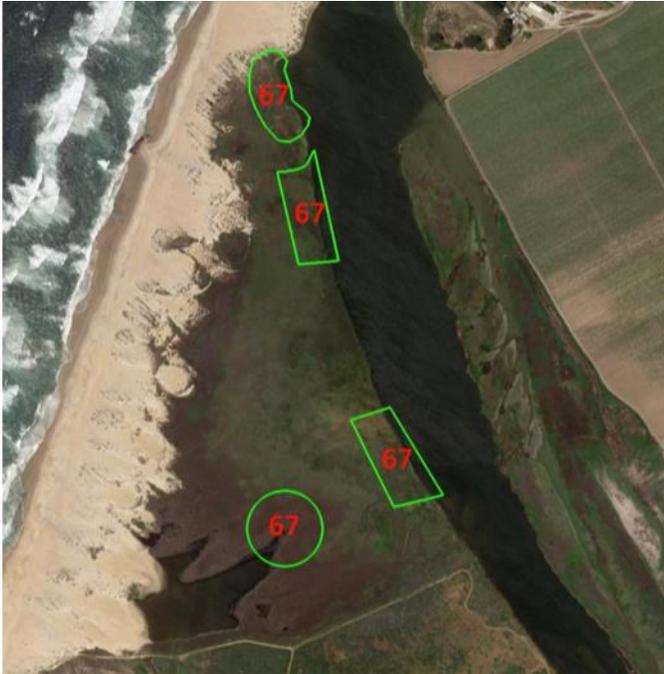
All four assessment areas received a good condition score of 67 for the Hydrology Attribute (Figure 4). The reason for the lack of variability is due to the design of the metrics and what they assess. All three metrics look at landscape level indicators of condition, so all assessment areas in a system will most often receive the same score. The assessment areas scored low for the water source metric due to the high amount of agricultural land use in the immediate watershed. The Hydroperiod metric, which looks at the breaching pattern of the mouth, received a moderate score. The Hydrologic Connectivity metric also received a moderate score due to the presence of some levees within the system, restricting the spread of rising floodwaters up a natural transition zone from wetland to upland.

**Figure 4.** Hydrology Attribute scores for each Assessment Area for the Salinas River lagoon.

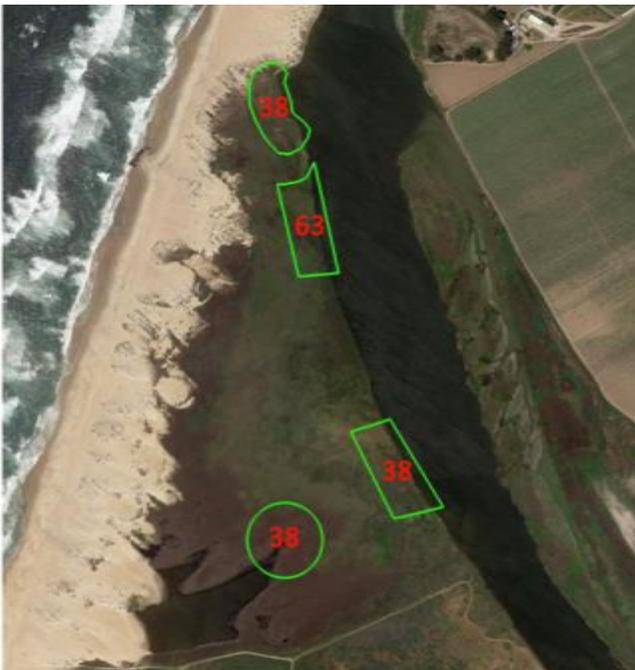
The Physical Structure Attribute received an average score of 44, ranging from 38 to 63. The majority of the sites received a score in the “poor” condition category due to a low number of physical patch types observed in the assessment areas and a lack of topographic complexity across the marsh plain.

**Figure 5.** Physical Structure Attribute scores for each Assessment Area for the Salinas River lagoon.

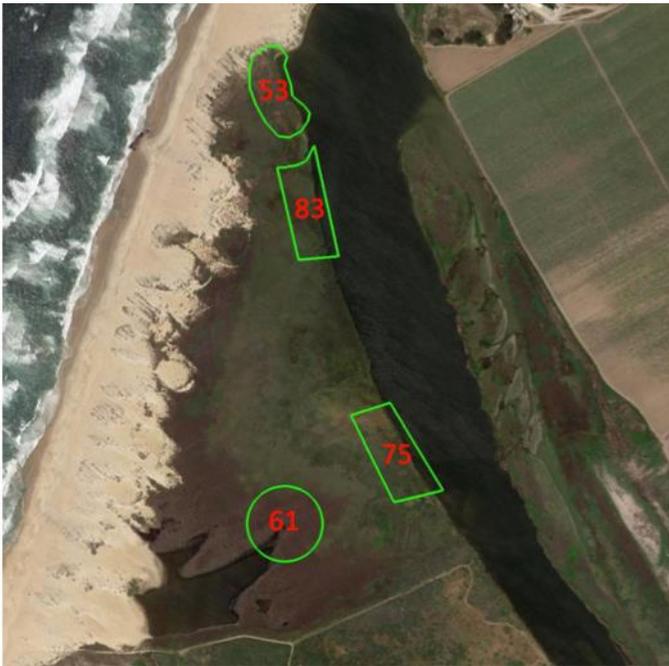
The Biotic Structure Attribute received an average condition score of 78, ranging from 53 to 83, and falling in the “good” category. Three out of the four sites received the maximum score for lack of invasive plant species and biotic vertical structure, which looks at the density of the canopy of the marsh vegetation. Most of the sites received low to moderate scores for the number of plant layers, number of co-dominant plant species and the interspersed of plant zones across the marsh plain.

**Figure 6.** Biotic Structure Attribute scores for each Assessment Area for the Salinas River lagoon.

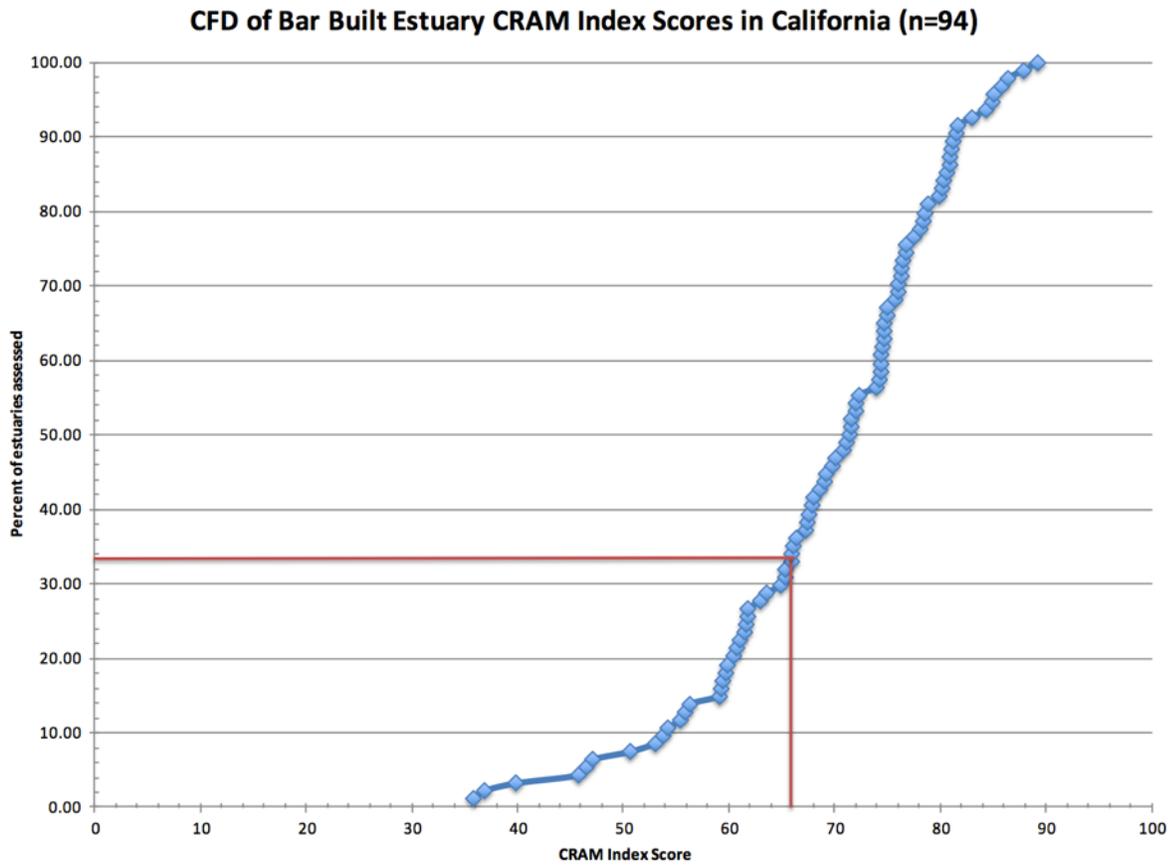
In general, the Salinas River Lagoon falls in the lower end of what is considered a “good” condition estuary in California according to CRAM. Figure 7 provides context on how this lagoon compares to lagoons throughout California. The Salinas River lagoon falls in the 33<sup>rd</sup> percentile of 94 bar-built estuaries, a.k.a. lagoons, in California. Two-thirds of the estuaries assessed had higher scores than the Salinas River lagoon, while one-third of sites had lower scores (Figure 7). The sites assessed are representative of the entire coastline and a wide range of sizes of estuaries.

**Figure 7.** Cumulative Frequency Distribution graph of CRAM Index Scores from 94 bar-built estuaries in California. The red line represents the Salinas River lagoon.
