# **Pre-Project Implementation Condition Assessment**

Carmel River Floodplain (Carmel, CA)

Summary Report

## September 2015

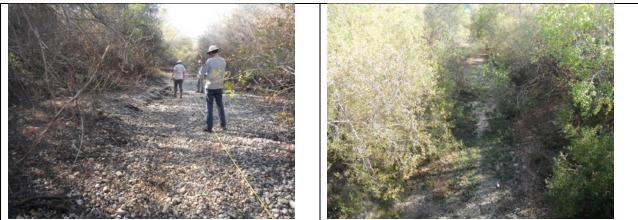
Figure 5. Photos of the riverine CRAM assessments.

The riverine CRAM assessments of the main channel of the Carmel River found condition scores of 69 (Good) near the Hwy 1 bridge and 57 (Fair) at the upstream end of the project area (Table 2, Figure 5). Six CRAM assessments completed for other purposes in areas on the Carmel River downstream of the San Clemente dam (available on EcoAtlas.org) can be used for comparison of conditions with the assessments conducted for this project. The six upstream sites had Index scores ranging from 64 to 89. Four of the sites that were located along the main stem adjacent to Carmel Valley Road scored from 64 to 76, while two sites slightly higher in the watershed away from main roads scored 82 and 89 (Excellent). All six of the sites exhibit similar or higher Physical Structure and Biotic Structure Attribute scores as compared to the areas assessed at the CRFREE site. This confirms that the Carmel River can achieve good to excellent condition scores for all CRAM attributes and the Index score.

The difference in CRAM Index scores between the two CRFREE riverine sites was driven by large variability in the Buffer and Landscape Context Attribute scores (90 at the bridge and 48 upstream). The condition scores for the stream corridor continuity metric, which looks at the width of the stream corridor upstream and downstream of the assessment area, was most different between the two locations. The assessment area near the bridge received an 'A' for continuity while the assessment area at the upstream location received a 'D', due to the presence of the golf course within 500 meters of the upstream assessment area. The buffer condition for the two assessment areas were relatively similar, with the bridge site scoring slightly better, due to a wider riparian zone. The upstream site scored slightly better for the buffer width metric. We anticipate that the planned restoration actions of the floodplain will increase all of the Buffer sub-metric scores for both of these assessment areas.

The Hydrology Attribute for the two assessment areas was similar; 58 for the bridge site and 50 for the upstream site. Both sites received the same metric scores for Water Source (C) and Channel Stability (B). The bridge site scored better for hydrologic connectivity due to less incision in the main channel closer to the lagoon. The planned removal of the levees and reconnection for the main channel with the adjacent floodplain will increase the hydrologic connectivity score for this portion of the river.

Both riverine sites included relatively few structural patch types, which resulted in the moderate Physical Structure score of 63. The proposed reconnection of the main channel of the river with the floodplain will enhance dynamic fluvial processes, which will lead to an increase in physical complexity of the floodplain and improve metric scores for both physical patch types and topographic complexity.

For the Biotic Structure Attribute both sites received a score of 67. Both sites had relatively few co-dominant plant species (6 at the bridge and 7 at the upstream site) and low interspersion of unique plant zones. By reconnecting the main channel of the river with the floodplain and by enhancing floodplain topography through the planned grading efforts, a more diverse and dynamic ecosystem will be reestablished. The construction of a more complex moisture gradient and the diversity of plant species included in the planning palate, will result in an increase in the biotic structure and increase Biotic scores.

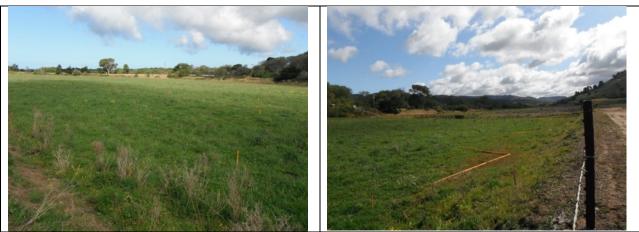
Figure 6. Photos of the slope CRAM assessment.

The CRAM assessment of the Carmel River floodplain was assessed using the Slope CRAM module and received a condition score of 47 (Table 3, Figure 6). Forty seven is a low CRAM condition score and is driven by low scores for the Buffer and Landscape Connectivity, Physical Structure and Biotic Structure Attributes. The lack of wetlands within 500 meters of the assessment area resulted in a 'D' score for Landscape Connectivity. The area had few physical patch types and low topographic complexity, leading to a low Physical Structure score. These low scores were expected in an area dominated by cattle grazing and other agriculture uses until recently. Few co-dominant plant species, high numbers of invasive plants, poor interspersion of unique plant zones, and poor vertical complexity of plant layers led to a low Biotic Attribute score.

This condition assessment serves as a baseline from which the planned restoration activities on the floodplain can be evaluated. Replicate assessments in the future at the same locations once the restoration and enhancement actions have taken place will help document the change in the condition of the riparian floodplain.

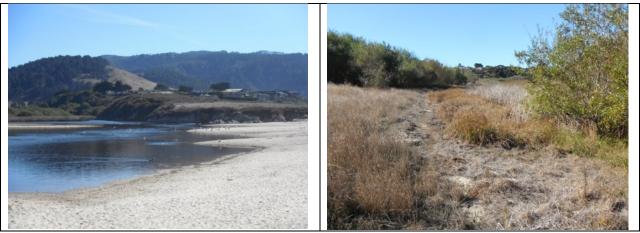
Figure 7. Photos of the BBE CRAM assessment.

The CRAM assessment of the portion of the Carmel River lagoon located within the project area had a condition score of 63 (Table 4, Figure 7). This score is slightly lower than the average conditions score of 72, based on five other assessments within the Carmel River Lagoon that have been performed since 2011 (Table 5, Figure 8).

The Buffer and Landscape Context Attribute received a score of 56 due to a degraded stream corridor upstream of the estuary and a low abundance of adjacent wetland areas. A new channel that will be built during construction will link the arm of the estuary to the river under Hwy 1, improving stream connectivity, and increasing the amount of adjacent wetlands.

The Hydrology Attribute received a score of 67, which, driven by common up stream water resources, is identical for all assessments in the estuary.

The Physical Attribute received a score of 50 due to a low number of physical patch types observed in the assessment area. We expect this score will improve with the restoration of the floodplain and formation of the new channel under Hwy 1. These proposed changes will provide more biotic and abiotic complexity to the arm of the estuary, leading to and improved Physical Structure attribute score.

The Biotic Attribute received a score of 78. The assessment area scored the maximum points for all metrics except for the number of co-dominant species and unique plant zones. Both of these metrics will be enhanced by the restoration and mitigation actions planned for the site.
