# Carr Lake Restoration Site: Pre-Implementation Condition Assessment

## *Final Summary Report*

**December, 2019**

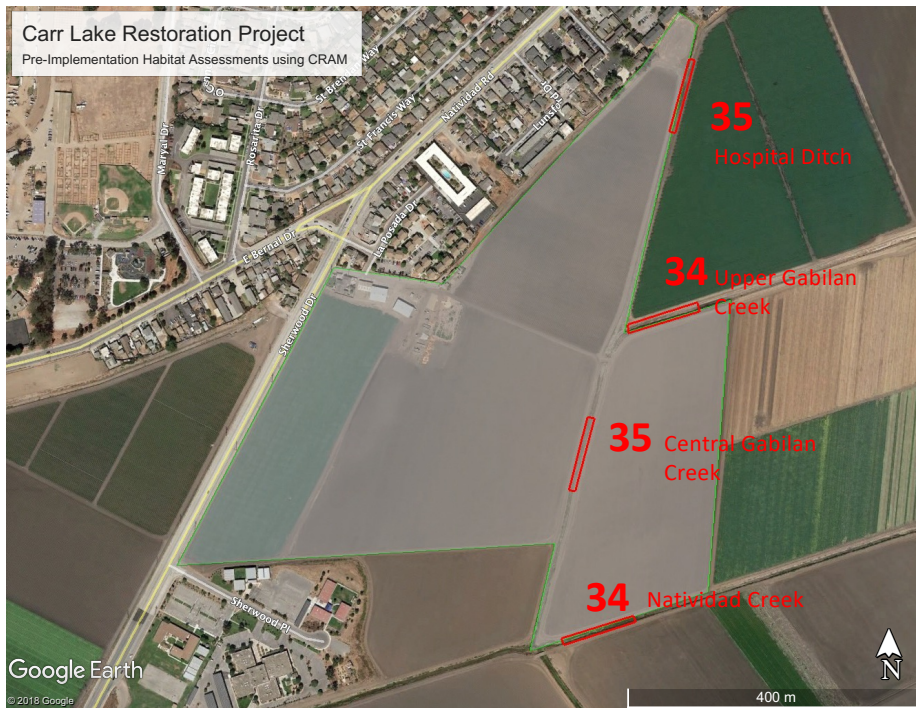
The riverine CRAM assessment of the Carr Lake restoration site showed an average condition score of 34.5 (Figure 2, Table 2). The Index Scores ranged from 34 to 35, with the range of scores all within the margin of error of the methodology.

**Figure 2.** CRAM Index scores for each Assessment Area in the Carr Lake restoration project area. All sites scored in the “poor” category.

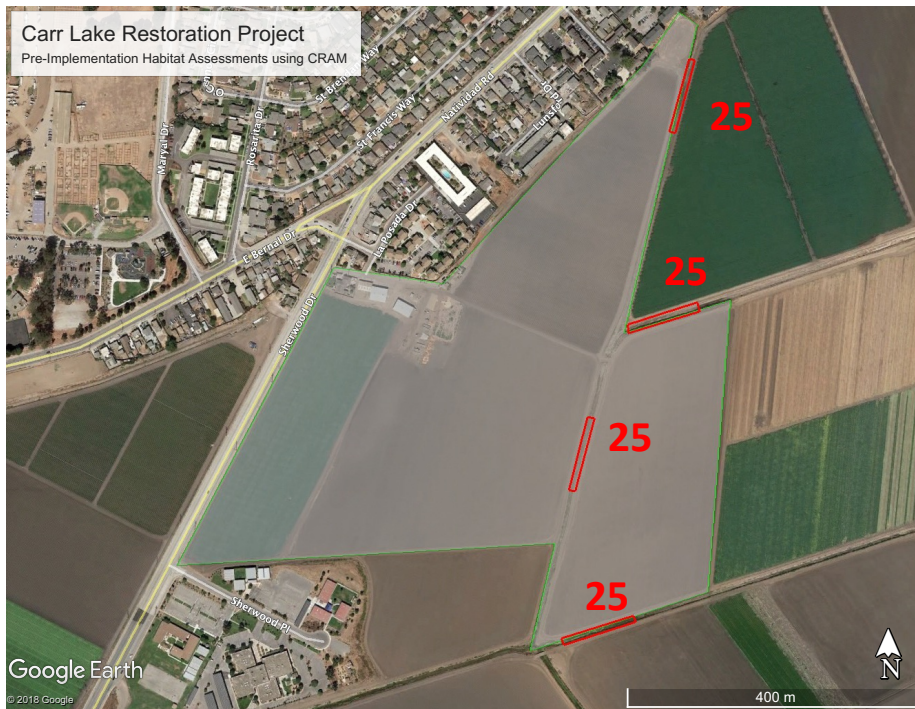
The average Buffer and Landscape Context Attribute score showed an poor condition score of 25, with all sites reporting the same score (Figure 3). This was due to the streams being located in an active agricultural setting, preventing the assessment areas from having wide buffers of wetland and upland habitat surrounding them. In addition, there is poor stream corridor continuity upstream and downstream of the assessment areas due to the lack of a riparian corridor.

**Figure 3.** Buffer and Landscape Attribute scores for each Assessment Area.

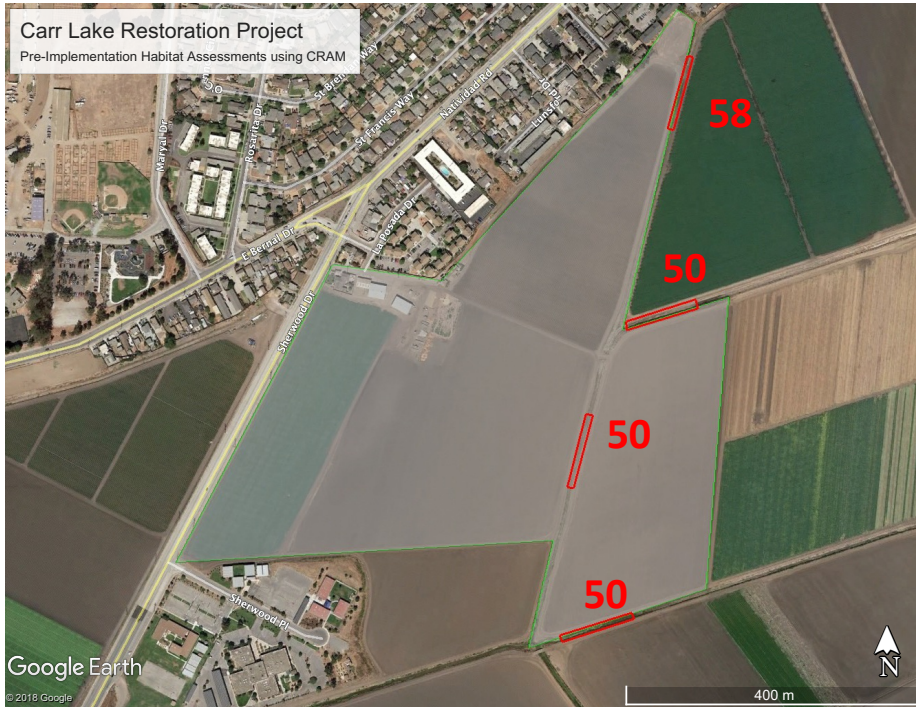
All four of the assessment areas received a fair condition score of 50 or 58 for the Hydrology Attribute (Figure 4). The assessment areas scored low for the water source metric due to the high amount of agricultural land use in the immediate watershed. The Channel Stability metric, which looks at the amount of aggradation or degradation within the Assessment Area, received a low score as well. The Hydrologic Connectivity metric, which compares the bankfull width of the stream to the flood prone width of the stream, ranged from a score of C to a score of B.

**Figure 4.** Hydrology Attribute scores for each Assessment Area for the Salinas River lagoon.

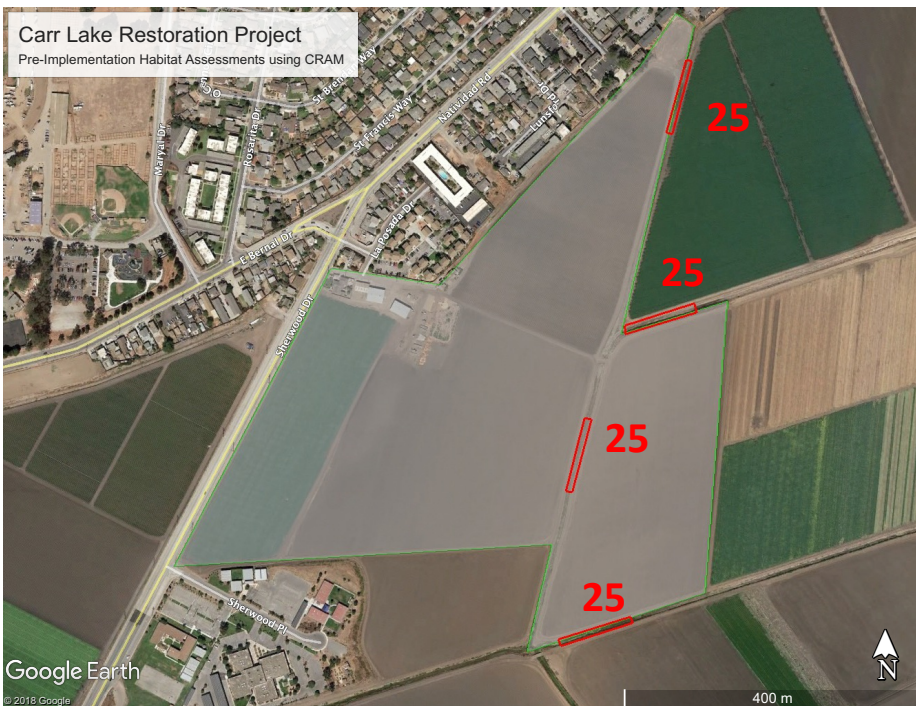
The Physical Structure Attribute received an average score of 25, with all four sites having the same score. The sites received a score in the “poor” condition category due to a low number of physical patch types observed in the assessment areas and a lack of topographic complexity in the stream channels.

**Figure 5.** Physical Structure Attribute scores for each Assessment Area.

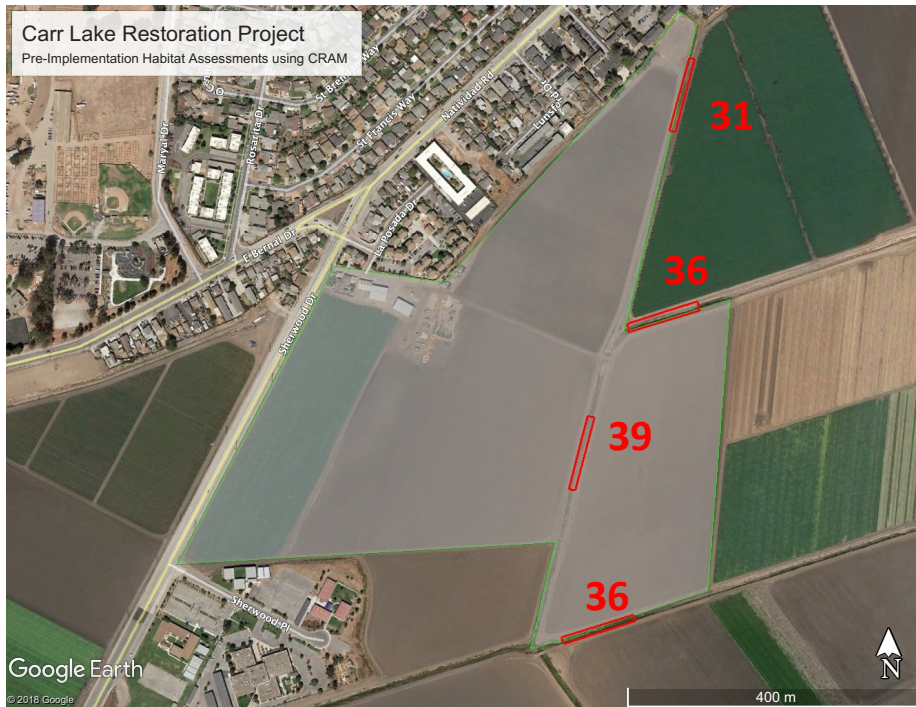
The Biotic Structure Attribute received an average condition score of 35, ranging from 31-39, and falling in the “poor” category. Three out of the four sites received the high score for lack of invasive plant species, however, all sites lacked high numbers of plant species, plant layers, interspersions of plant zones and vertical structure in the plant community. This led to overall low scores for this attribute.

**Figure 6.** Biotic Structure Attribute scores for each Assessment Area.

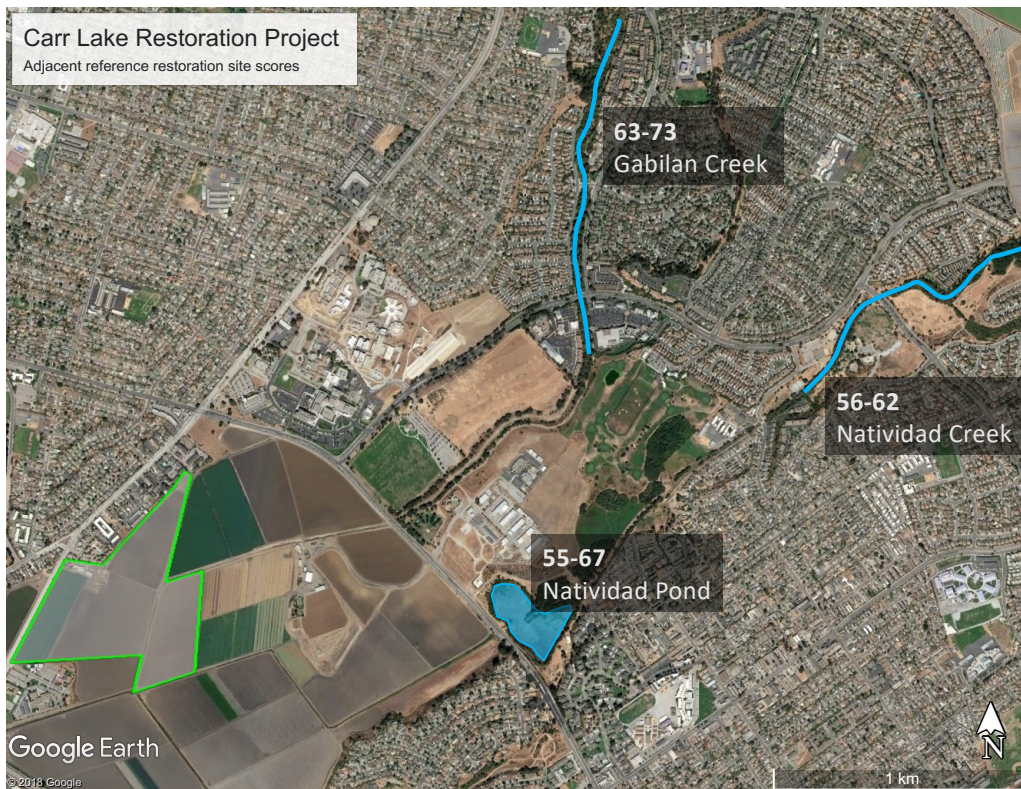
In general, the Carr Lake restoration site falls in the lower end of what is considered a “poor” condition stream in California according to CRAM. Figure 7 provides context of how the aquatic resource condition on the site (described above) currently compares to restored areas in the immediate vicinity, including stream sites along the Gabilan and Natividad Creeks as well as a pond site just upstream of the proposed restoration project. Due to the landscape setting of the site in the center of an urban area with row crop agriculture, one cannot expect an “excellent” condition stream or pond upon completion of the restoration actions, but a significant amount of functional lift can still occur.

**Figure 7.** Range of CRAM Index Scores at restoration sites (blue) in the immediate vicinity of the proposed restoration project (green).
