ARROYO SEQUIT

ESTUARY FACT SHEET

State Park Location: Leo Carrillo State Park
Coordinates: 334.044800, -118.934000
Estuary Size: 4.2 ha
Estuary Area within State Park: 99%
Watershed Area: 28.2 sq. km
Watershed in Conservation: 69%

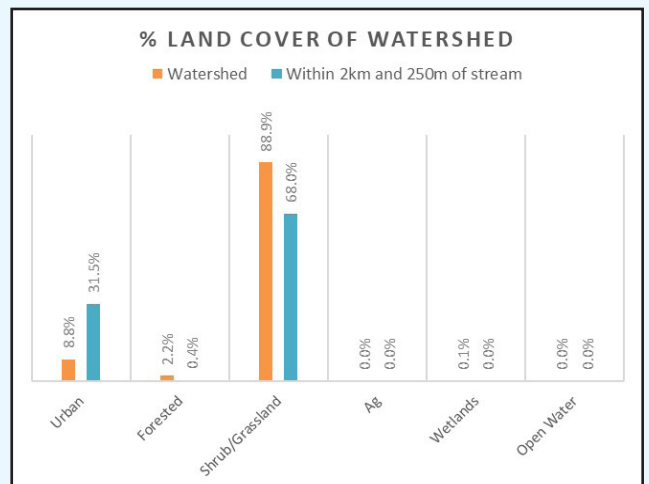
Graph shows % land cover within entire watershed compared to within a buffer of 2km upstream of outlet and 250 meters from stream. Land cover within the watershed is dominated by shrub/grassland.

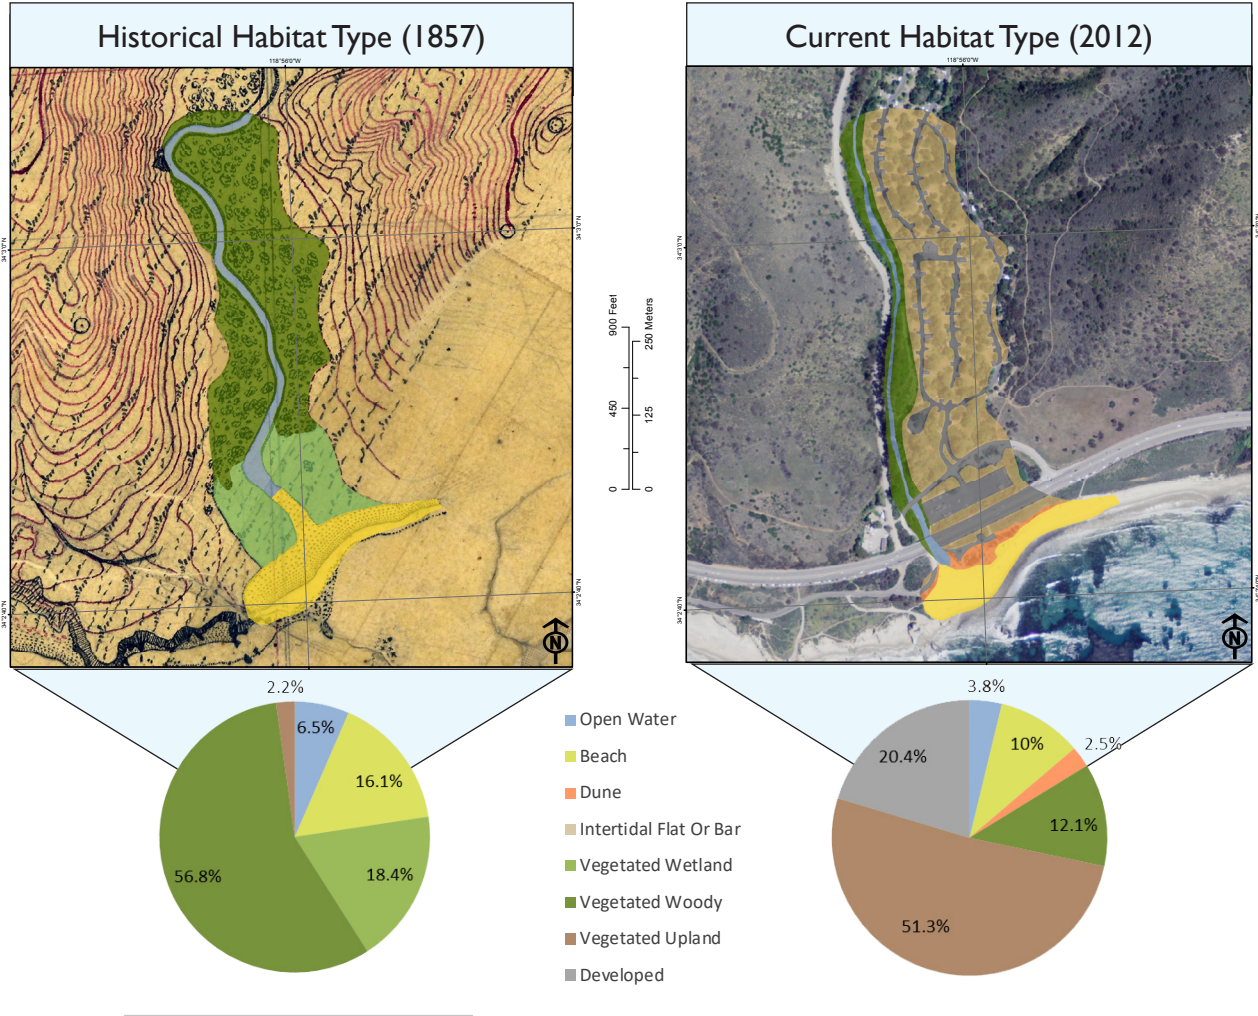
Habitat Change Analysis

Habitat type maps and charts for 1857 and 2012. Habitat maps use USGS T-Sheets for the historical map and National Agriculture Imagery Program (NAIP) imagery (2012) for the current map. Much of the estuary’s historical vegetated wetland and woody habitat has become vegetated upland habitat or has been developed.

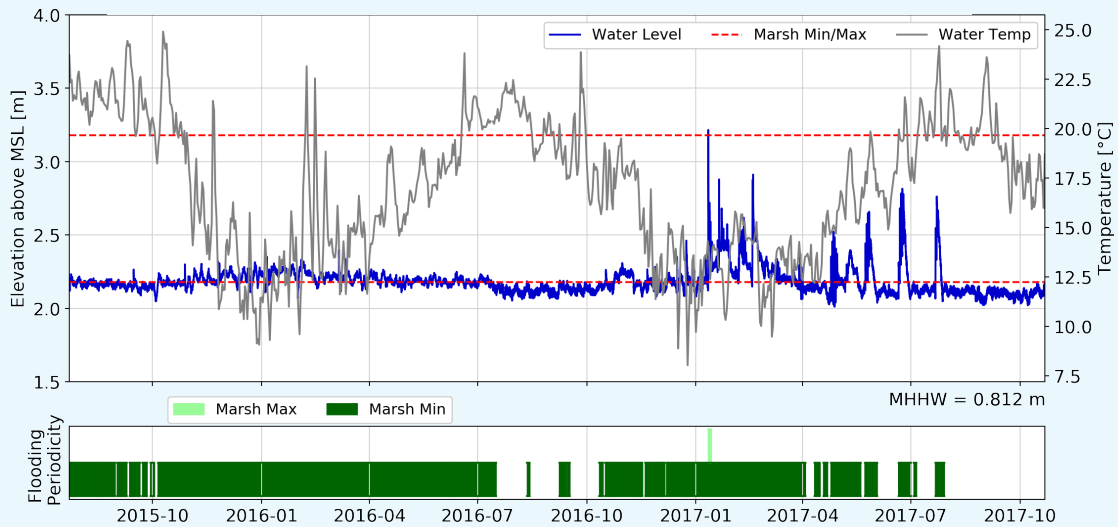
Estuary Water Elevation and Temperature

Graph shows fluctuations in water elevation and temperature, as well as flooding periodicity of marsh plain from October 2015–October 2017. Water temperatures are daily mean values.
