# TUNITAS CREEK

## Site Info

**Summary:** The site's CRAM score (74) fell into the *fair* condition category. Land cover within the watershed is dominated by forest and shrub/grassland. The system has lost most of its historic wettable lowlands which have been replaced by upland and vegetated woody habitat.

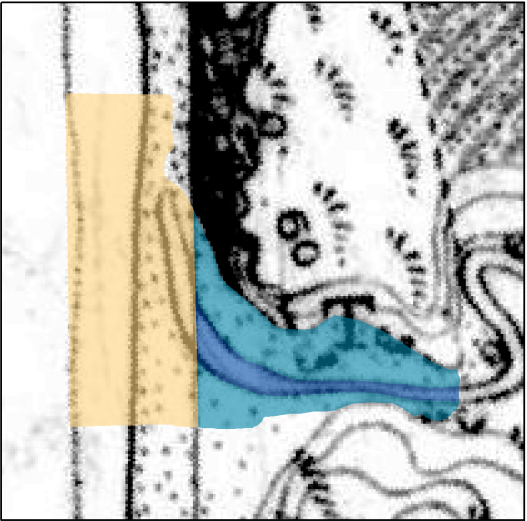
Historic Habitat Type

HABITAT TYPE	CHANGE IN %
Beach	-8
Open Water	-2
Developed	1
Upland	26
Vegetated Woody	8
Wettable Lowland	-24
