# Assessment of Select Estuaries of Marin County

## *Summary Data Report*

San Francisco Bay Regional Water Quality Control Board

**July 2018**

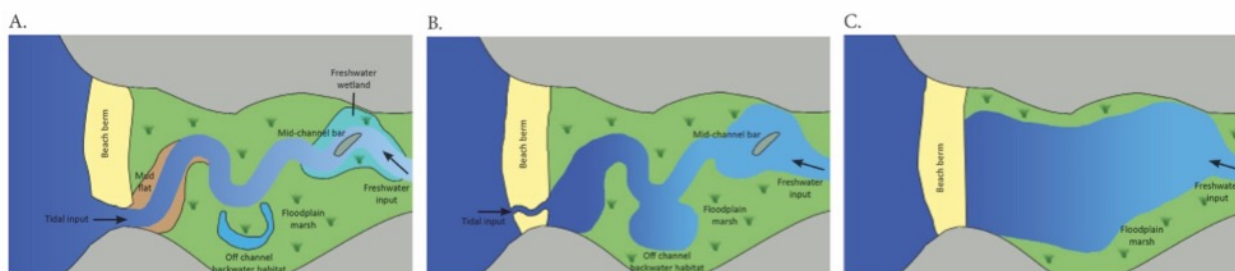
Figure 1. Conceptual figure of a) open, b) partially open, and c) closed bar-built estuary.

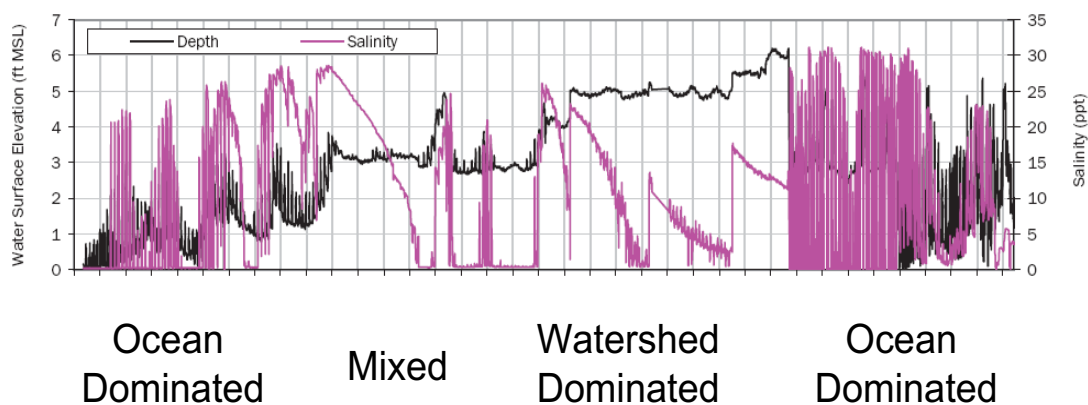
Figure 2. Hydrograph indicating variability in depth and salinity of a BBE over time.

The frequency and duration of inlet closure can be natural or managed. Many of these systems exhibit prolonged muted or non-tidal periods when ocean and river mixing is restricted leading to highly variable salinity regimes, ranging from fresh to hypersaline (Figure 2).

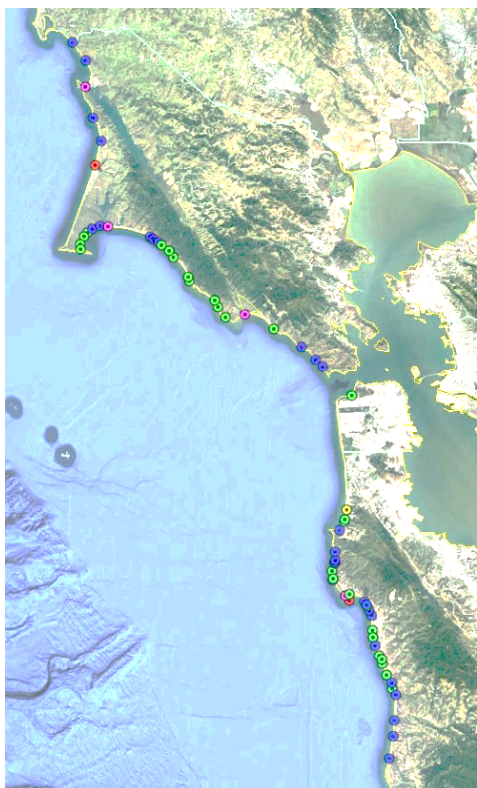
Figure 3. Locations of all coastal confluences in Marin and San Mateo Counties. (blue=BBE, green=creek mouth, red=true lagoon, pink=open estuary, yellow=coastal depression).

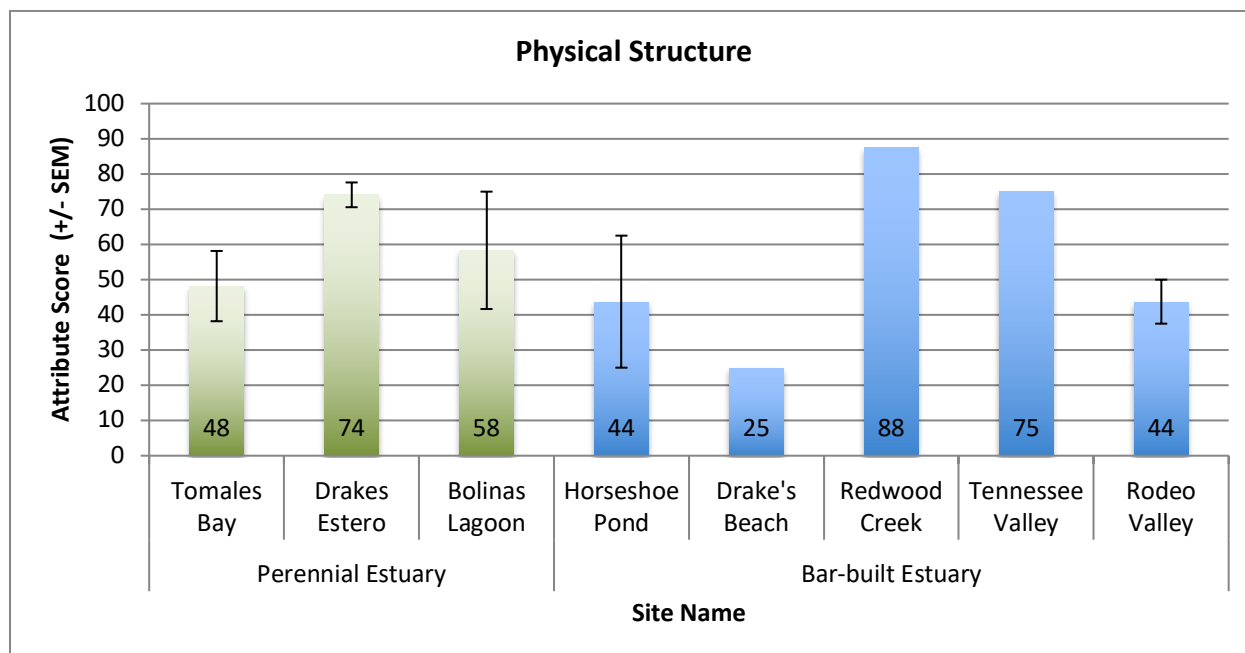
Figure 9. The physical structure attribute evaluates the complexity of form and structure affecting the biodiversity and other functions of a wetland by looking at structural patch richness and topographic complexity within the Assessment Area. Error bars representing the standard error of the mean are present at sites when more than one CRAM assessment was performed for a particular system.

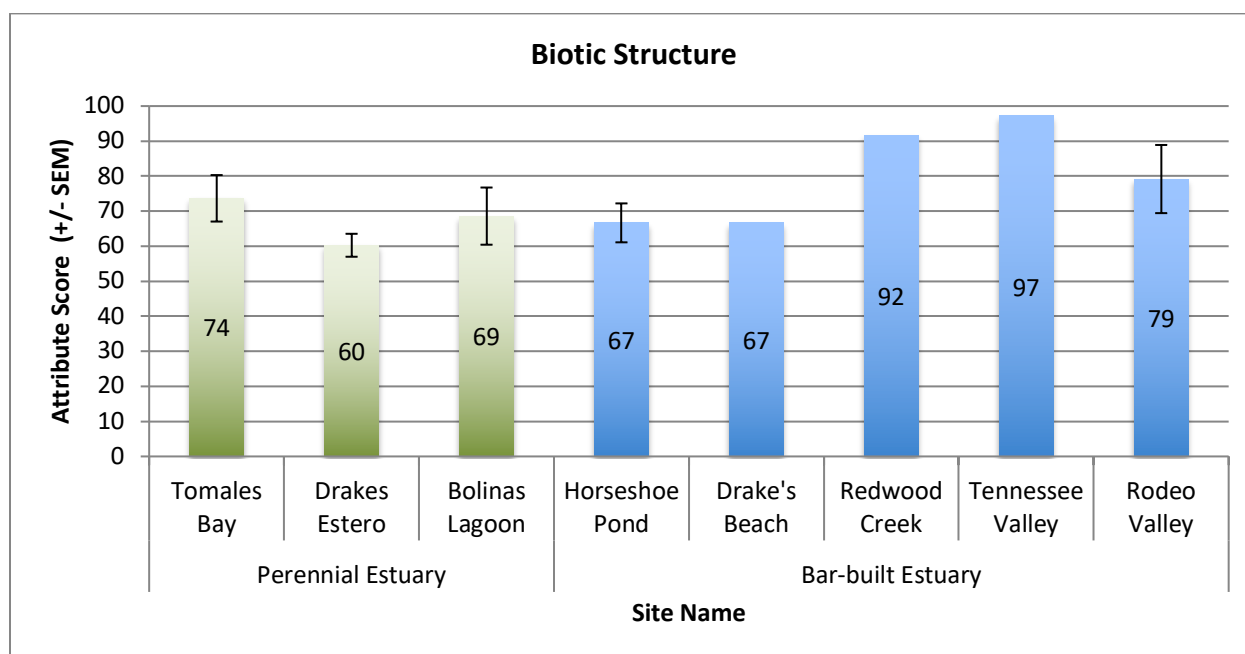
*Figure 10. The biotic structure attribute addresses the complexity of a wetland by looking at plant species richness, horizontal zone complexity, and vegetation layering within the assessment area. Error bars representing the standard error of the mean are present at sites when more than one CRAM assessment was performed for a particular system.*
