**Demonstration of an Integrated Watershed Assessment
using the Level 1, 2, 3 Monitoring Framework in the Morro
Bay Watershed**

December 2, 2008

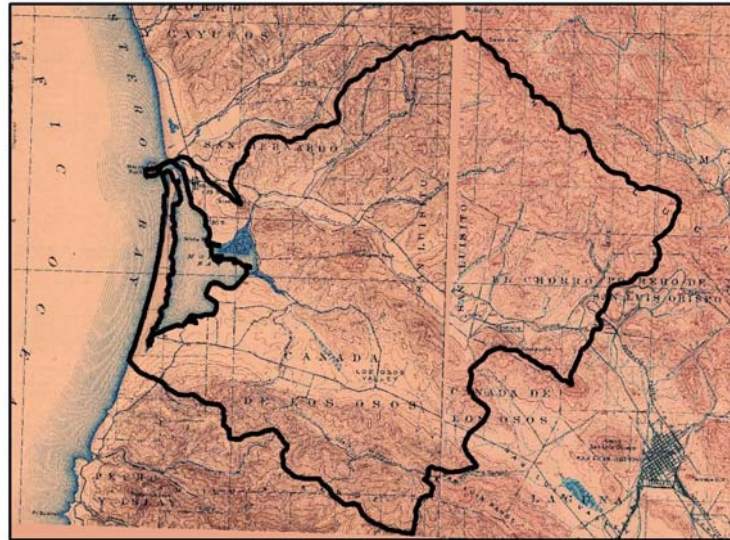
Extent of wetlands in the Morro Bay watershed, 1897

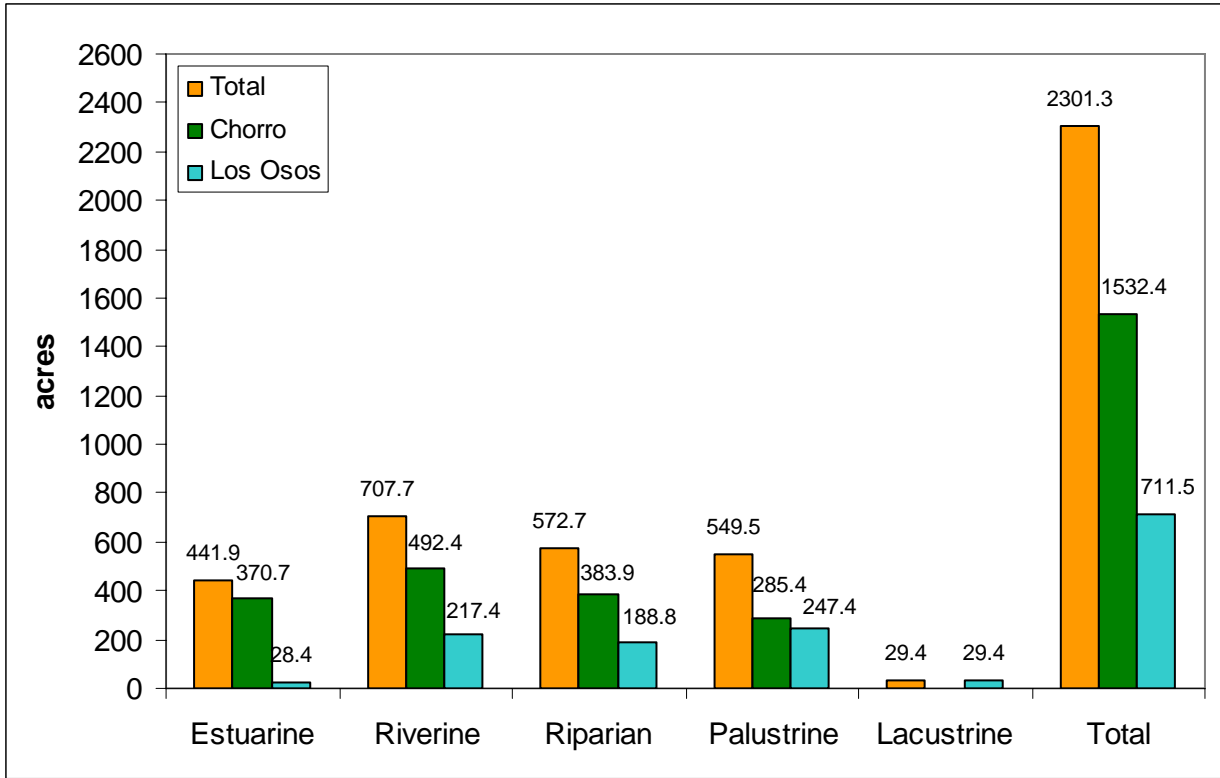
Figure 7. Summary of contemporary wetland acreage in Morro Bay for the full watershed and by subwatershed using a modified Cowardin classification system

The Chorro Creek sub-watershed contains 66.5 percent of the wetlands for the entire watershed. In contrast 31 percent are located in the Los Osos sub-watershed (Figure 7). The remaining 2.5 percent of wetlands are located in the delta between Morro and Estero Bay. An analysis to evaluate the loss of riparian acreage in relation to stream miles revealed that there is no significant difference in the composition of riverine and riparian acreage between the Los Osos and Chorro Creek sub watersheds.

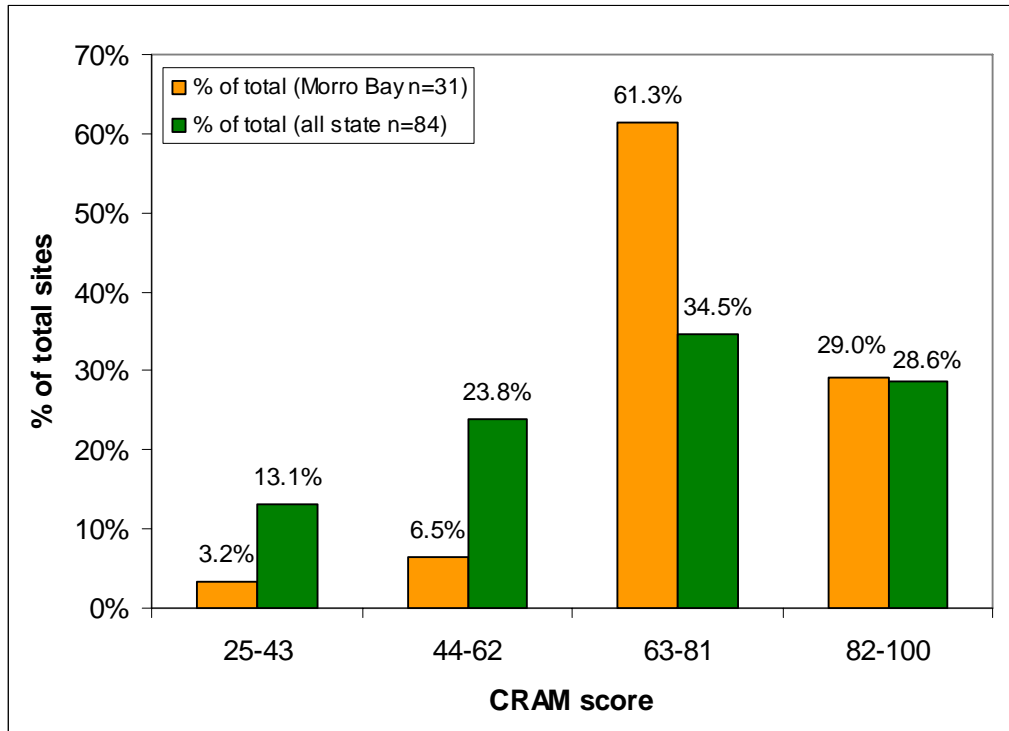
Figure 11. Comparison of the distribution of CRAM scores in the Morro Bay watershed to scores collected across the entire state of California at California Fish and Game Perennial Stream Assessment sites, 2008.

In comparing the ambient riverine condition of Morro Bay to that of a similar probabilistic inventory of wetlands throughout California, Morro Bay was found to have a higher percentage of sites in the “good” and “excellent” than the state as a whole (Figure 11, 90% compared to 63%).

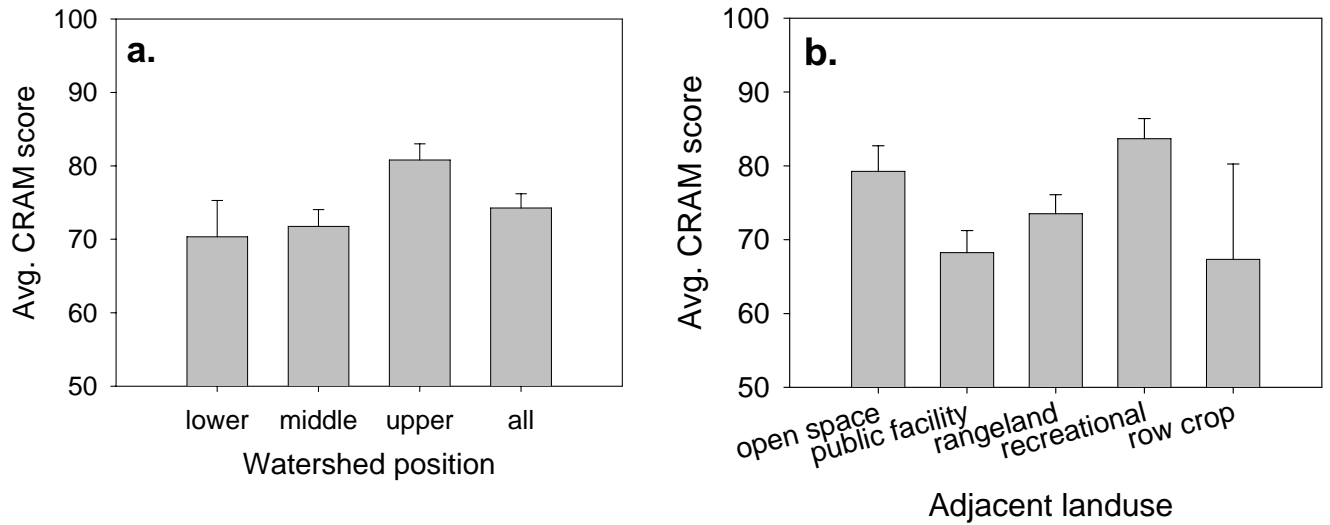
Figure 12. Mean CRAM scores by a) watershed position, and b) adjacent landuse type, bars represent SEM.

Overall CRAM scores varied by location within the watershed and illustrate clear patterns ($p=0.05$) between the upper (undeveloped) portions, the middle watershed (rangeland), and lower (more developed) portions in terms of condition (the “all watershed” condition average was added later for reference and not included in the statistical analysis) (Figure 12a). The upper watershed, which is comprised mostly of natural streams on public land, had the highest average CRAM score. The middle portion of the watershed, which is predominantly grazed rangeland, had lower average CRAM scores. The lower watershed, which is comprised of a mix of semi-natural and channelized systems through a mix of urban, agriculture and relatively natural landuse types, had the lowest scores. CRAM scores also varied significantly by adjacent landuse type ($p=0.05$). Riverine condition at sites located on recreational land (mainly the Los Padres national Forest) and open space had higher scores in general than sites located on rangeland, public facility land (mainly the California Men’s Colony) and on land with row crop agriculture (Figure 12b). Error estimates for CRAM evaluations have been estimated to be +/-10%, which suggest that differences between wetlands are real if not statistically significant as a population.

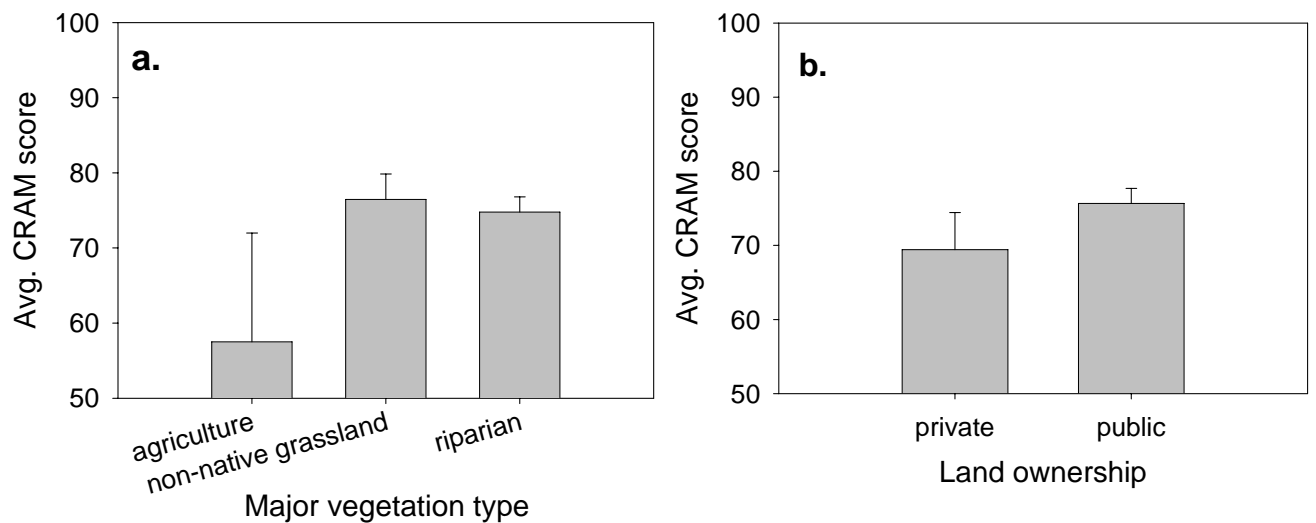
Figure 13. Effect of a) major adjacent vegetation type and b) land ownership on mean CRAM score, bars represent SEM

Comparing CRAM scores among sites with different adjacent vegetation and land ownership revealed no significant results. However, it showed a trend for higher scores on non-native grassland and riparian vegetation than at sites surrounded by agriculture (Figure 13a). Slightly higher scores were observed on public land than on private (Figure 13b).

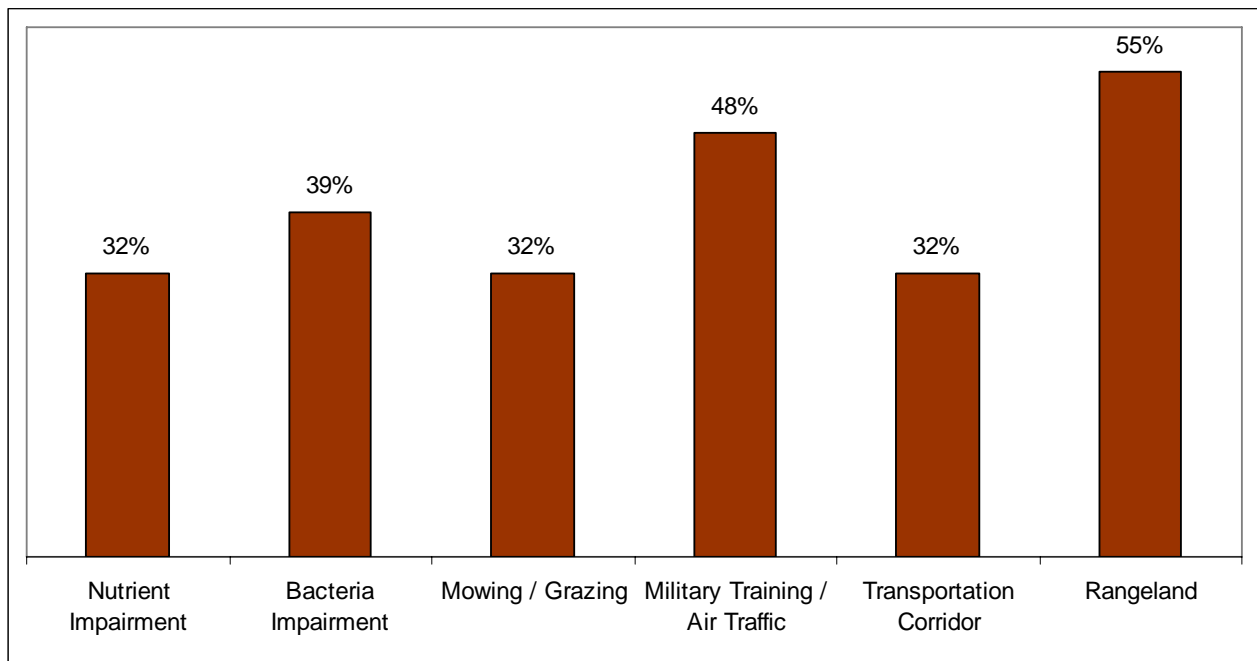
Figure 14. The six most common stressors present at ambient assessment locations with percent of assessments that had the stressor present.

Analysis of stressors affecting ambient assessment locations showed over half of the ambient sites, 55 percent, had rangeland as a stressor, while 48 percent had military/air traffic present as a stressor, and bacterial impairment was present at 39 percent of sites (Figure 14). Nutrient impairment, mowing/grazing within 50m of the assessment area, and transportation corridor all had a similar occurrence, 32 percent, at the ambient assessment locations.

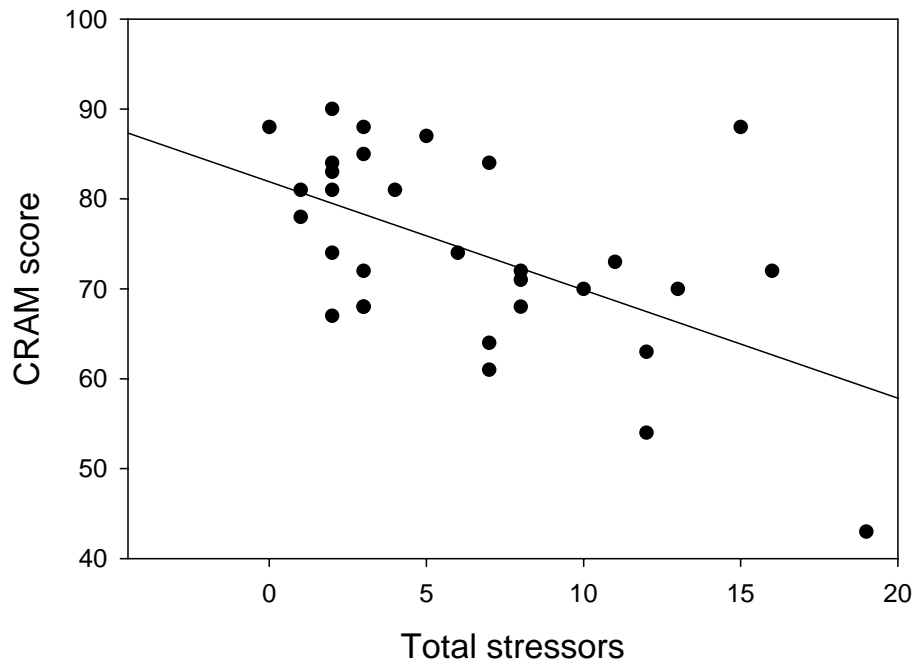
Figure 15. Comparison of total CRAM score to the total number of stressors present at an assessment site.

In analyzing the relationship between the condition of an assessment area and the stressors affecting them, it was found that an increase in the total number of stressors (both present and significant) at each site showed to have a significant negative effect on the CRAM score of that site ($p=0.001$, $r^2=0.309$) (Figure 15).

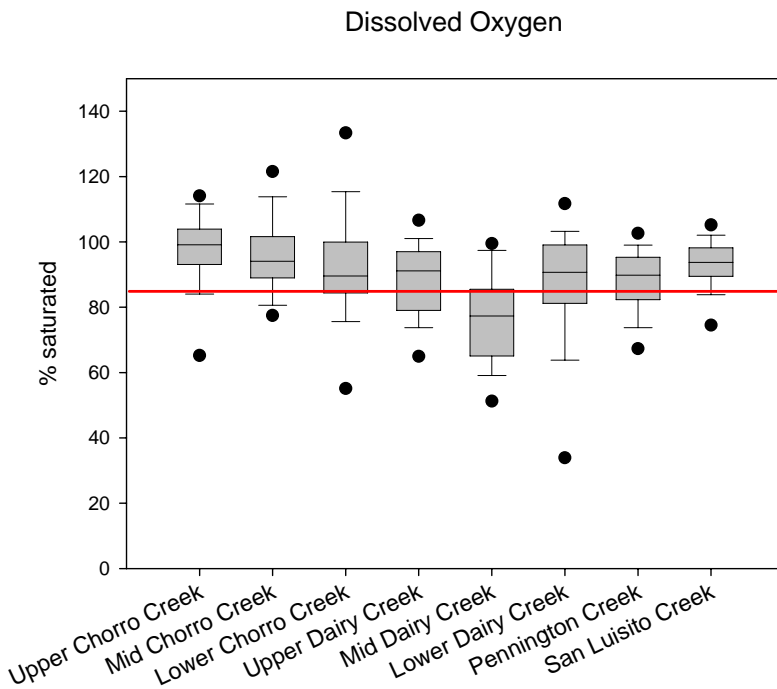
Figure 18. Average recorded a) concentration of dissolved oxygen and b) saturation of dissolved oxygen from 2002-2007 at VMP water quality stations.

According to Kitajima (2008), water quality sites that were sampled by the MBVMP from 2002-2007, and were in close proximity to an ambient assessment site, did not have median values that fell below the threshold of 7 mg/L of dissolved oxygen as defined by the Central Coast Basin Plan for protecting fish habitat (Figure 18a). However, many water quality sites did fail the 85% saturation level also set by the Central Coast Basin Plan (Figure 18b). Seventy five percent of the samples at the Mid Dairy Creek site exceeded the 85% saturation threshold. Samples from the upper and lower portions of Dairy Creek exceeded the saturation threshold 42 and 30 percent respectively. Thirty six percent of the samples at Pennington Creek, while 27 percent of the samples from the Lower Chorro Creek site were in exceedance.

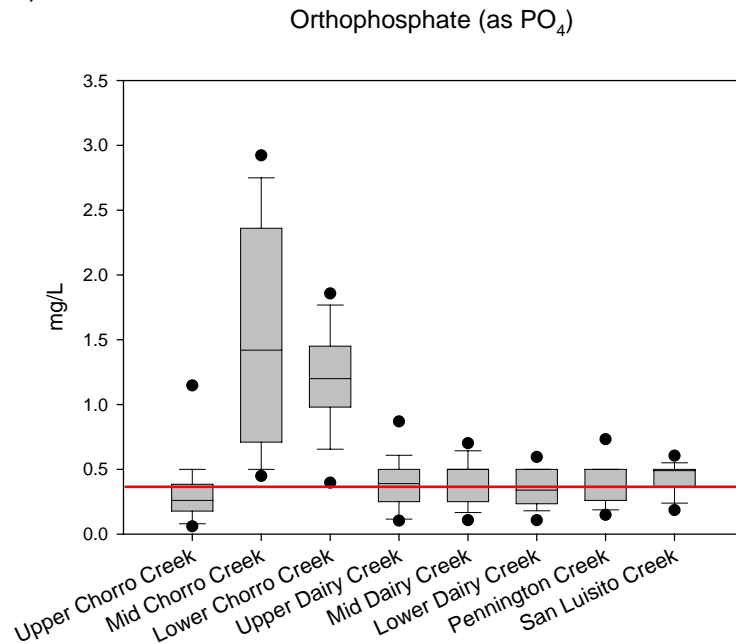
Figure 20. Average recorded a) nitrate concentration and b) phosphate concentration from 2002-2007 at VMP water quality stations.

The median nitrate concentration exceeded CCAMP's level of concern concentration of 2.25 mg/L 46% of the time at mid Chorro Creek and 57% of the time at lower Chorro

Creek (Figure 20a). The median orthophosphate concentrations exceeded CCAMP's informal attention level of 0.37 mg/L at all water quality sites on average 52% of the time (Figure 20b) (Kitajima, 2008).

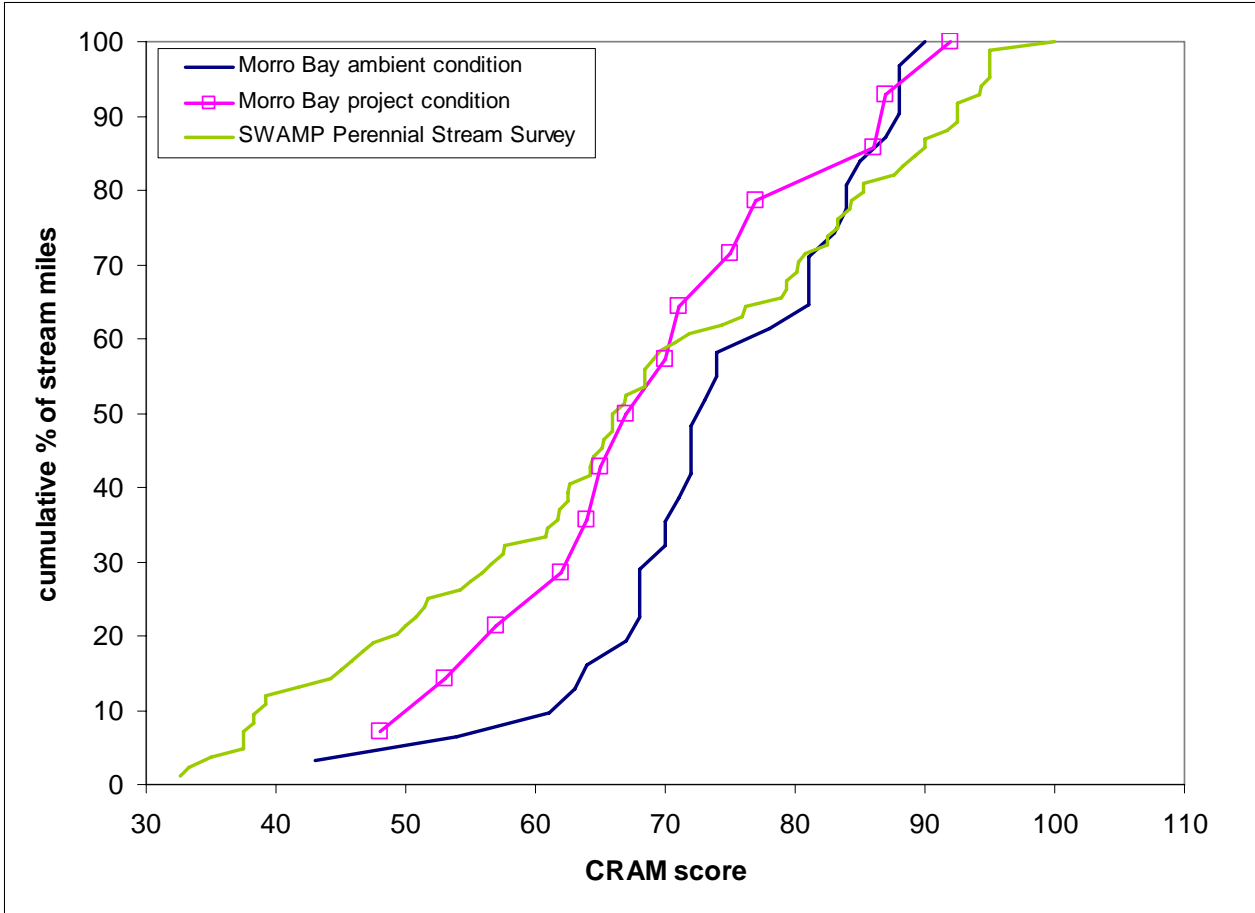
Figure 21. Comparison of the cumulative distribution functions for ambient, project sites, and the SMAMP Perennial Stream Survey of ambient statewide condition assessed with CRAM in the Morro Bay watershed.

Level 2 assessments of ambient condition provide the context for interpreting habitat data collected at restoration project sites in the watershed. A comparison of cumulative distribution functions for CRAM scores from the 2007 ambient survey sites and the fourteen project sites suggests that restoration project activities are able to achieve condition scores comparable to the best ambient conditions recorded. Cumulatively however, the project condition scores reflect limitations in restoration activities ability to enhance certain aspects of wetland condition, reflected in lower average CRAM metric scores (Figure 21).

Therefore, the CRAM score by itself provides context for the condition of the wetland being assessed. For example, an overall CRAM index score of 72 can be interpreted as median condition compared to all other wetlands within the class being assessed throughout the Morro Bay watershed. Our overall sample frame did not include as vast a range of wetland conditions to those found throughout the state as shown by the SWAMP Perennial Stream Survey CRAM results. Since CRAM score maxima are based on an ideal wetland, it is not surprising to find that high quality wetlands within this semi-arid watershed score lower than wetlands within the state as a whole. However, the low occurrence of sub-optimal wetlands in general within this study is most likely the result of a less degraded overall condition within the watershed as well as limited access to portions of the watershed which potentially have a lower overall condition (Figure 21).
