**APPENDIX 1: DEMONSTRATION OF AN INTEGRATED WATERSHED  
ASSESSMENT USING THE LEVEL 1, 2, 3 MONITORING FRAMEWORK  
IN THE MORRO BAY WATERSHED**

**Demonstration of an Integrated Watershed Assessment  
using the Level 1, 2, 3 Monitoring Framework in the Morro  
Bay Watershed**

*December 2, 2008*

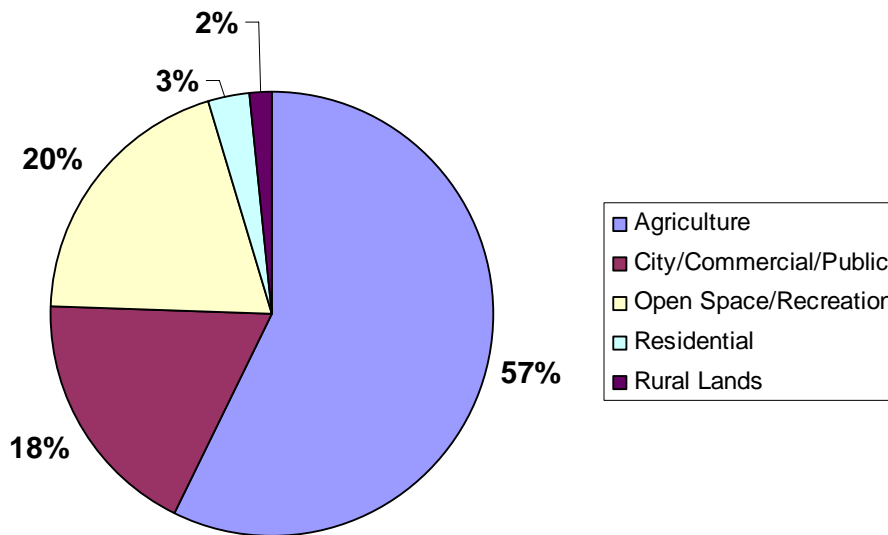
**Figure 10.** The proportion of land use types recorded in the Morro Bay Watershed

Approximately 57 percent of the watershed has been designated as agricultural use; this is primarily rangeland with some row-crop agriculture in the valley floors. Twenty percent has been set aside as open space or recreational areas, including the Los Padres National Forest. Only 2 percent of the watershed is considered rural land, while the remaining 3 percent is residential area (Figure 10).

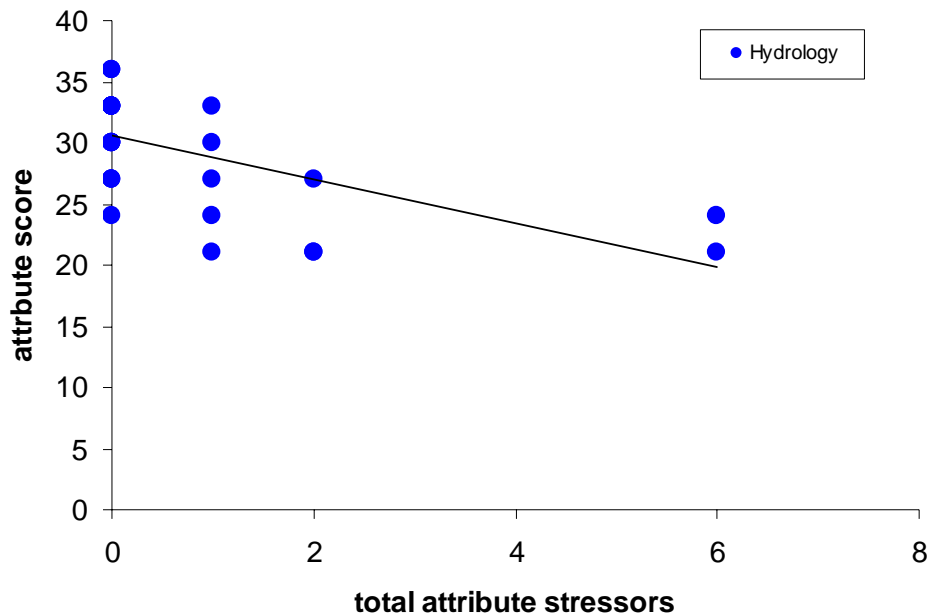
**Figure 16.** Comparison of the attribute score to the total number of attribute stressors present for the Hydrology at all 31 ambient assessment sites.

Taking this analysis a step further to look at the relationship of stressors and CRAM scores at the attribute level, it was revealed that the negative relationship exists for the hydrology ( $p < 0.001$ ,  $r^2 = 0.36$ ) attribute, composed primarily of external factors that affect the assessment area (Figure 16). However there was no relationship found between attribute score and the number of attribute stressors affecting the biotic structure and physical structure of an assessment area, both composed of internal metrics affecting the assessment area.

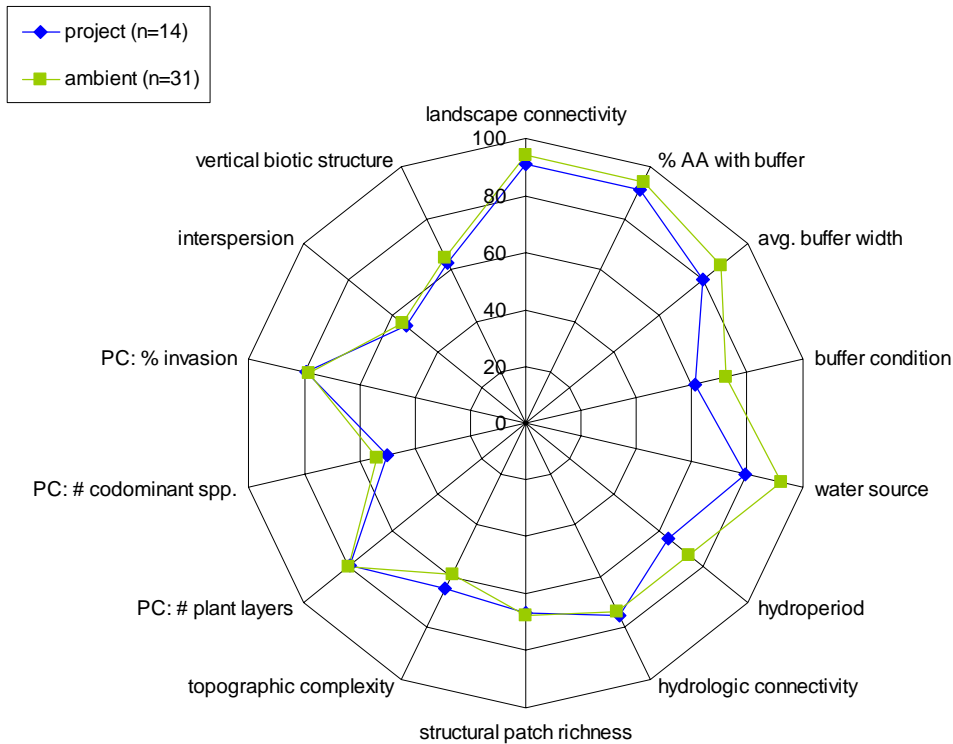
**Figure 17.** Comparison of the metric scores among project and ambient assessment sites in the Morro bay watershed.

Comparison of the metric scores among ambient and project sites for the Morro Bay watershed found differences in average scores for the buffer width, buffer condition, water source, hydroperiod, and topographic complexity metrics (Figure 17). Only the topographic complexity metric had a higher average score in restored areas in comparison to ambient condition. Scores in both restored and ambient sites had lower condition scores than expected for vertical biotic structure, interspersions, and # codominants metrics. Since CRAM was designed to quantify the range of wetland condition throughout the state, these lower scores may be the result of natural limitations in the biotic complexity of rivers in this moderately arid region.

Comparison of the metric scores between restoration project sites and the ambient assessment sites revealed the project assessments scored at or below the ambient assessments with exception of topographic complexity and hydrologic connectivity. The largest metric score difference is seen in water source, followed by buffer condition, hydroperiod, and average buffer width. At the metric scale the ambient assessments seem to be in better condition than the project sites, but overall the CRAM scores are very similar. These data suggest that restoration activities can establish a condition similar to ambient but the individual project condition ranged as widely.

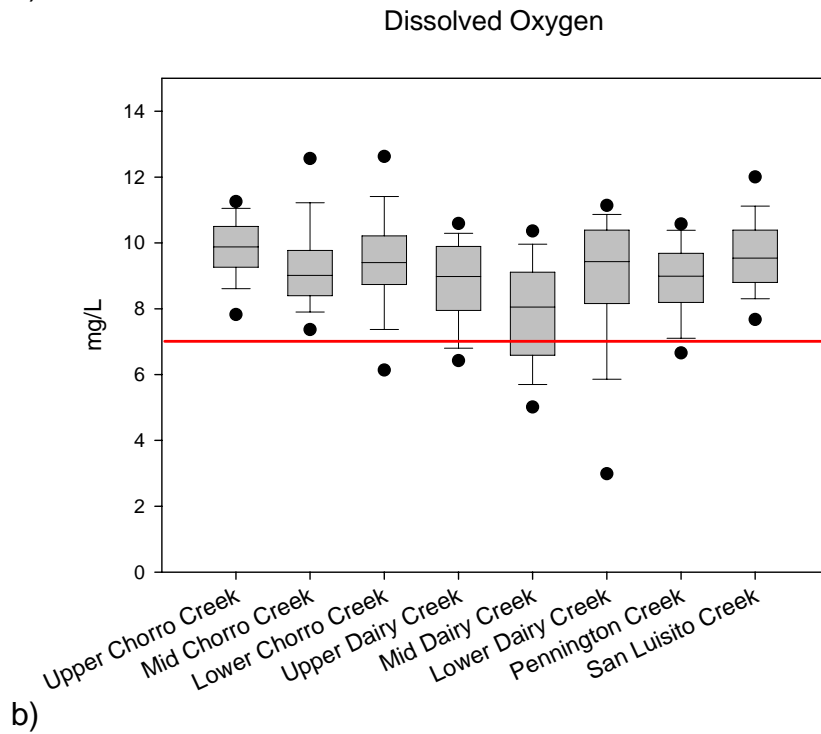
**Figure 18.** Average recorded a) concentration of dissolved oxygen and b) saturation of dissolved oxygen from 2002-2007 at VMP water quality stations.

According to Kitajima (2008), water quality sites that were sampled by the MBVMP from 2002-2007, and were in close proximity to an ambient assessment site, did not have median values that fell below the threshold of 7 mg/L of dissolved oxygen as defined by the Central Coast Basin Plan for protecting fish habitat (Figure 18a). However, many water quality sites did fail the 85% saturation level also set by the Central Coast Basin Plan (Figure 18b). Seventy five percent of the samples at the Mid Dairy Creek site exceeded the 85% saturation threshold. Samples from the upper and lower portions of Dairy Creek exceeded the saturation threshold 42 and 30 percent respectively. Thirty six percent of the samples at Pennington Creek, while 27 percent of the samples from the Lower Chorro Creek site were in exceedance.

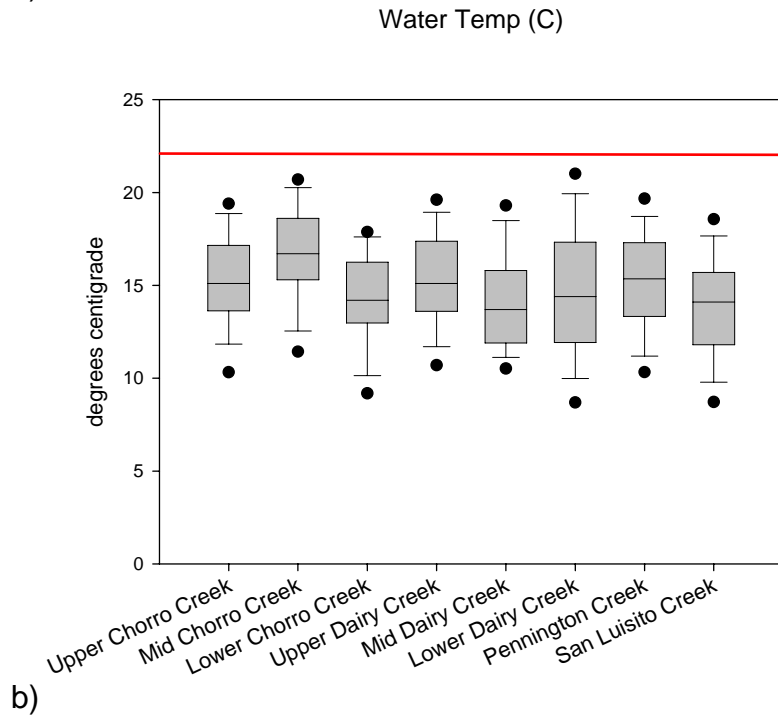
**Figure 19.** Average recorded a) water temperature and b) turbidity from 2002-2007 at VMP water quality stations.

The median temperature at the water quality sample sites did not exceed CCAMP's level of concern temperature of 22 degrees Centigrade (Figure 19a). Additionally, the

median turbidity levels at the water quality sites did not exceed the CCAMP informal attention level of 10 NTU (Figure 19b) (Kitajima, 2008).

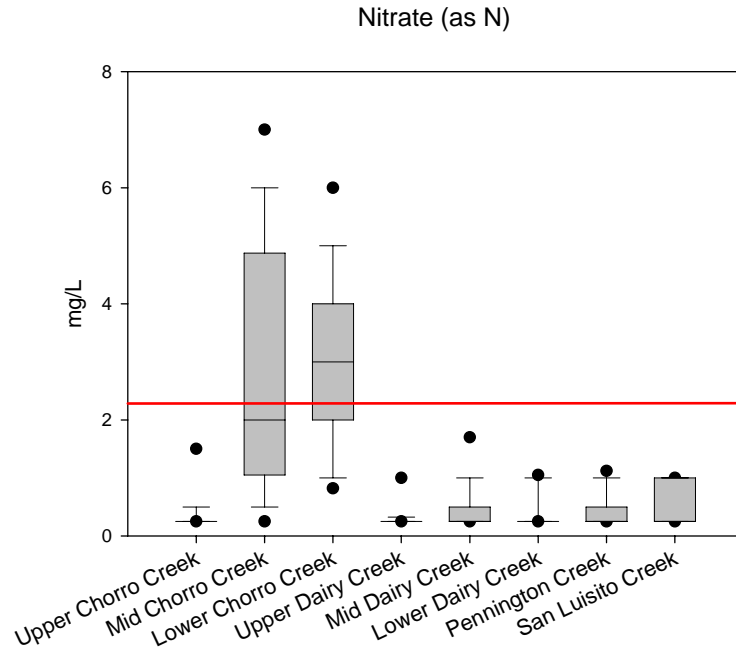
**Figure 20.** Average recorded a) nitrate concentration and b) phosphate concentration from 2002-2007 at VMP water quality stations.

The median nitrate concentration exceeded CCAMP's level of concern concentration of 2.25 mg/L 46% of the time at mid Chorro Creek and 57% of the time at lower Chorro

Creek (Figure 20a). The median orthophosphate concentrations exceeded CCAMP's informal attention level of 0.37 mg/L at all water quality sites on average 52% of the time (Figure 20b) (Kitajima, 2008).
