**I. Restoring Natural Water Systems in Rural
Residential Landscapes**

**Gabilan Watershed
Restoration Project**

**Section 319 (h) Funding
Agreement #05-104-553-0
Total Cost: \$594,000**

Creative Environmental Conservation

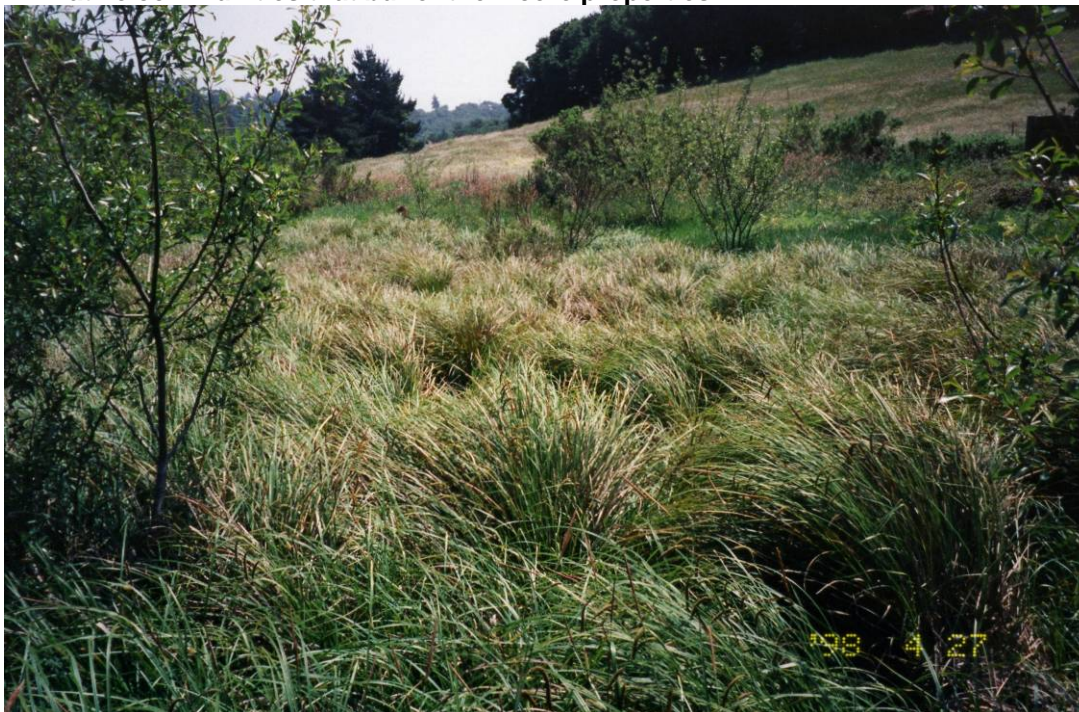
Figure 2 Walker Creek on the Johnson property directly downstream of Wagner. This site has one of the best fields of native *Caryx* (the low grass pictured here) in the Prunedale hills, and a well developed willow forest. Johnson is one of 8 properties surrounding the 4 core properties in Walker Valley. These 8 all have well developed native communities that buffer the 4 core properties.

We were already involved with several landowners in the Walker Creek area (Figure 2). The Guerrero, Wagner, Bacerra, and Yniguez families had reduced soil erosion in Walker Valley and recovered wetlands and riparian forests before the grant started. They were all involved in the grant, but only work on the Wagner property was charged to the grant.

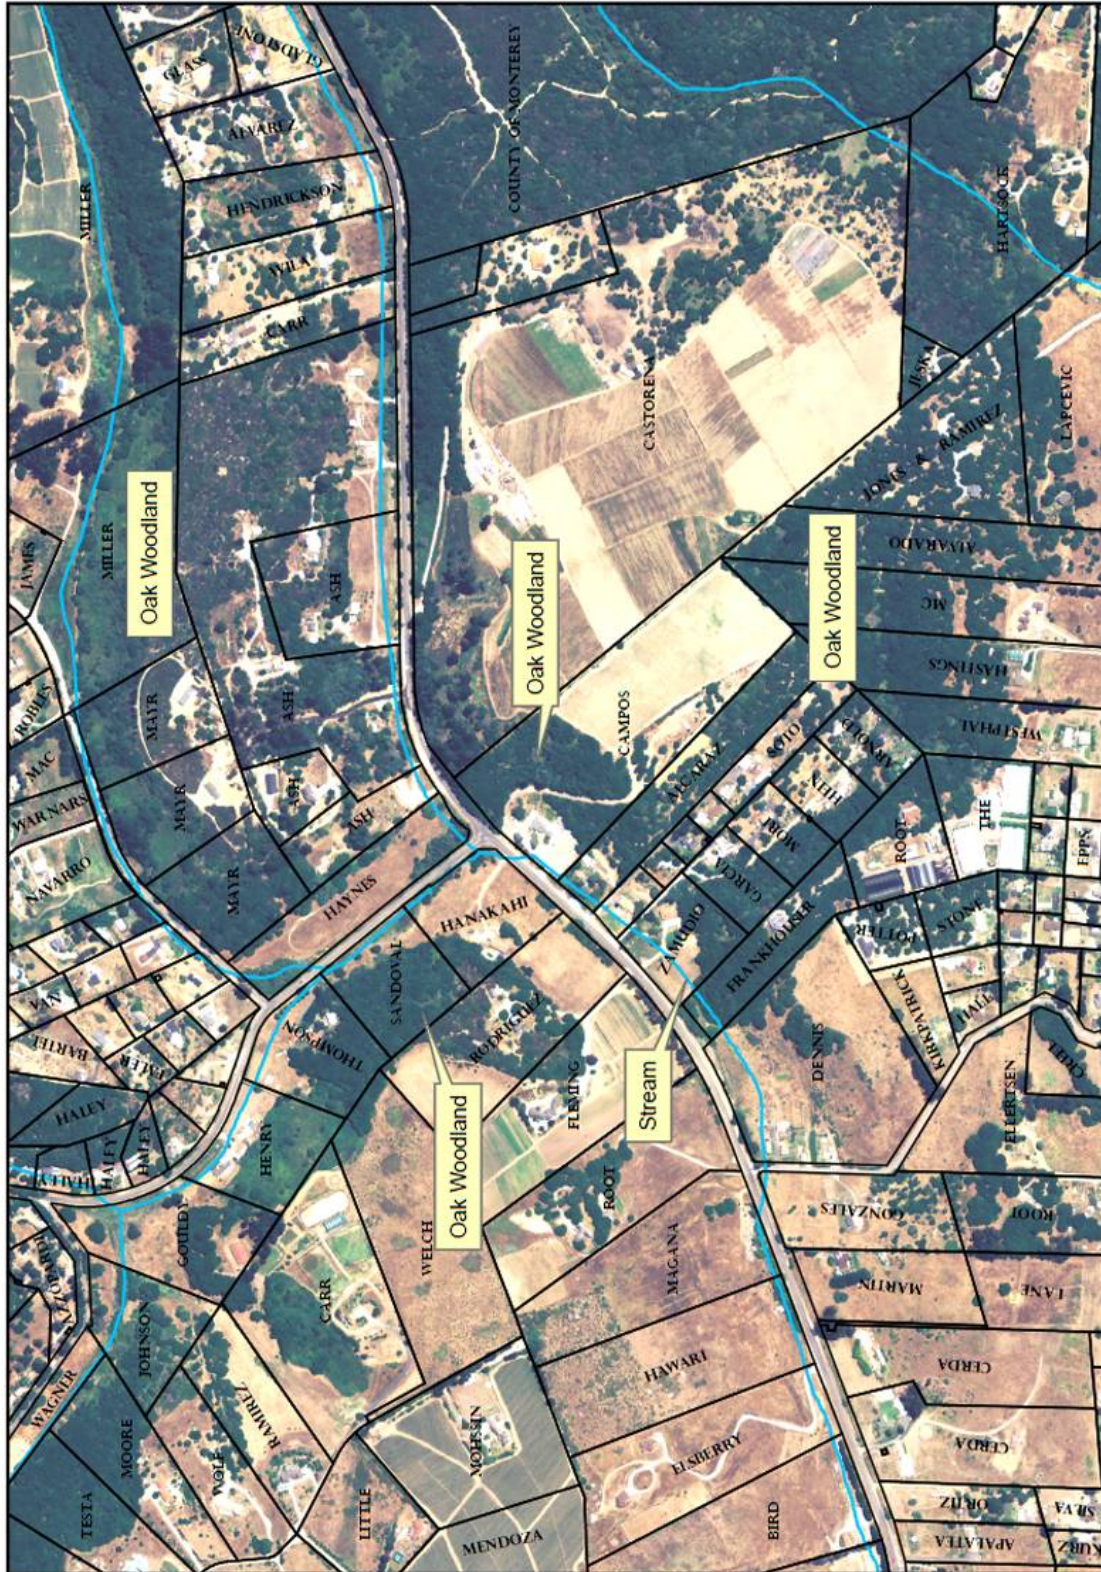
Paradise / Castroville Creeks Target Area Parcel Map

Figure 4 Paradise/ Castroville Creek subwatershed, just downstream of Walker Valley

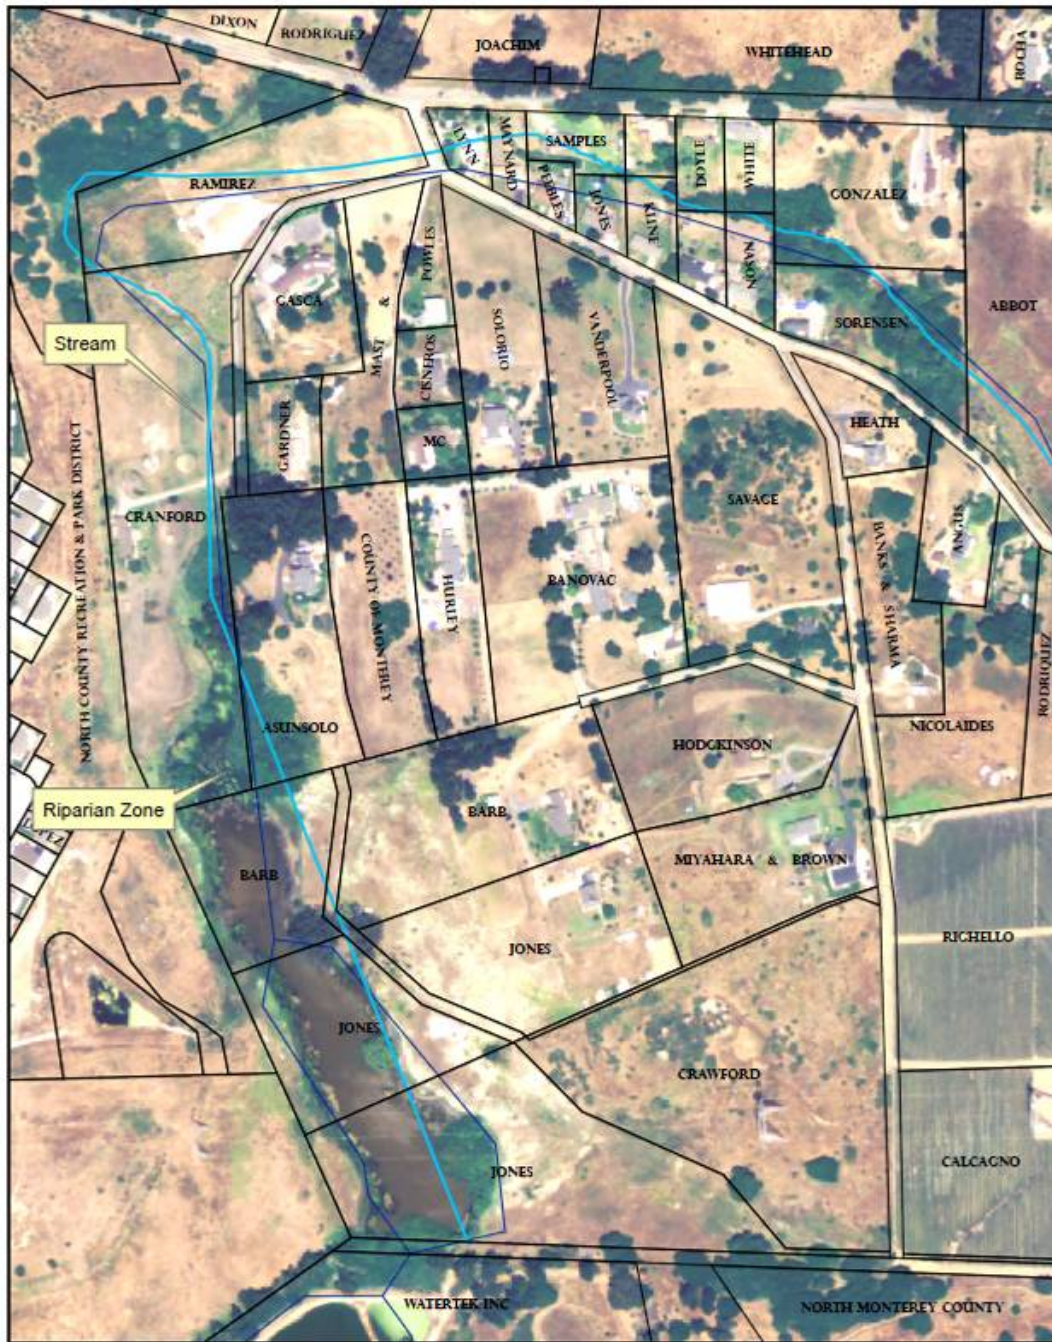
Valley Road Target Area Parcel Map

Figure 6 Valley Creek subwatershed flowing into another arm of Moro Cojo Slough just above North Monterey County High School.

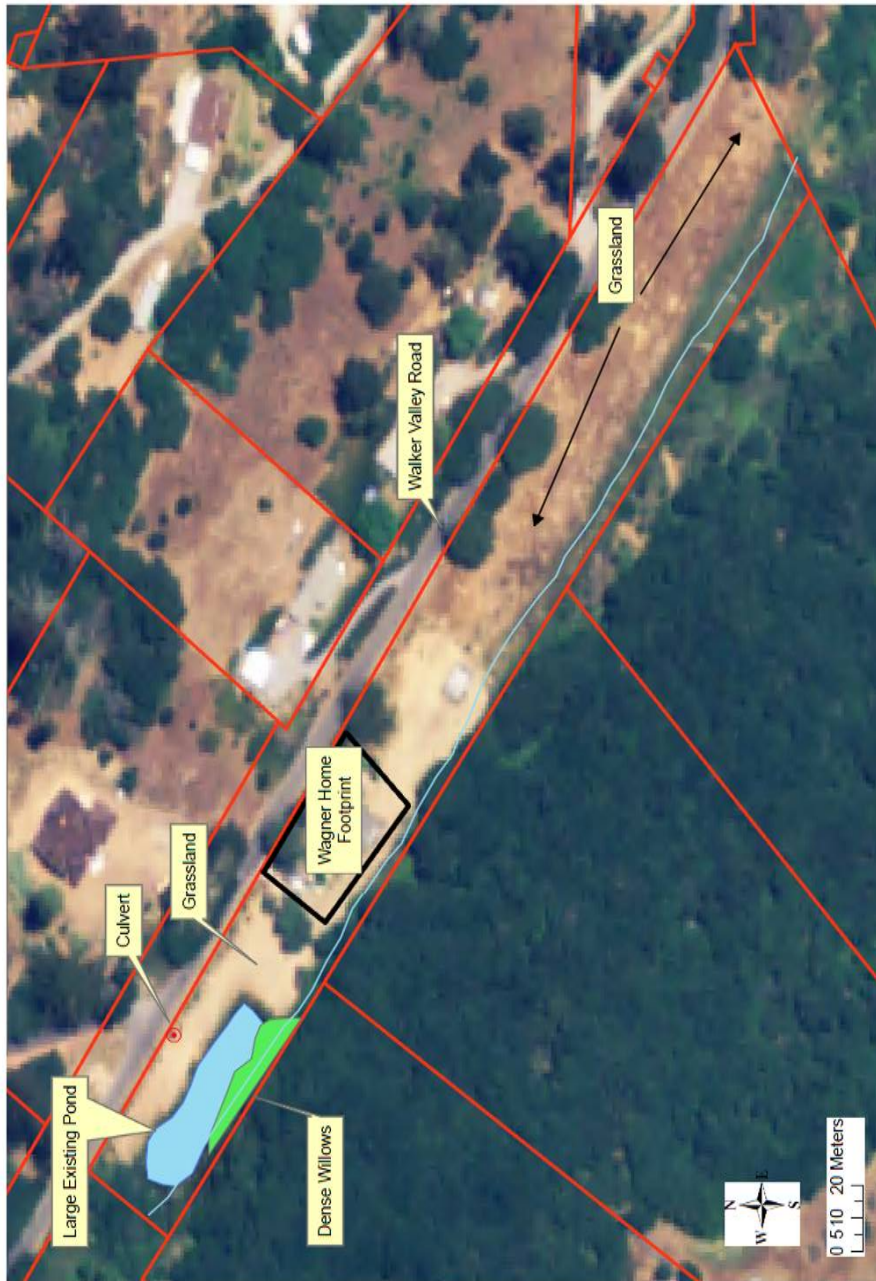
Figure 7 Existing conditions on Wagner parcel

The map below (Figure 7) detail the condition of the Wagner parcel before any restoration work was done.

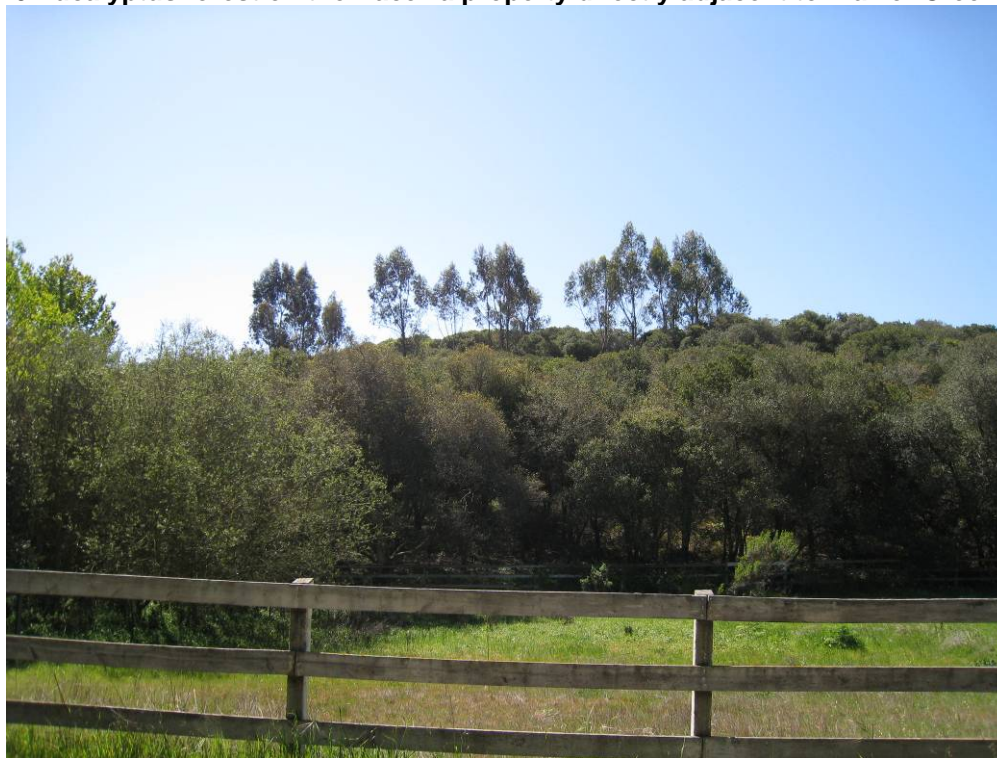
Figure 10 Eucalyptus forest on the Bacerra property directly adjacent to Walker Creek.

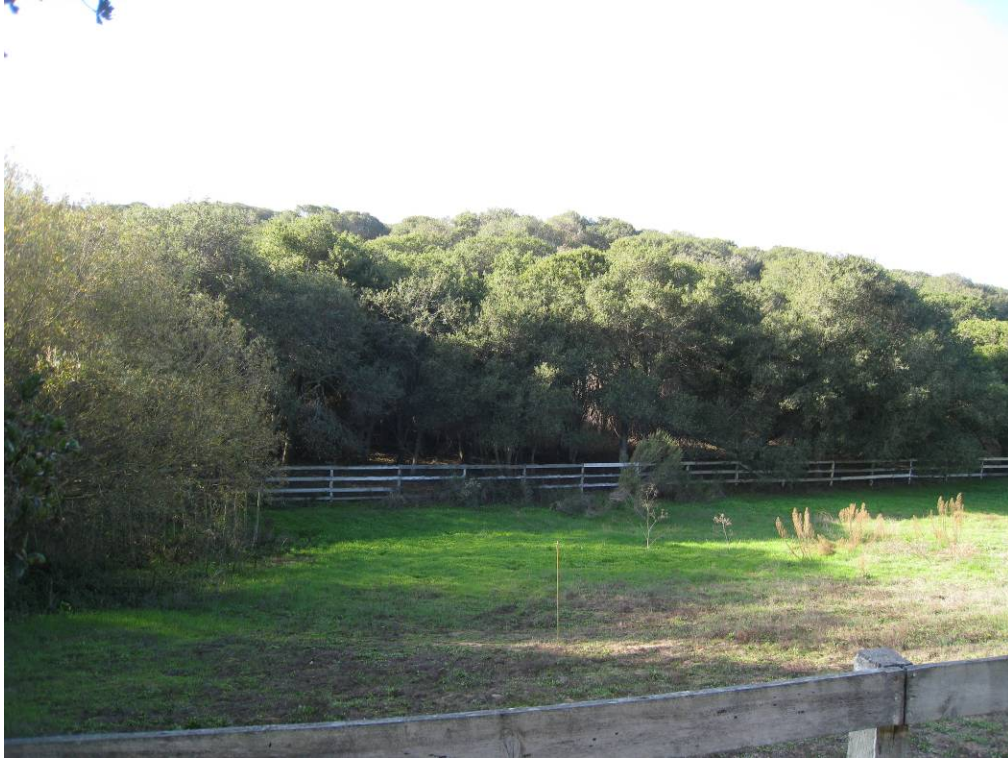
Figure 11 The same site after the removal of 34 Eucalyptus trees, an example of the weed removal BMP.

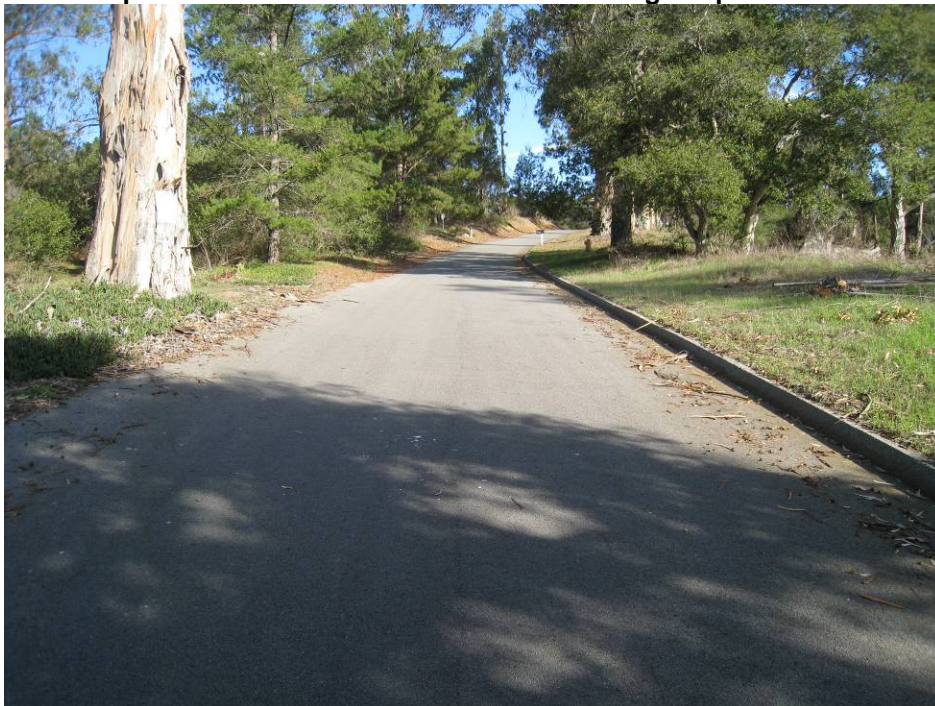
Figure 12 The watershed above the Wagner property is dominated by a wide road and at least as much impervious surfaces at each home site along the private road.

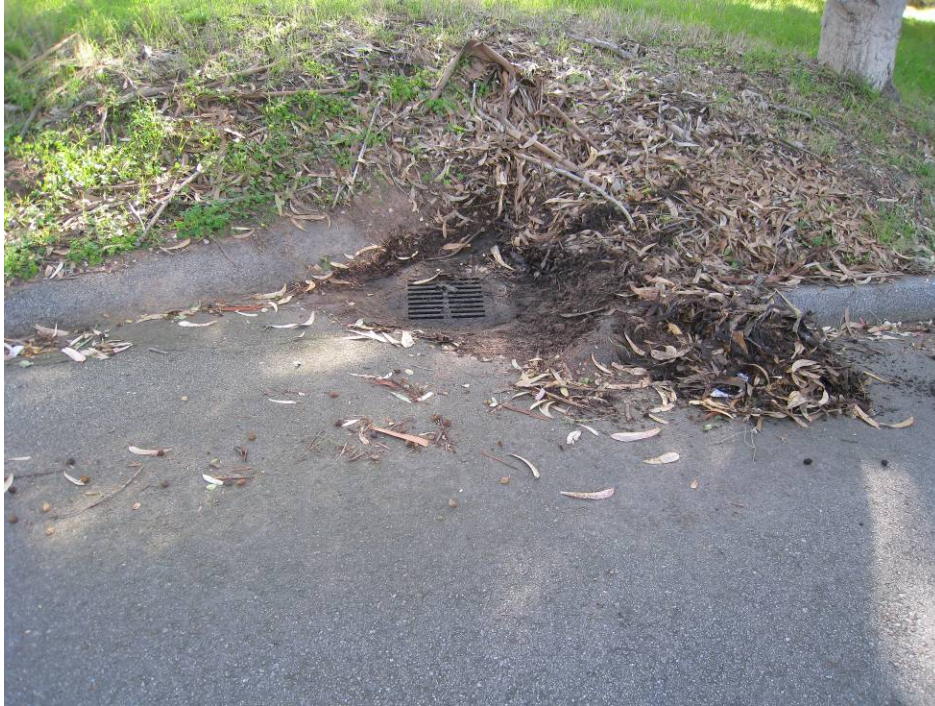
Figure 13 Water running down the road is captured in this drain and sent to a holding pond.

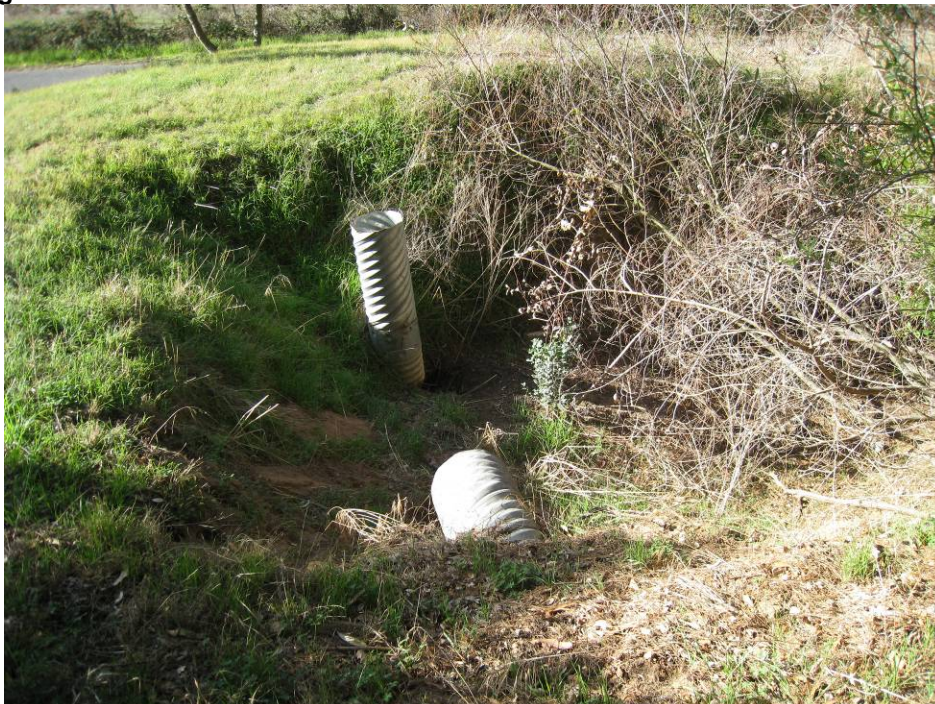
Figure 14 The horizontal culvert brings water from the road into the collecting basin which then flows into the vertical pipe and from here directly into Wagner pond. Before this project, the culvert ended at the edge of Walker Valley Road causing erosion and road flooding

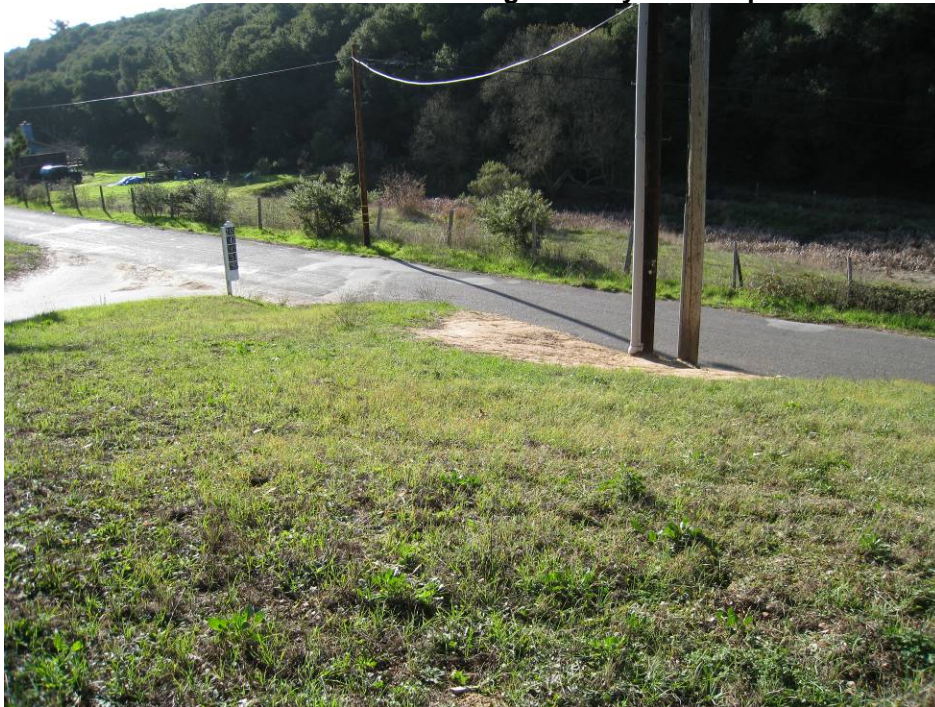
Figure 15 Looking from the water capture basin towards Wagner pond. We extended the culvert from the road's edge directly into the pond

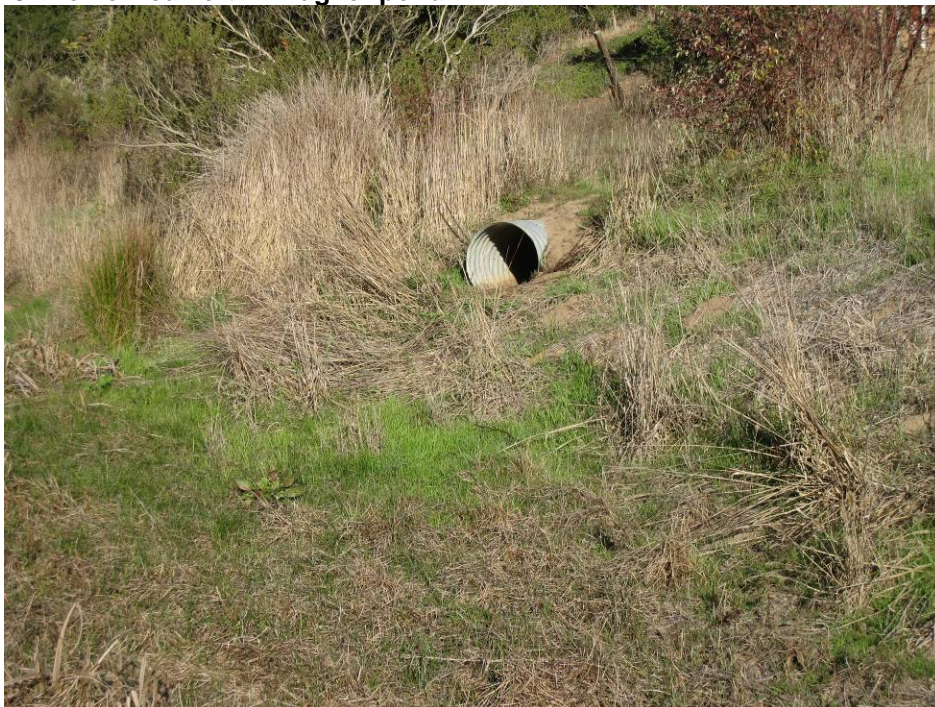
Figure 16 The new culvert in Wagner pond

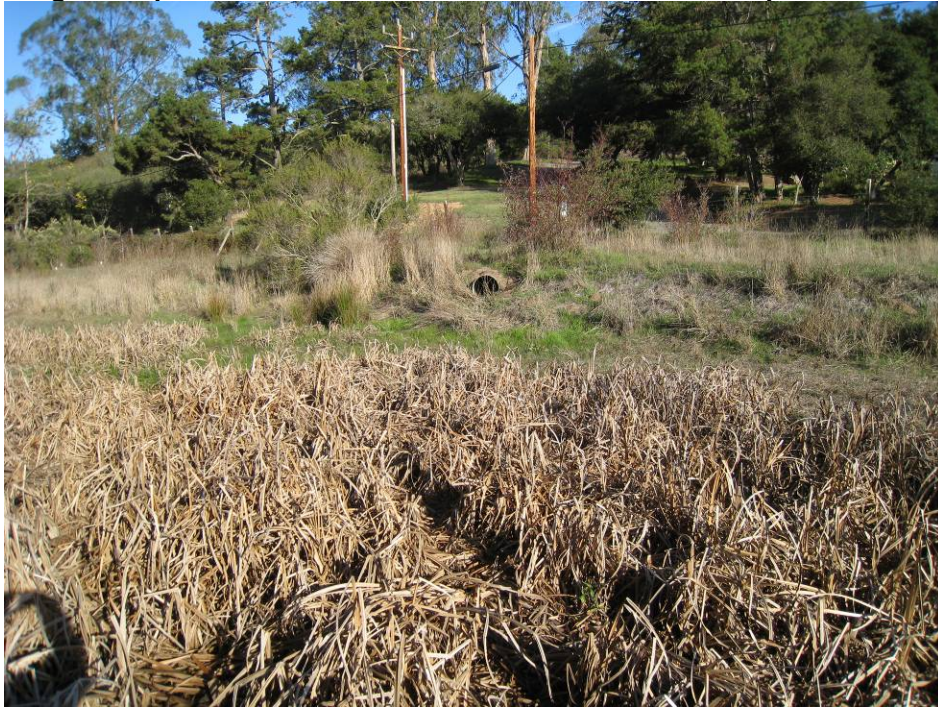
Figure 17 A view of the new culvert from further back in the pond. All water from the watershed now comes into this culvert and empties directly into the pond. This permits earlier filling of the pond and increases the total amount of water captured here

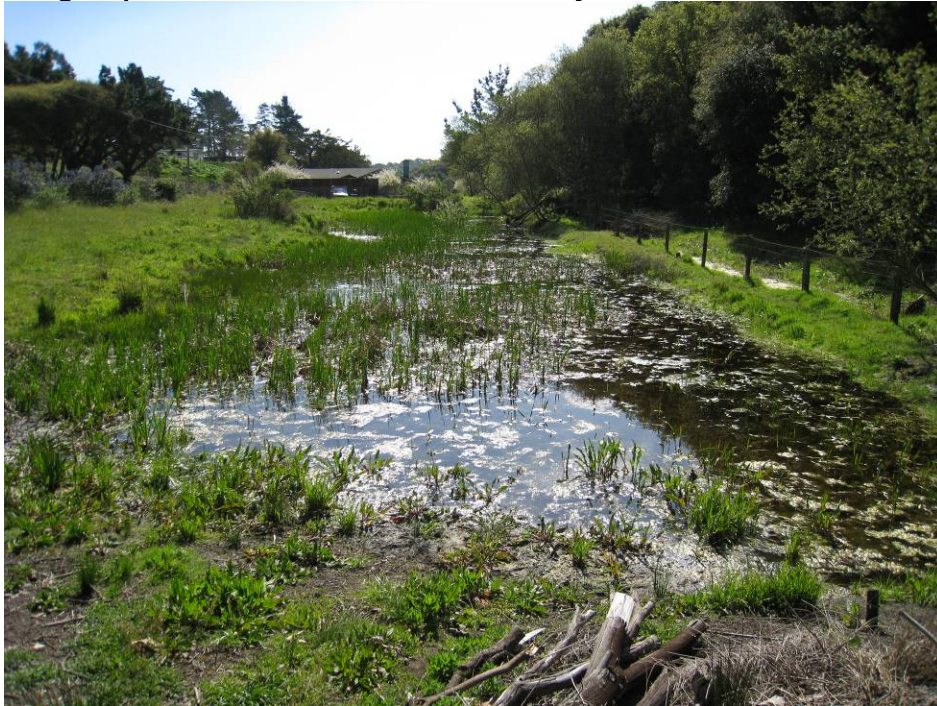
Figure 18 Wagner pond in March 2008 after a low rain year

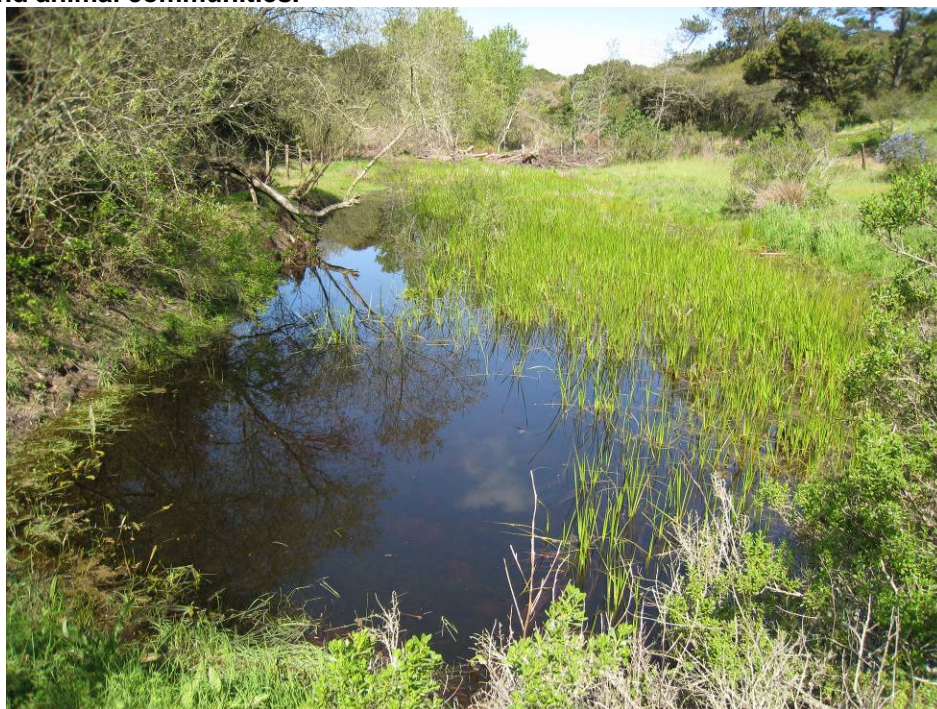
Figure 19 The downstream end of Wagner pond in March 2008. Several BMPs are illustrated by the reduced soil erosion and flooding and the improved pond hydrology resulting from the new culvert installation, as well as by the positive impacts on wetland plant and animal communities.

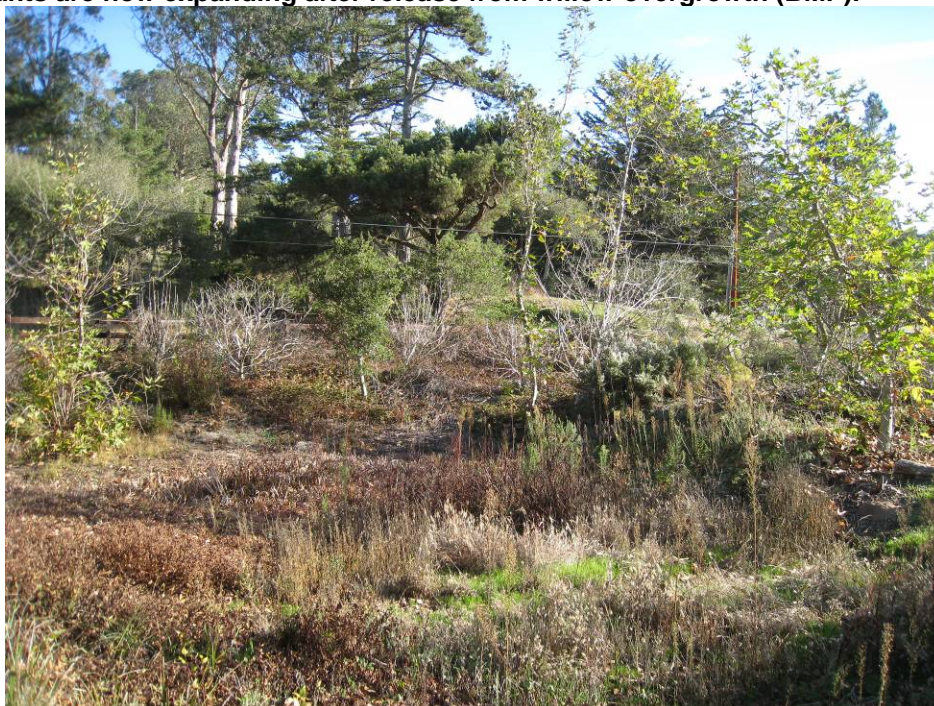
Figure 20 This part of the Guerrero and Wagner ponds was overgrown with willow trees, which extended into the middle of the pond. We improved the ponds for the endangered amphibians by removing willows from the pond (BMP). Several Sycamore trees and other native plants are now expanding after release from willow overgrowth (BMP).

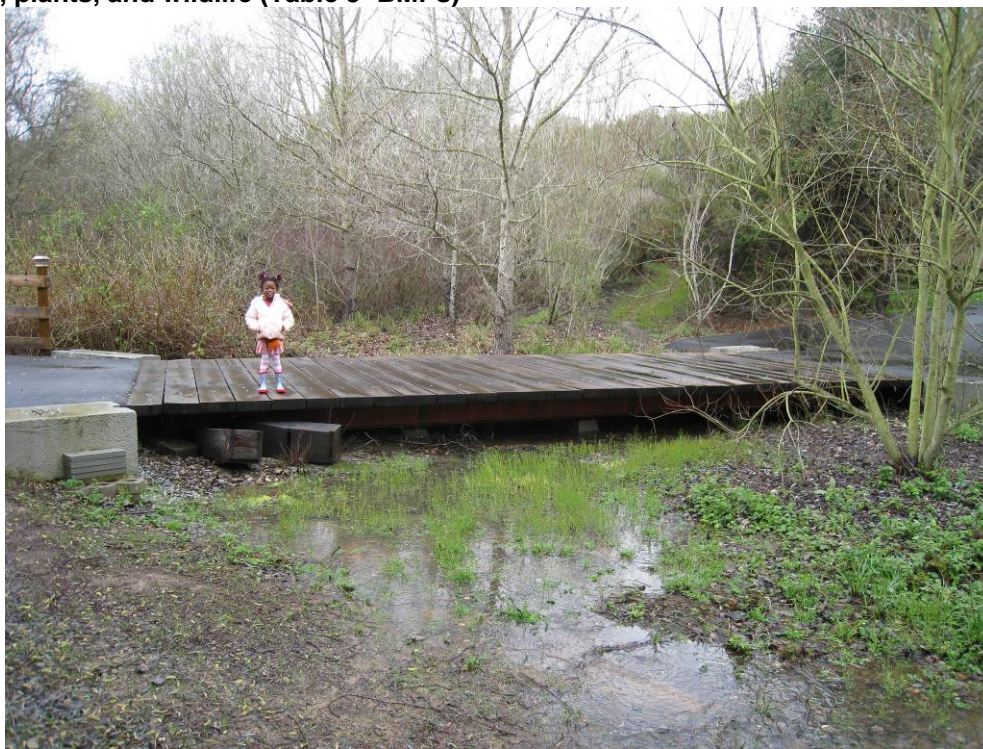
Figure 21 This bridge was constructed over Walker Creek on the Guerrero parcel. They no longer drive through the creek, with important positive impacts to the stream corridor, wetlands, plants, and wildlife (Table 3- BMPs)

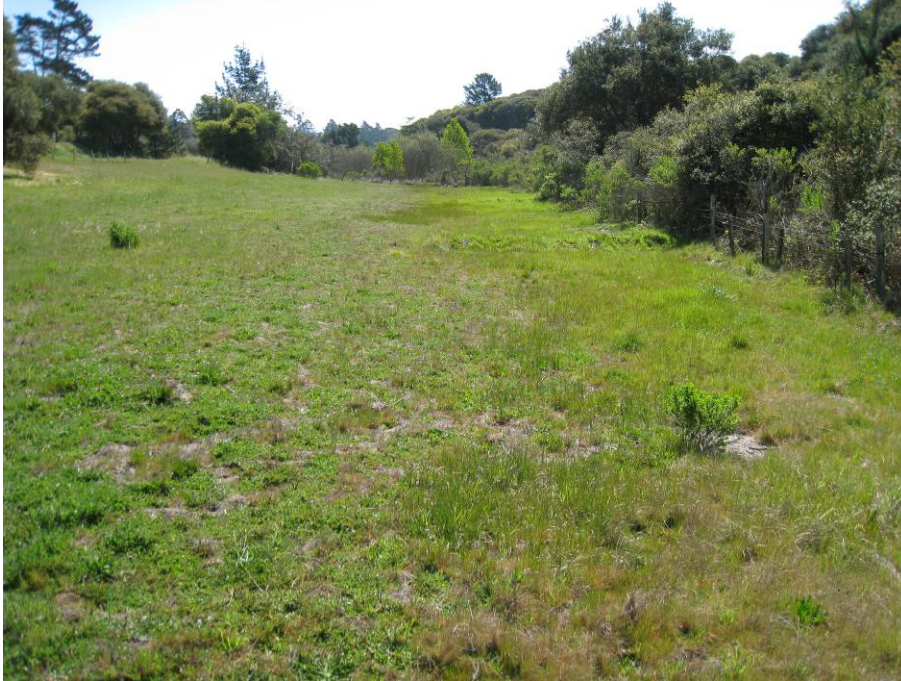
Figure 22 The lower end of the Wagner property where we constructed five small berms to spread water over the flood plain

The images below, Figures 22-26 show the work done at the Wagner parcel to allow for water to spread naturally over the low areas.

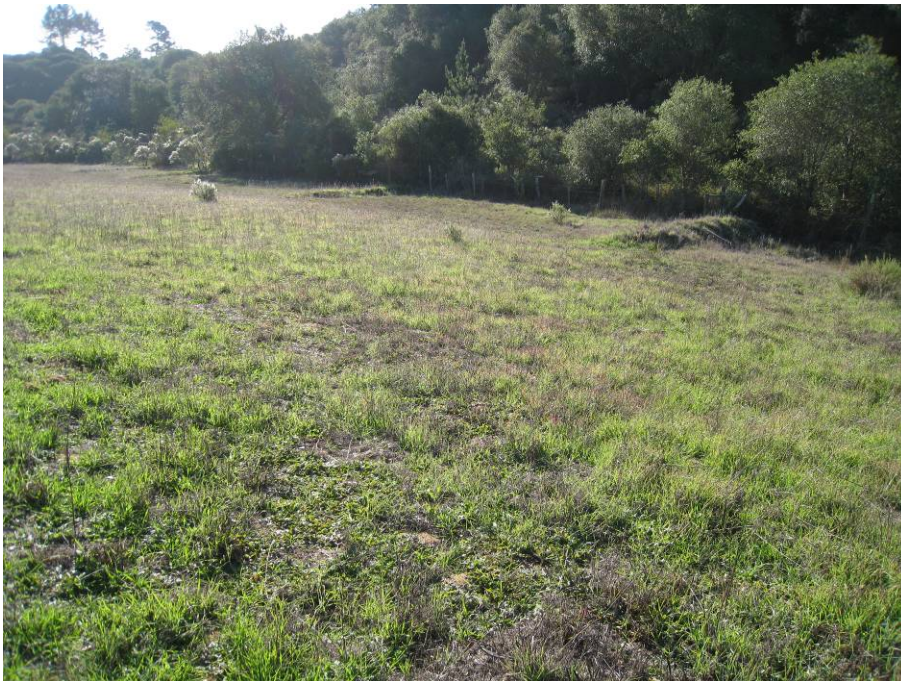
Figure 23 A closer view of two of the berms this Fall

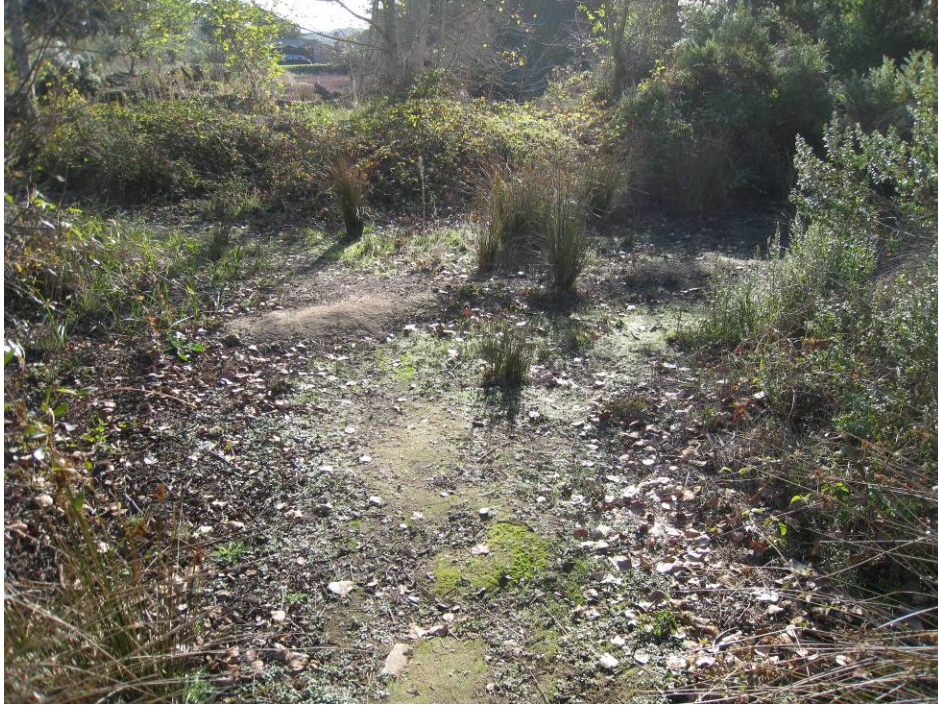
Figure 24 An example of a low berm constructed along Walker Creek on the Guerrero parcel

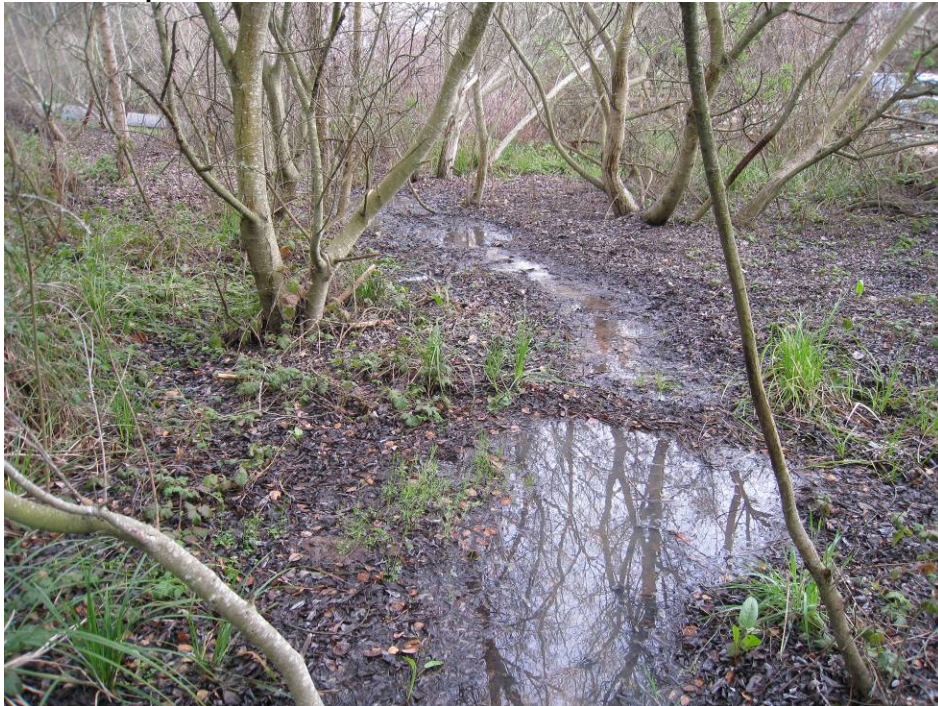
Figure 25 Water captured behind another low berm at Guerrero last winter

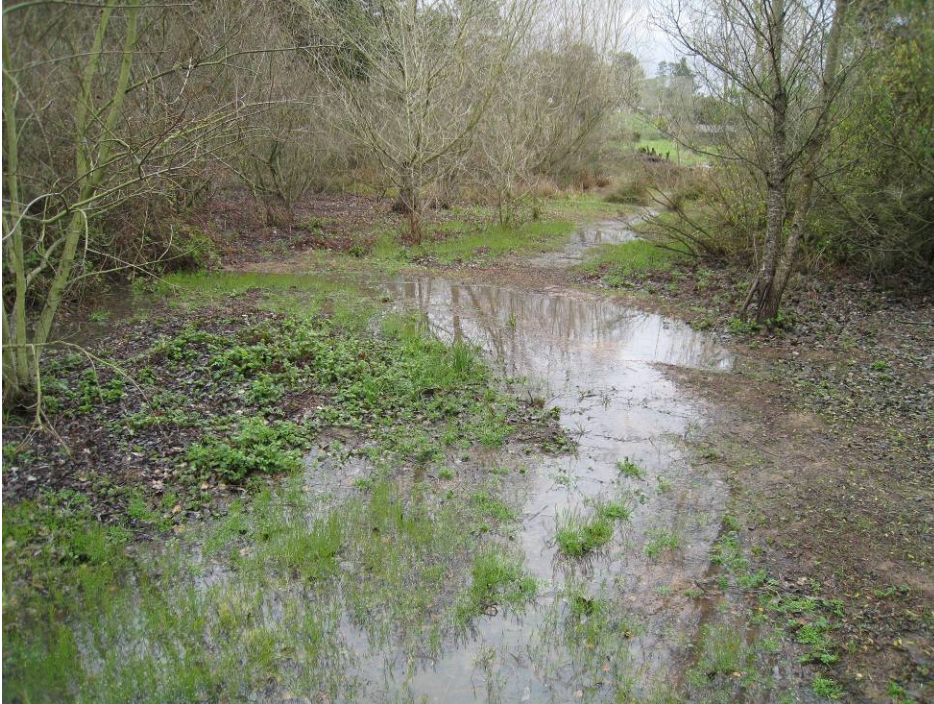
Figure 26 Spreading water behind another berm just downstream of the Guerrero bridge

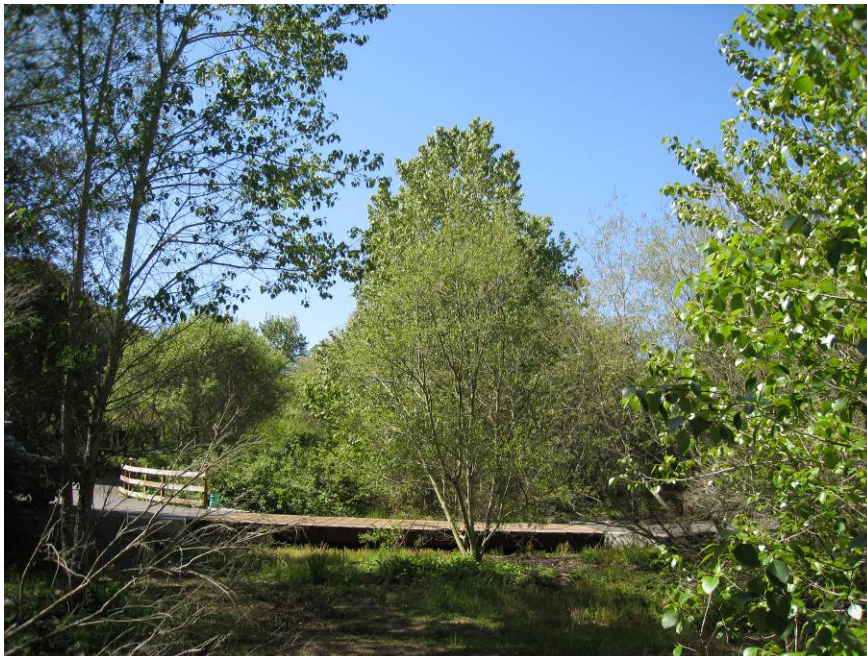
Figure 31 The new bridge lets the Guerrero family access their home without driving through the creek. This riparian forest is 15 years old. The same parcel was covered with chicken coups before the restoration started.

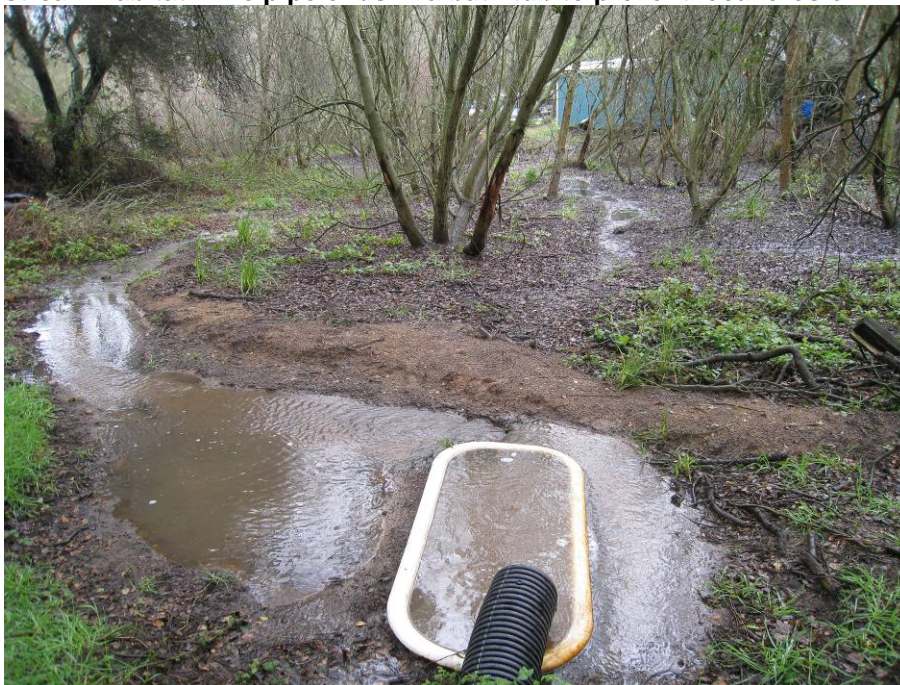
Figure 32 Water enters the upper end of the Guerrero wetland much like it does to Wagner pond, it is collected into a central culvert and piped underground to the top of the natural stream habitat. The pipe ends in a bath tub to prevent local erosion.

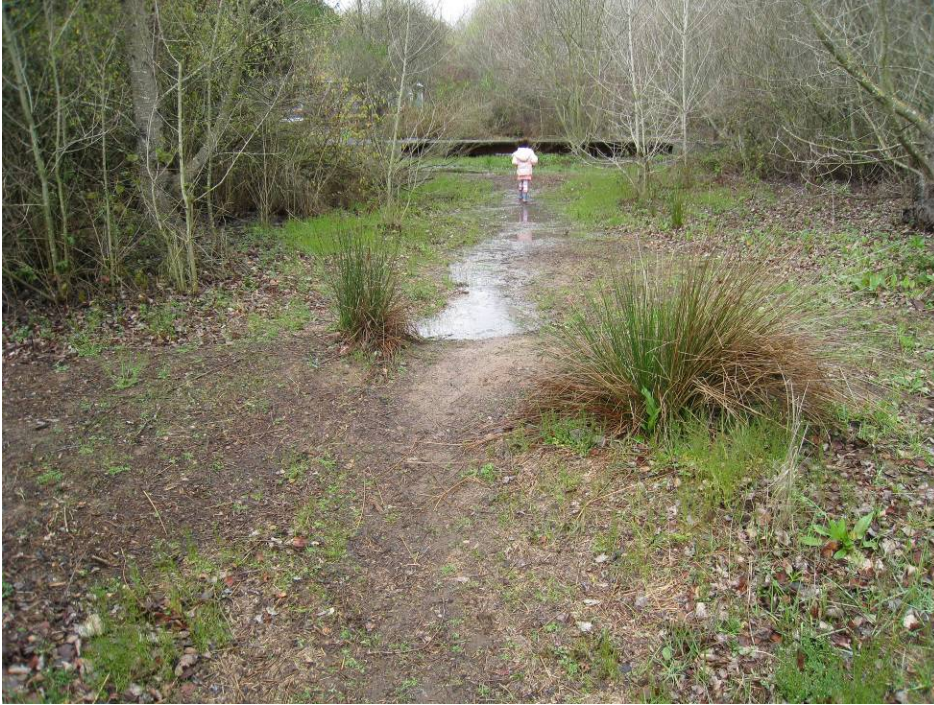
Figure 33 The end of water flow through the Guerrero wetland in 2008. The flow stopped behind the last low sediment berm just before the Guerrero pond, which was dry for both years of the project (2007-2008). This natural wetland cleaned and retained all the water went underground

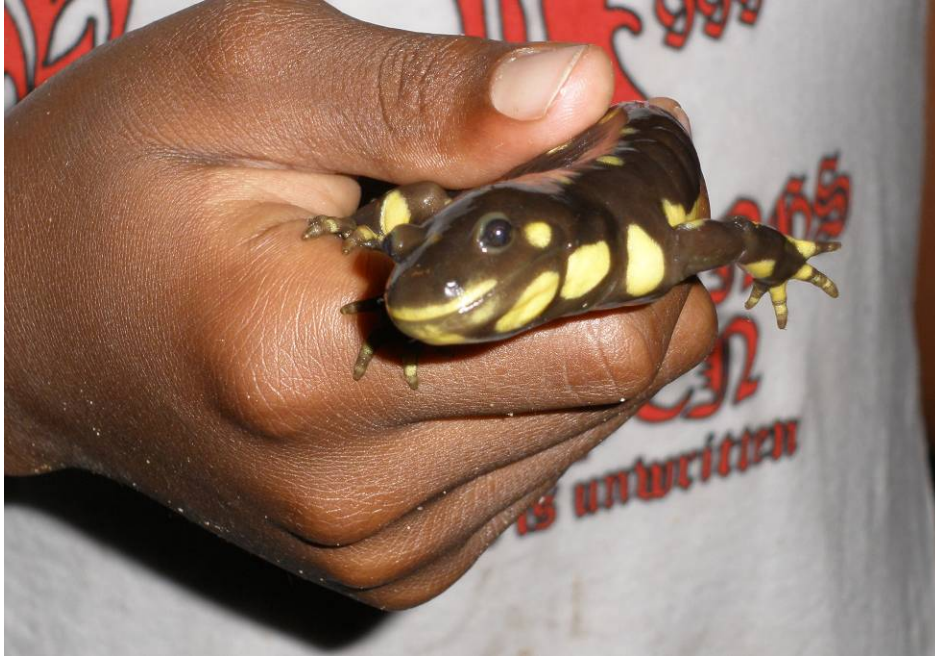
Figure 34 A California Tiger Salamander found in the enclosed porch at the Guerrero house

found 2 dead animals on the road and one alive in the Guerrero driveway. All observations were on warm, rainy nights. These are large animals (Figure 34). Large red-legged frogs have been observed around the Walker wetlands for many years. We found four during the first year, and two in 2008 (Figures 39-40).

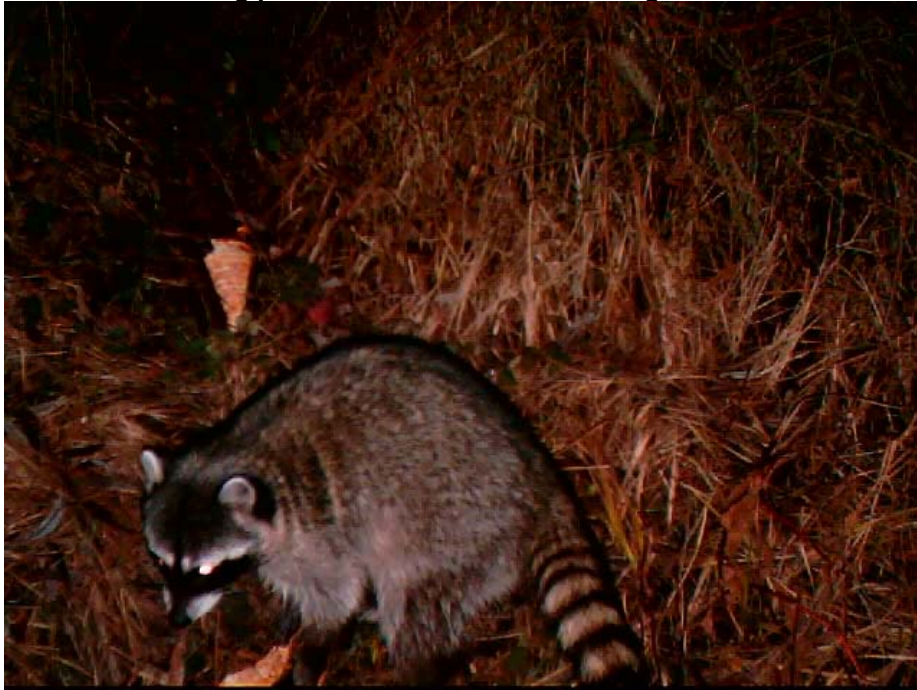
Figure 35 A raccoon eating pizza on the berm between Wagner and Guerrero Ponds

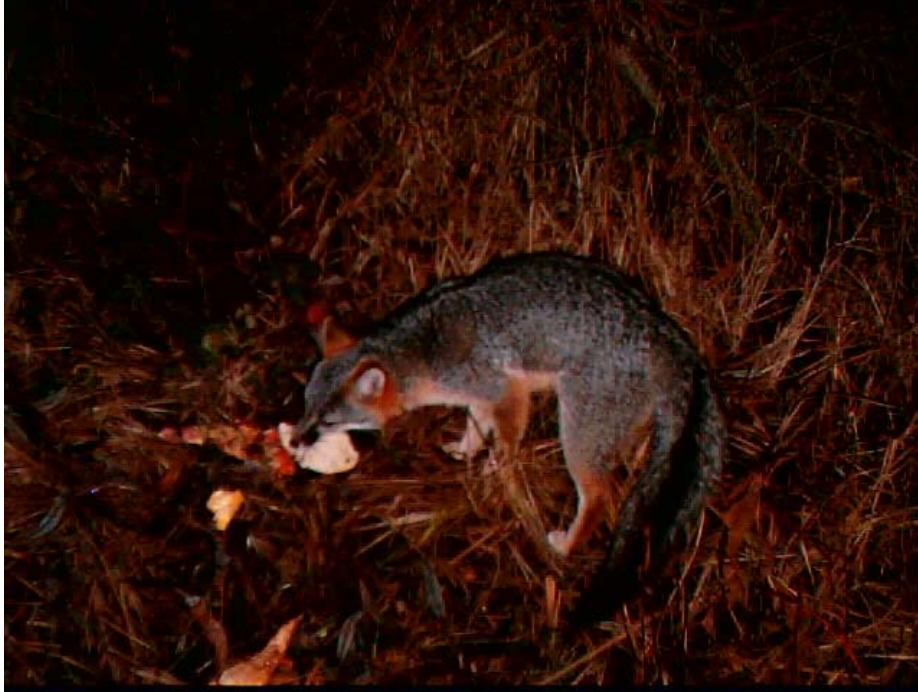
Figure 36 Gray Fox eating pizza on the berm between Wagner and Guerrero Ponds. Photographed in January 2007 with a motion sensitive camera. They are the most common mammal predator along the wetland.

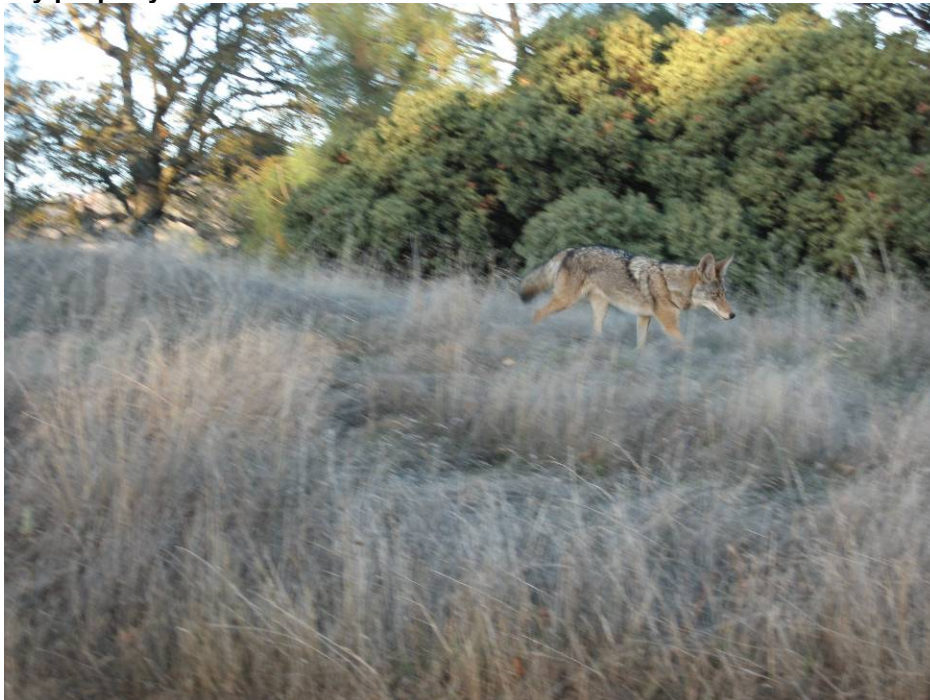
Figure 37 A coyote was commonly seen from Walker Valley Road in the large pasture on the Gouldy property
