**I. Restoring Natural Water Systems in Rural
Residential Landscapes**

**Gabilan Watershed
Restoration Project**

**Section 319 (h) Funding
Agreement #05-104-553-0
Total Cost: \$594,000**

Creative Environmental Conservation

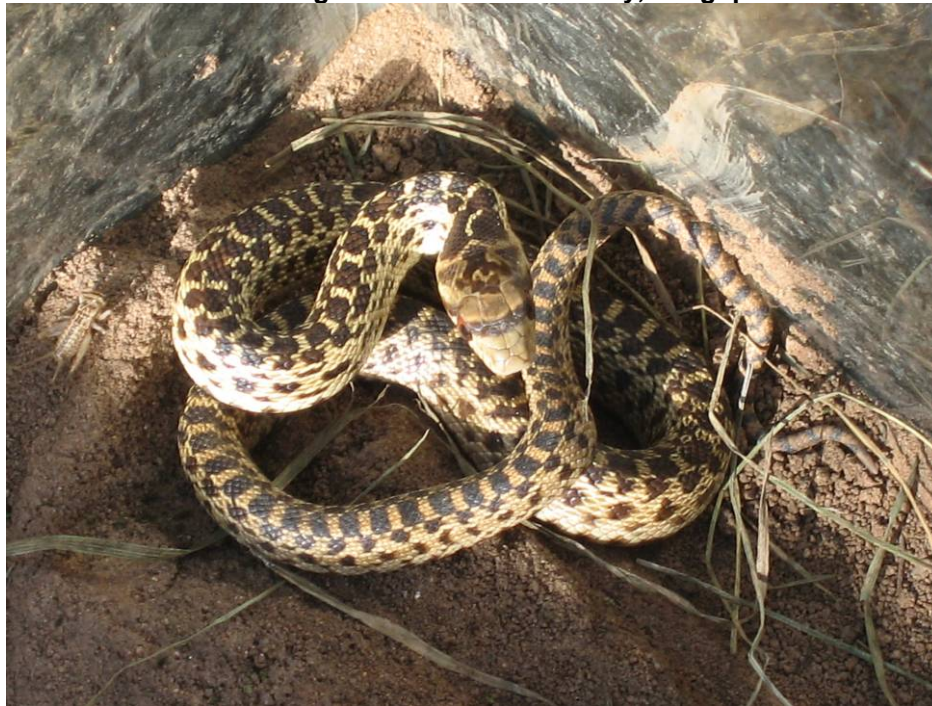
Figure 38 The most common large snake in Walker Valley, the gopher snake

Deer roamed throughout the valley throughout the year. When the ponds were dry, the Guerreros and others maintained drinking water for wildlife. The water bowls were frequently used by deer, which created distinct traveling trails to the bowls. Coyote were only observed at the downstream end of the Wagner parcel and the adjacent downstream properties (Johnson and Gouldy). Here they dug for mice, ate two roaming cats, and left scat (Figure 37). The interns set baited camera traps along the berm between the Wagner and Guerrero ponds. The camera is triggered by motion. It captured gray fox and raccoon (Figures 35 and 36), but not coyote. Gray fox dominate the Guerrero wetlands. They defecate around the Guerrero bridge almost every evening. This June a family of gray fox (2 adults and 4 pups) spent several days on the Wagner porch, and another day under the Guerrero porch and bridge. The fox family has a den on the Schmeiser property across the road from Guerrero. The dominant small snake in the valley was the sharp-tailed and the most common larger snake was the gopher (Figure 38).

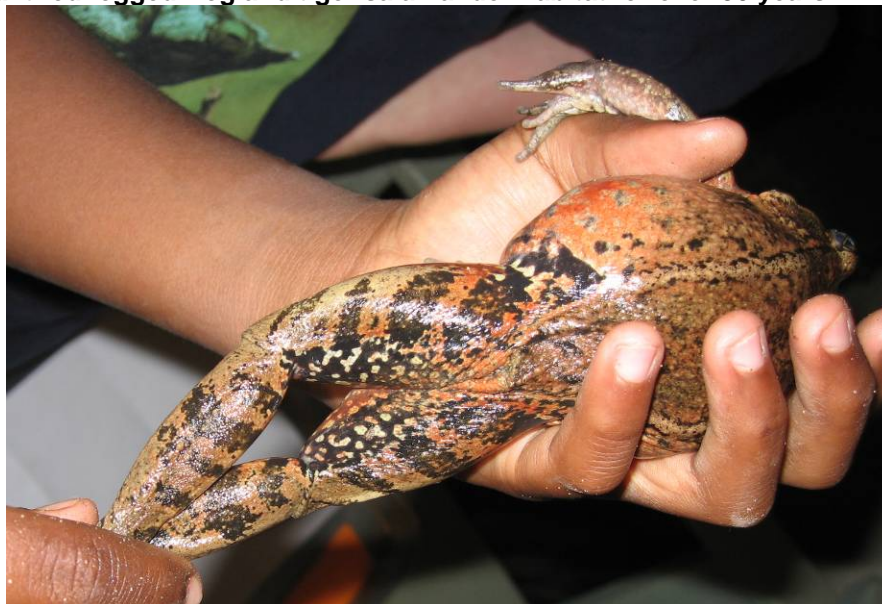
Figure 39 Red-legged frog from Guerrero wetland April 2007. Animals this large have been present since the first year of restoration at Guerrero, since 1995. Wagner pond has been important red-legged frog and tiger salamander habitat for over 50 years.

found 2 dead animals on the road and one alive in the Guerrero driveway. All observations were on warm, rainy nights. These are large animals (Figure 34). Large red-legged frogs have been observed around the Walker wetlands for many years. We found four during the first year, and two in 2008 (Figures 39-40).

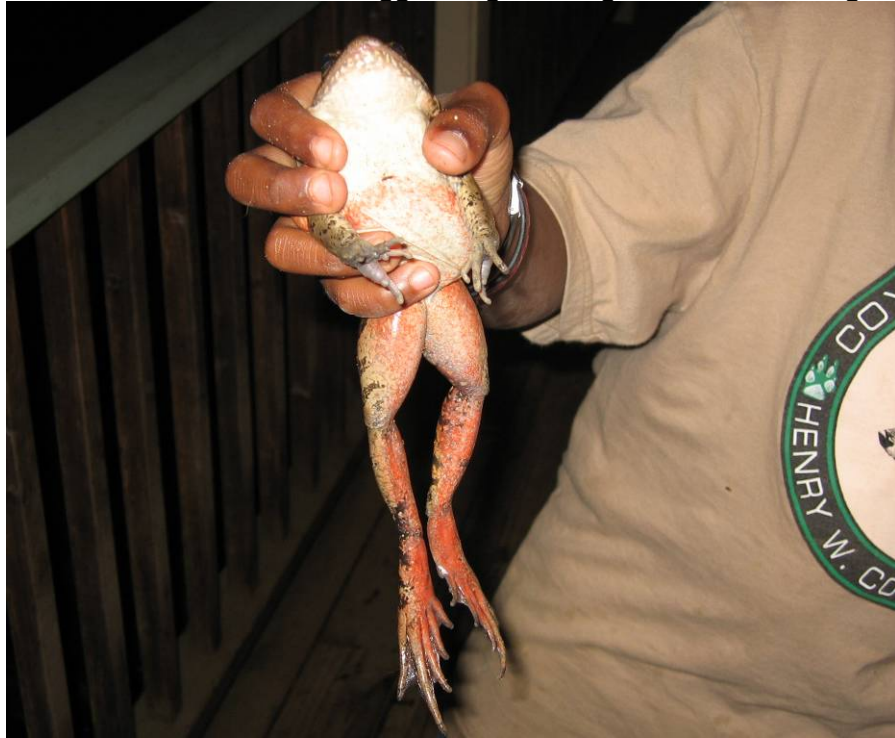
Figure 40 The other side of the red-legged frog showing the distinct red legs.

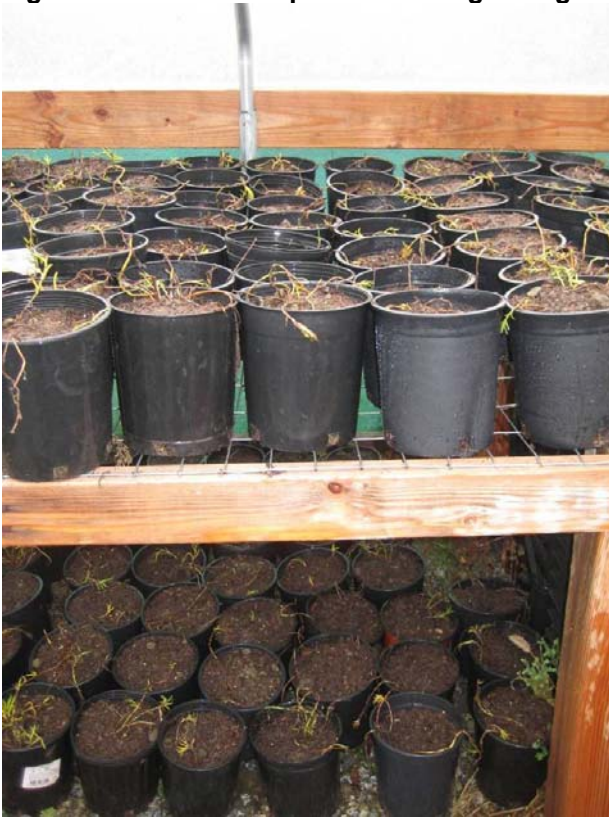
Figure 44 The wetland plant *Jaumea* growing in the project greenhouse

For the Calcagno parcel restoration, native wetland species were taken from local sites and transplanted at the Coastal Conservation and Research Inc greenhouse where they were given some time to adjust (Figures 43 and 44). Then after approximately 10 days in the greenhouse the species were transplanted into the newly fenced-off marsh.

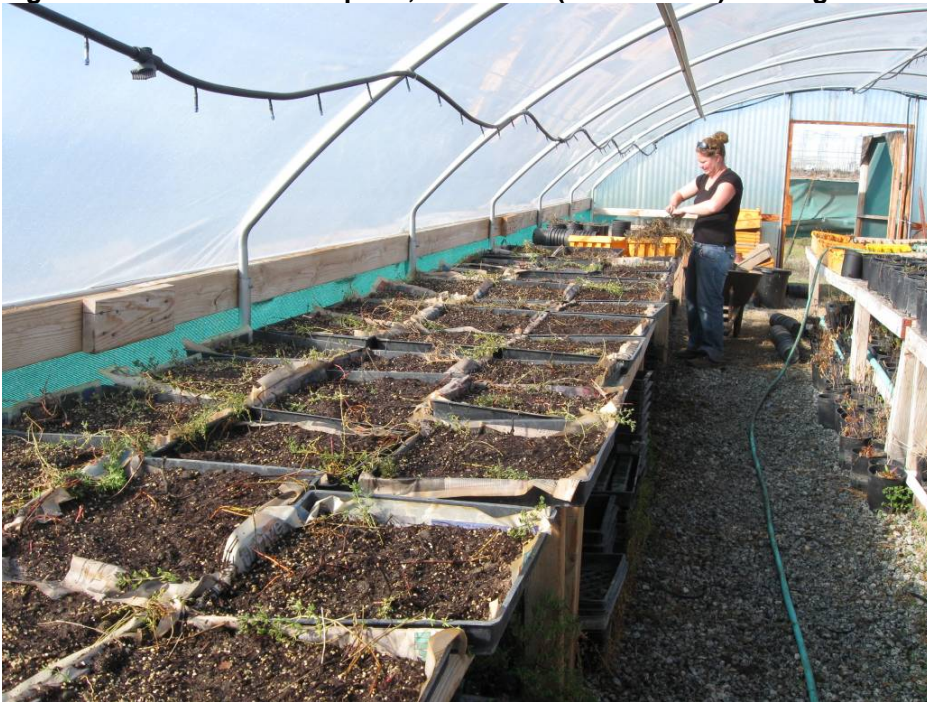
Figure 45 Another wetland plant, *Frankenia* (Alkali Heath) in the greenhouse

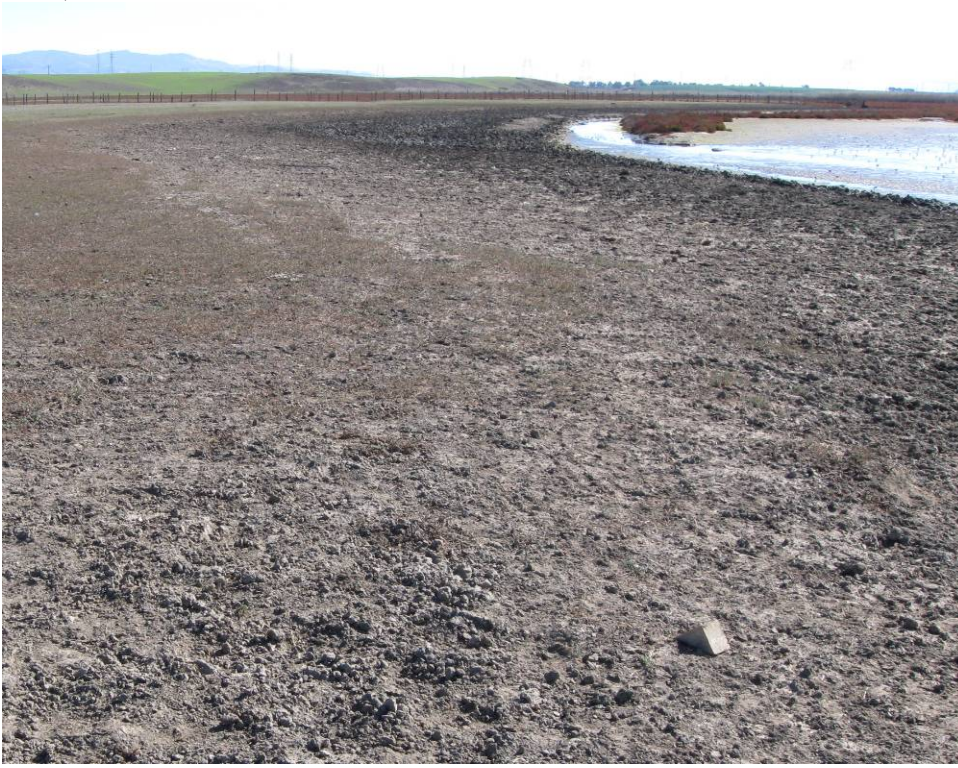
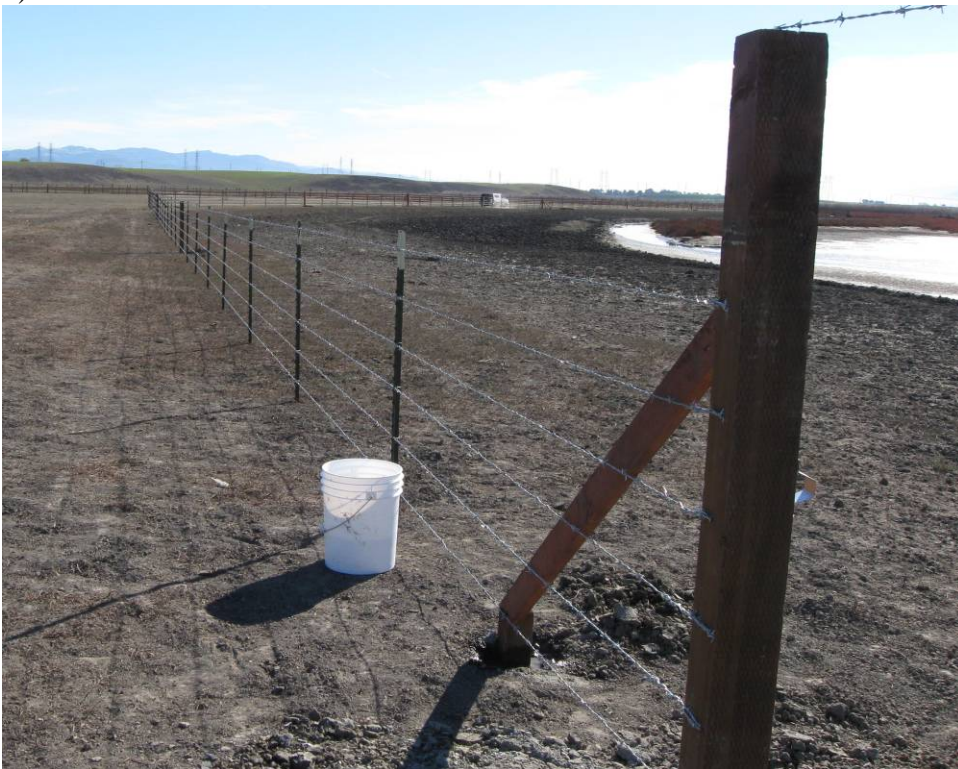
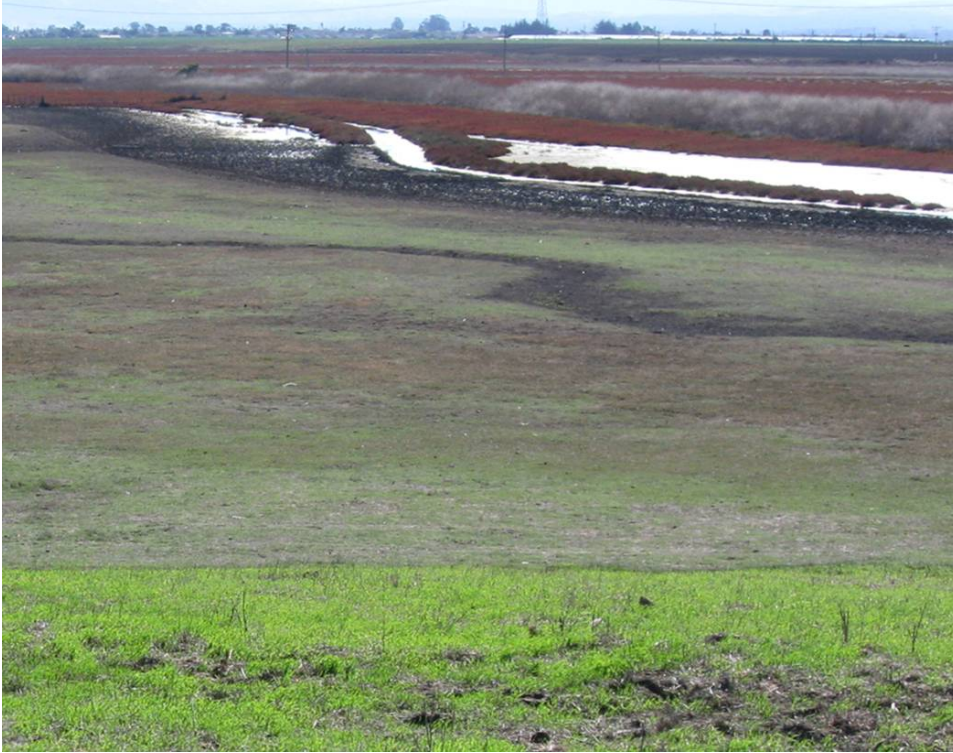
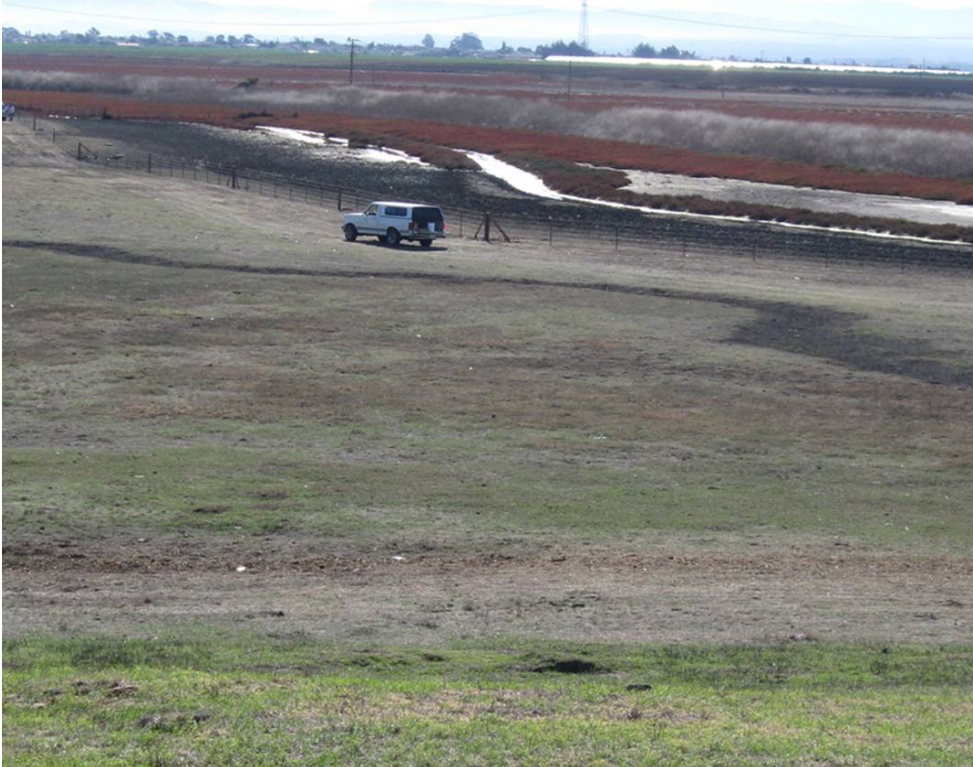
A 909 foot long fence was installed on the Calcagno property on the South East corner of the parcel, see Figures 46 and 47. The fence follows the Moro Cojo Slough at a distance of 12 feet from the edge of the water. This keeps animals out of a total of 2.3 acres of salt marsh that has been heavily grazed. With the help of planting hundreds of wetland plants, this area should return to a healthy marsh now that the grazing has been stopped. Work was also performed on the fence at the West side of the parcel to improve its condition and help continue to block grazing animals from gaining access to the area.

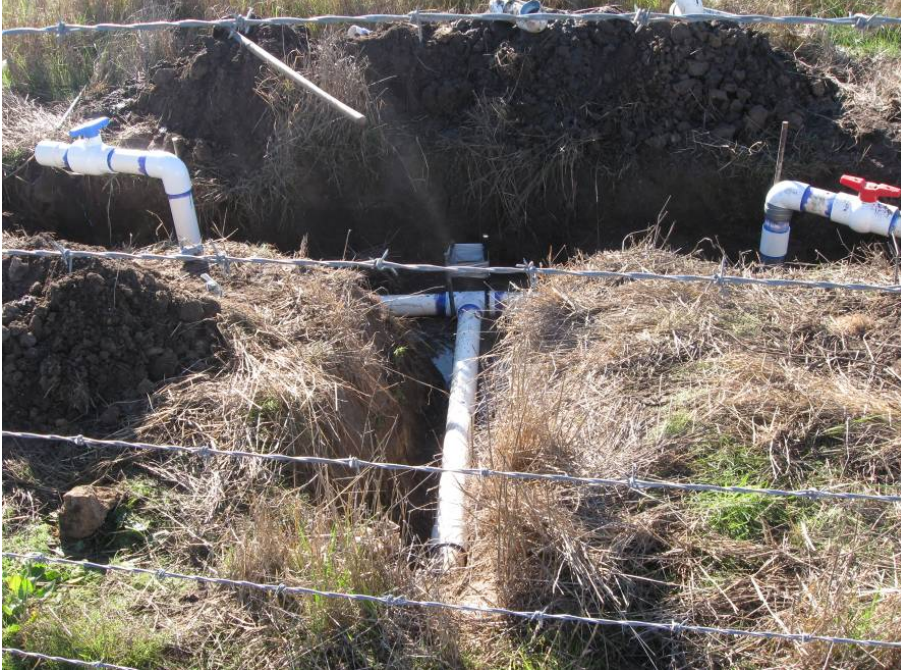
Figure 48 Photograph of new irrigation line being attached to existing line on the slough side

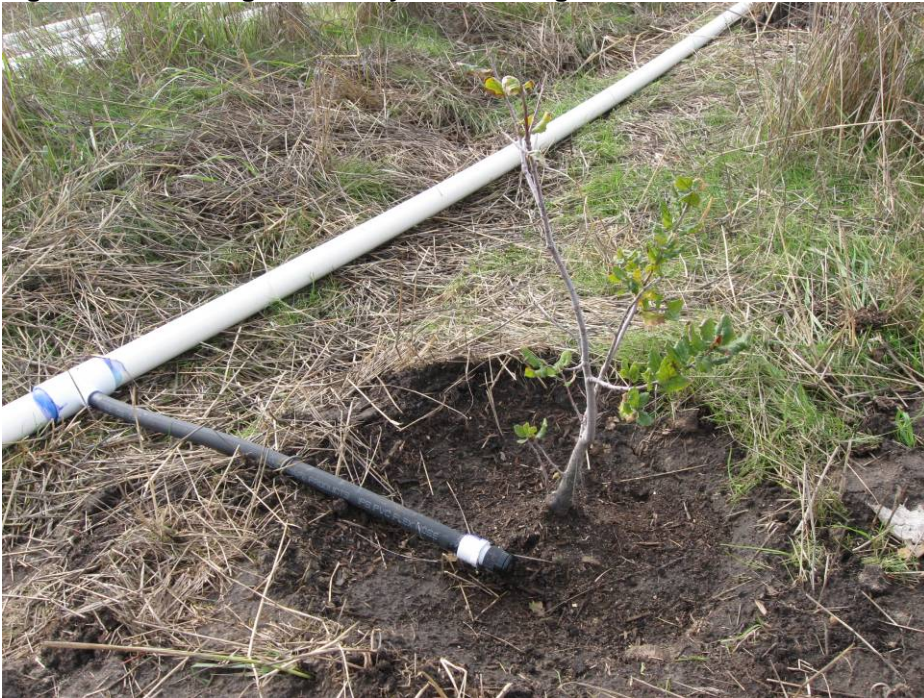
Figure 49 Oak being watered by the new irrigation line

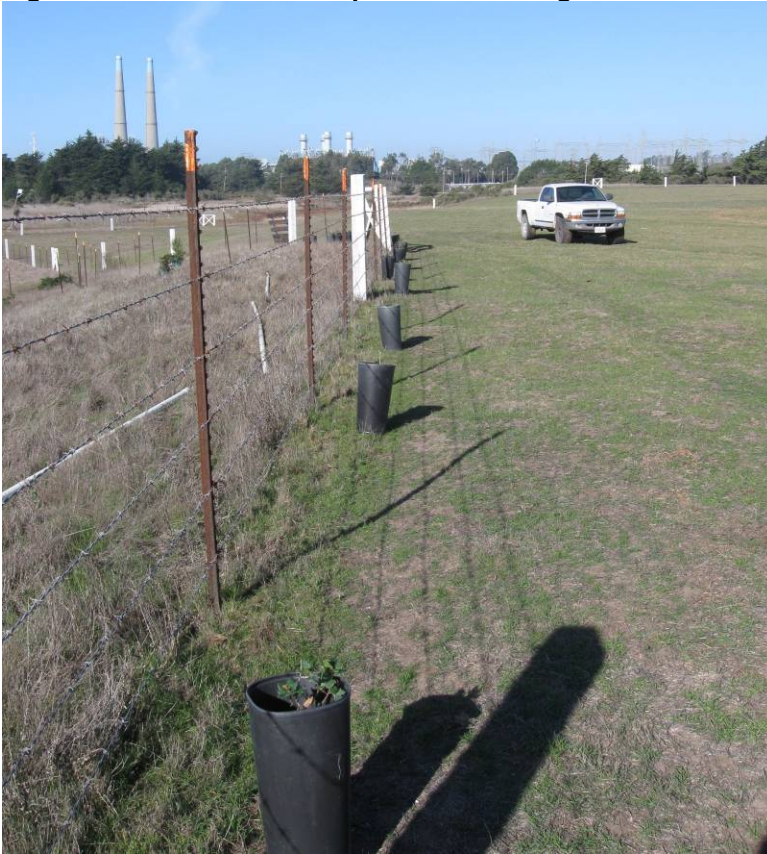
Figure 53 Oaks about to be planted at Calcagno

Figures 51 and 52 show the location of the new Live Oaks and wetland plants, and the areas that were seeded and the photographs below, Figures 53 and 54 show the Live Oaks and wetland plants being planted at the Calcagno parcel.

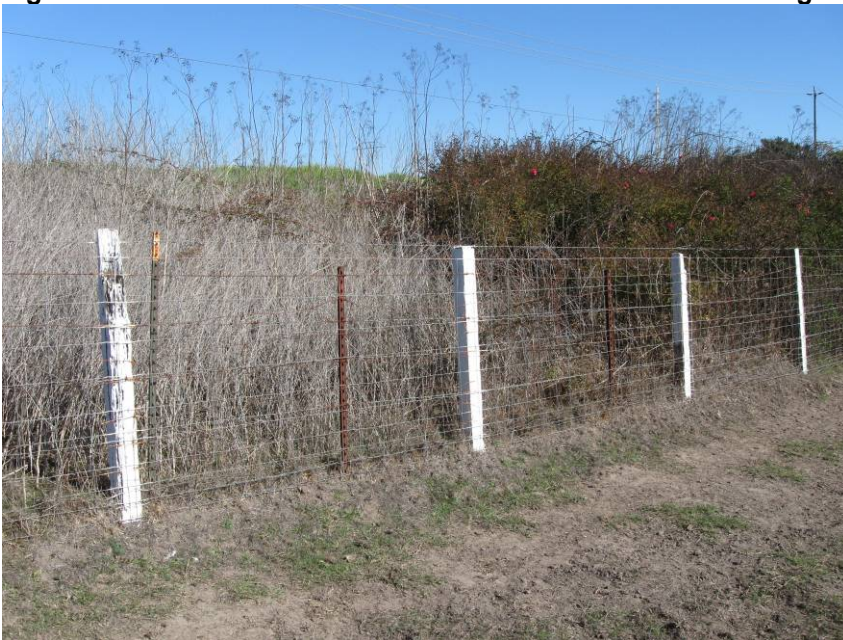
Figure 54 Picture of roadside before weeds were removed and grass seeds planted

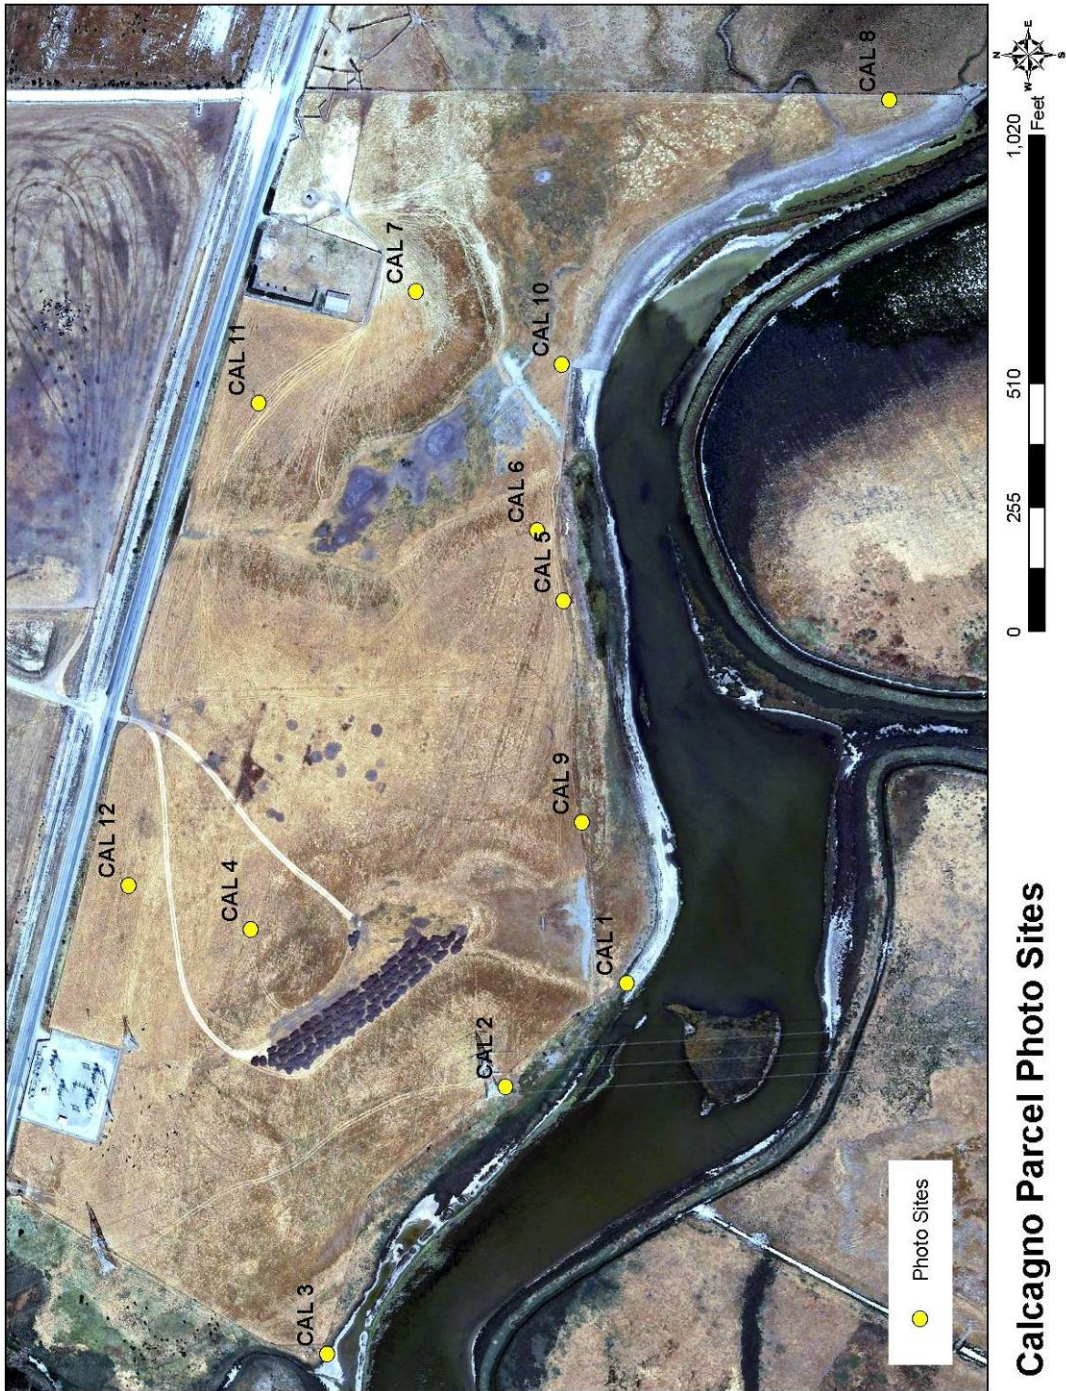
Figure 56 Location of photographic monitoring stations at Calcagno

We have 12 photo sites for the Calcagno parcel which have been utilized to document the site before, during and after restoration. The sites are highlighted below in Figure 56, and a list of the coordinates for each site can be found in Appendices 14.

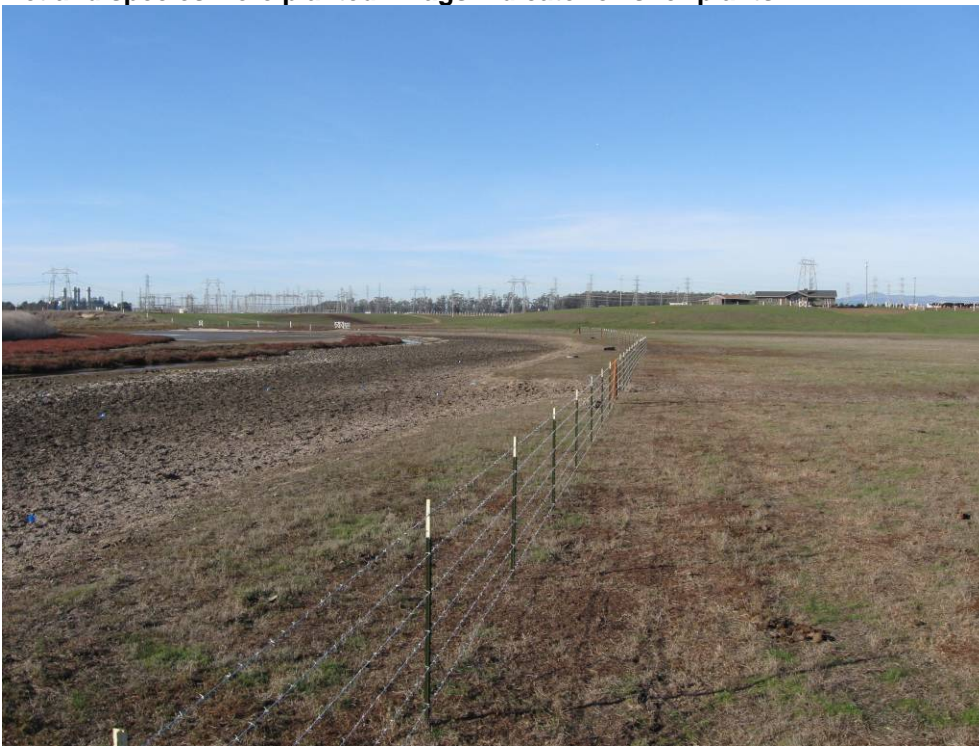
Figure 57 Marsh area of Calcagno parcel after the new fence was built but before the wetland species were planted. Flags indicate rows for plants.

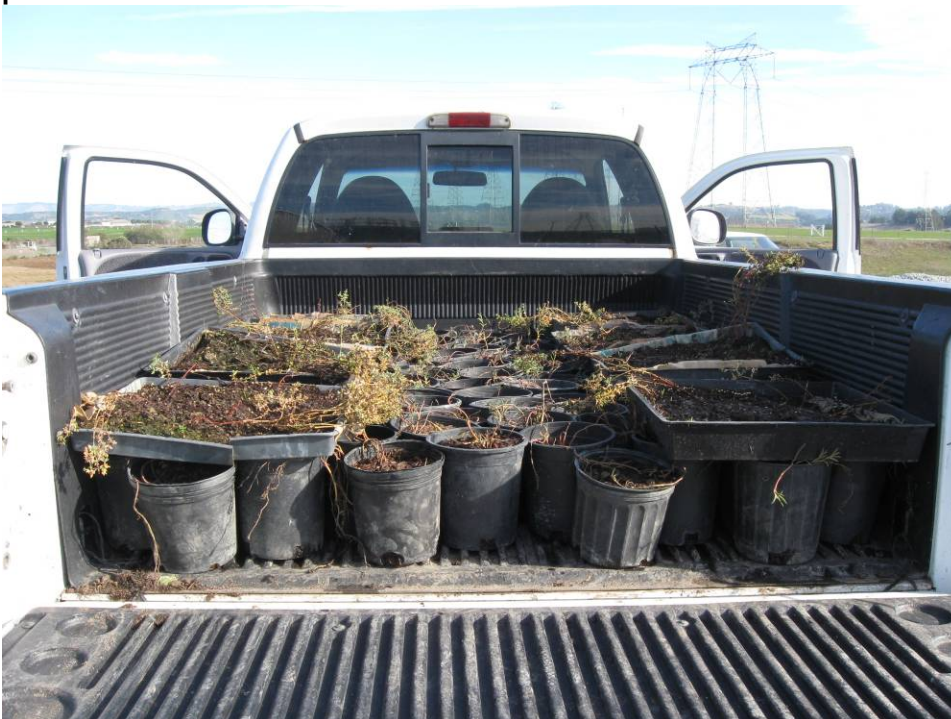
Figure 58 Wetland plants being transported from project greenhouse to the marsh to be planted

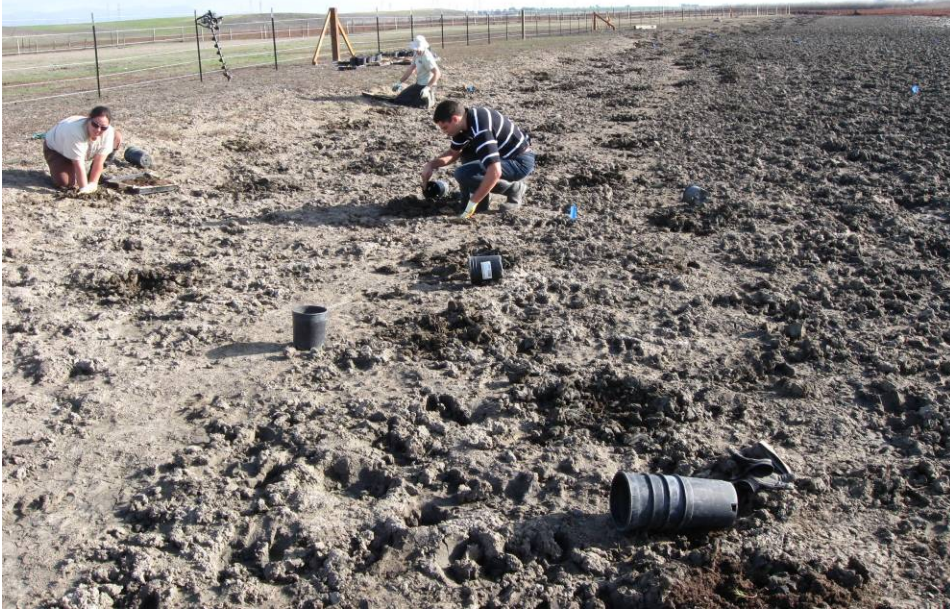
Figure 59 Habitat Restoration crew planting the wetland species in the Marsh on the Calcagno parcel

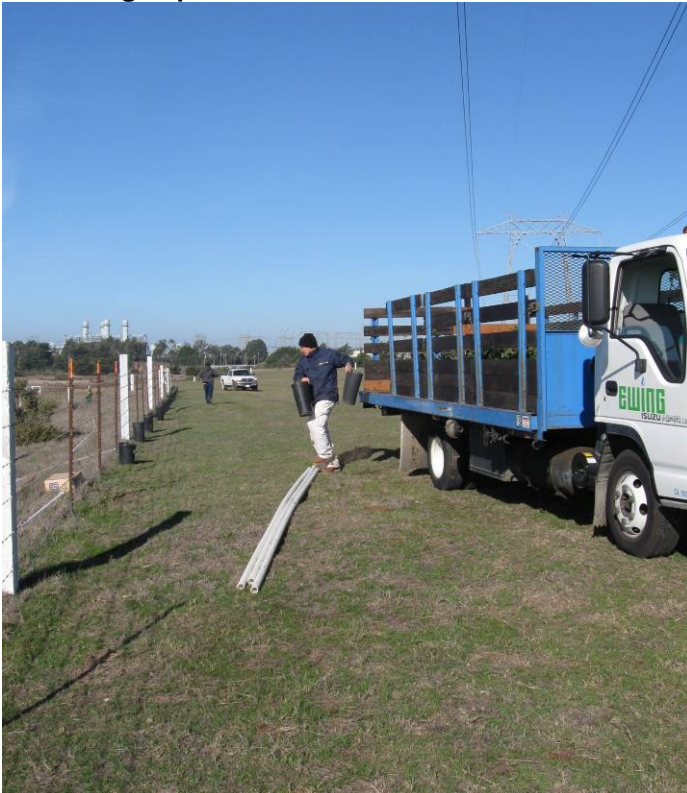
Figure 60 Oaks being brought from the Watershed Institute greenhouse to be planted at the Calcagno parcel

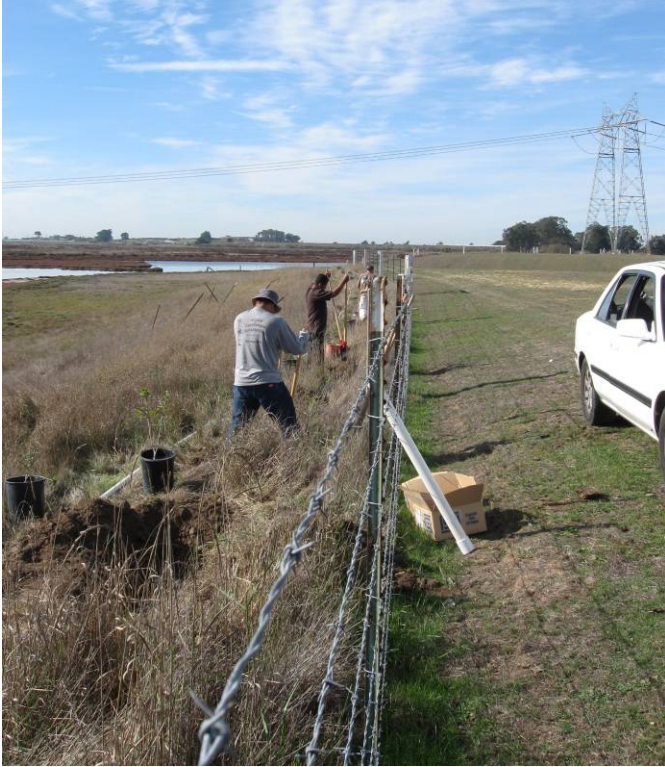
Figure 61 Workers planting the oaks next to the new irrigation line at the Calcagno Parcel.

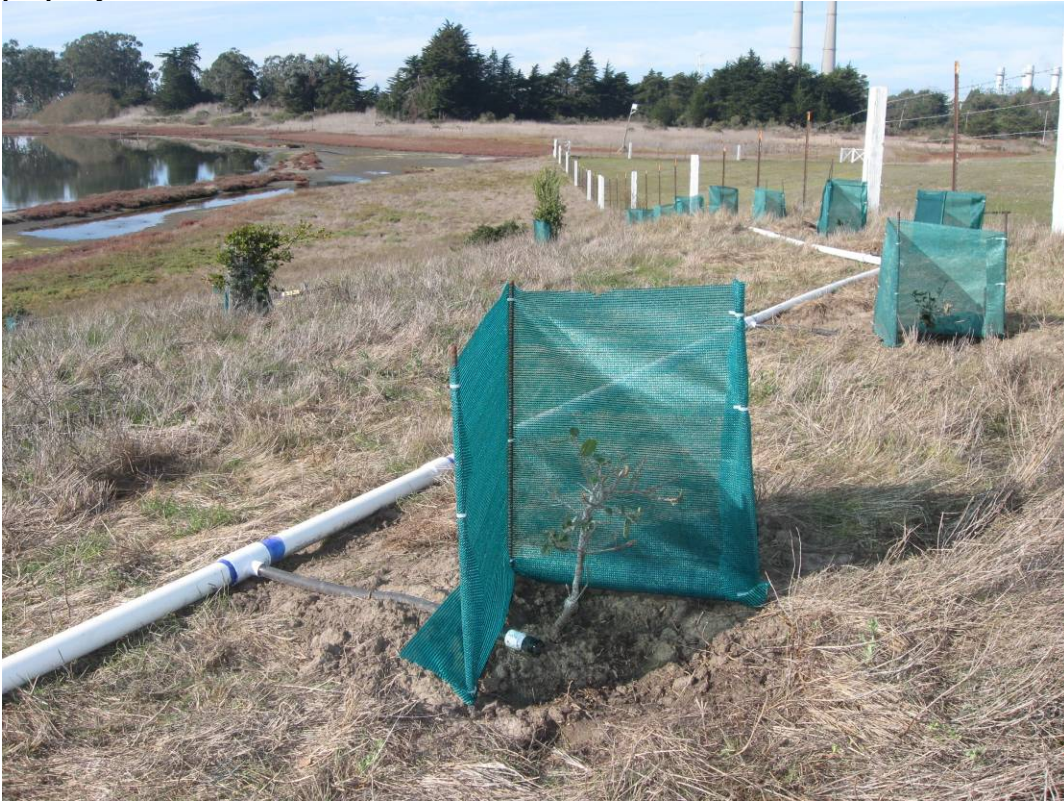
Figure 62 Shade cloth is used as a windbreak for the young Oak trees on the Calcagno property

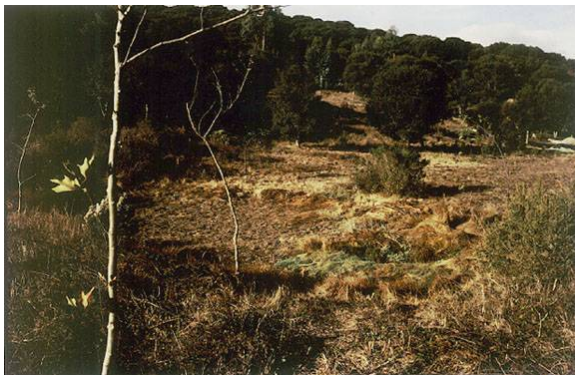
The wet area is preserved with a conservation easement and property tax exemption (please see our other handouts), and the public has secured a functioning section of the natural freshwater system. This ecological engineering has been used successfully throughout Salinas Valley in the restoration projects with the Watershed Institute and Moss Landing Marine Laboratories. Included below are several photos of a successful example of restoration on Walker Creek.

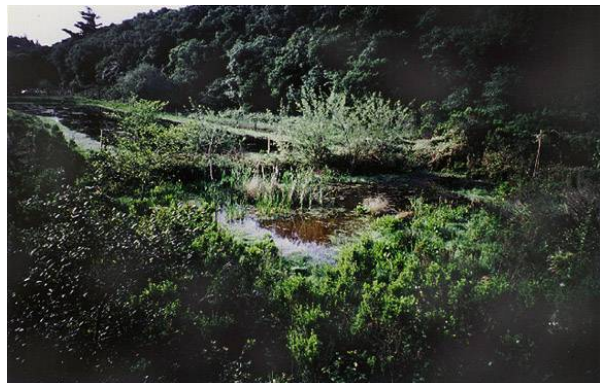
Photo 2. Walker Creek 5 years after restoration during wet season (distance photo).

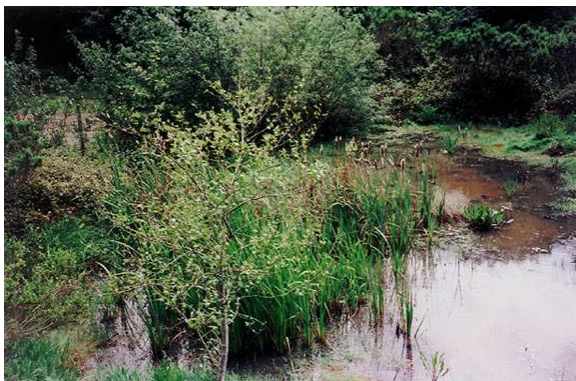
Photo 3. Walker Creek 5 years after restoration during wet season (close-up photo).
