Extreme Erosion Control at McWay Landslide

Winter Report - May, 1998

Prepared for CalTrans Environmental Planning San Luis Obispo

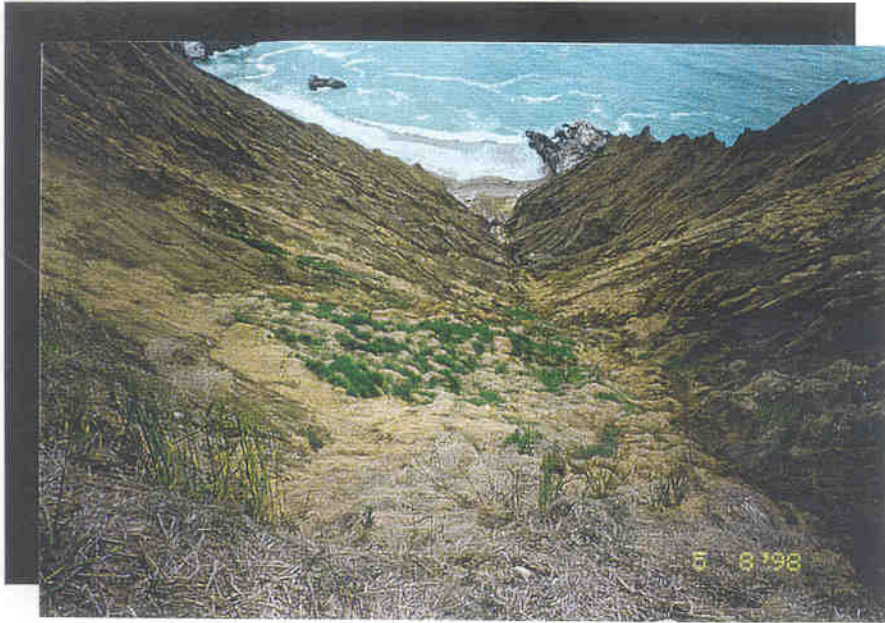
Erosion Control

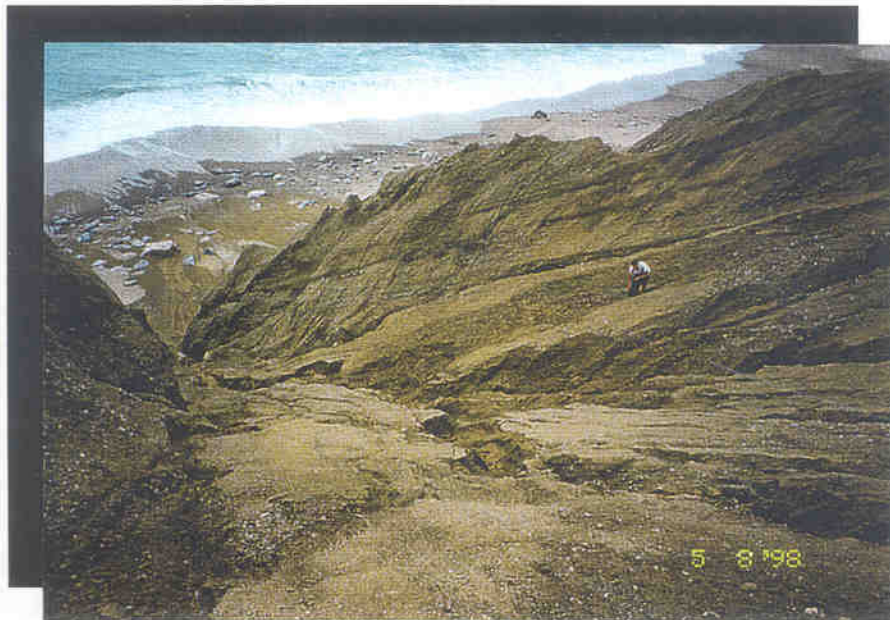
No Erosion Control

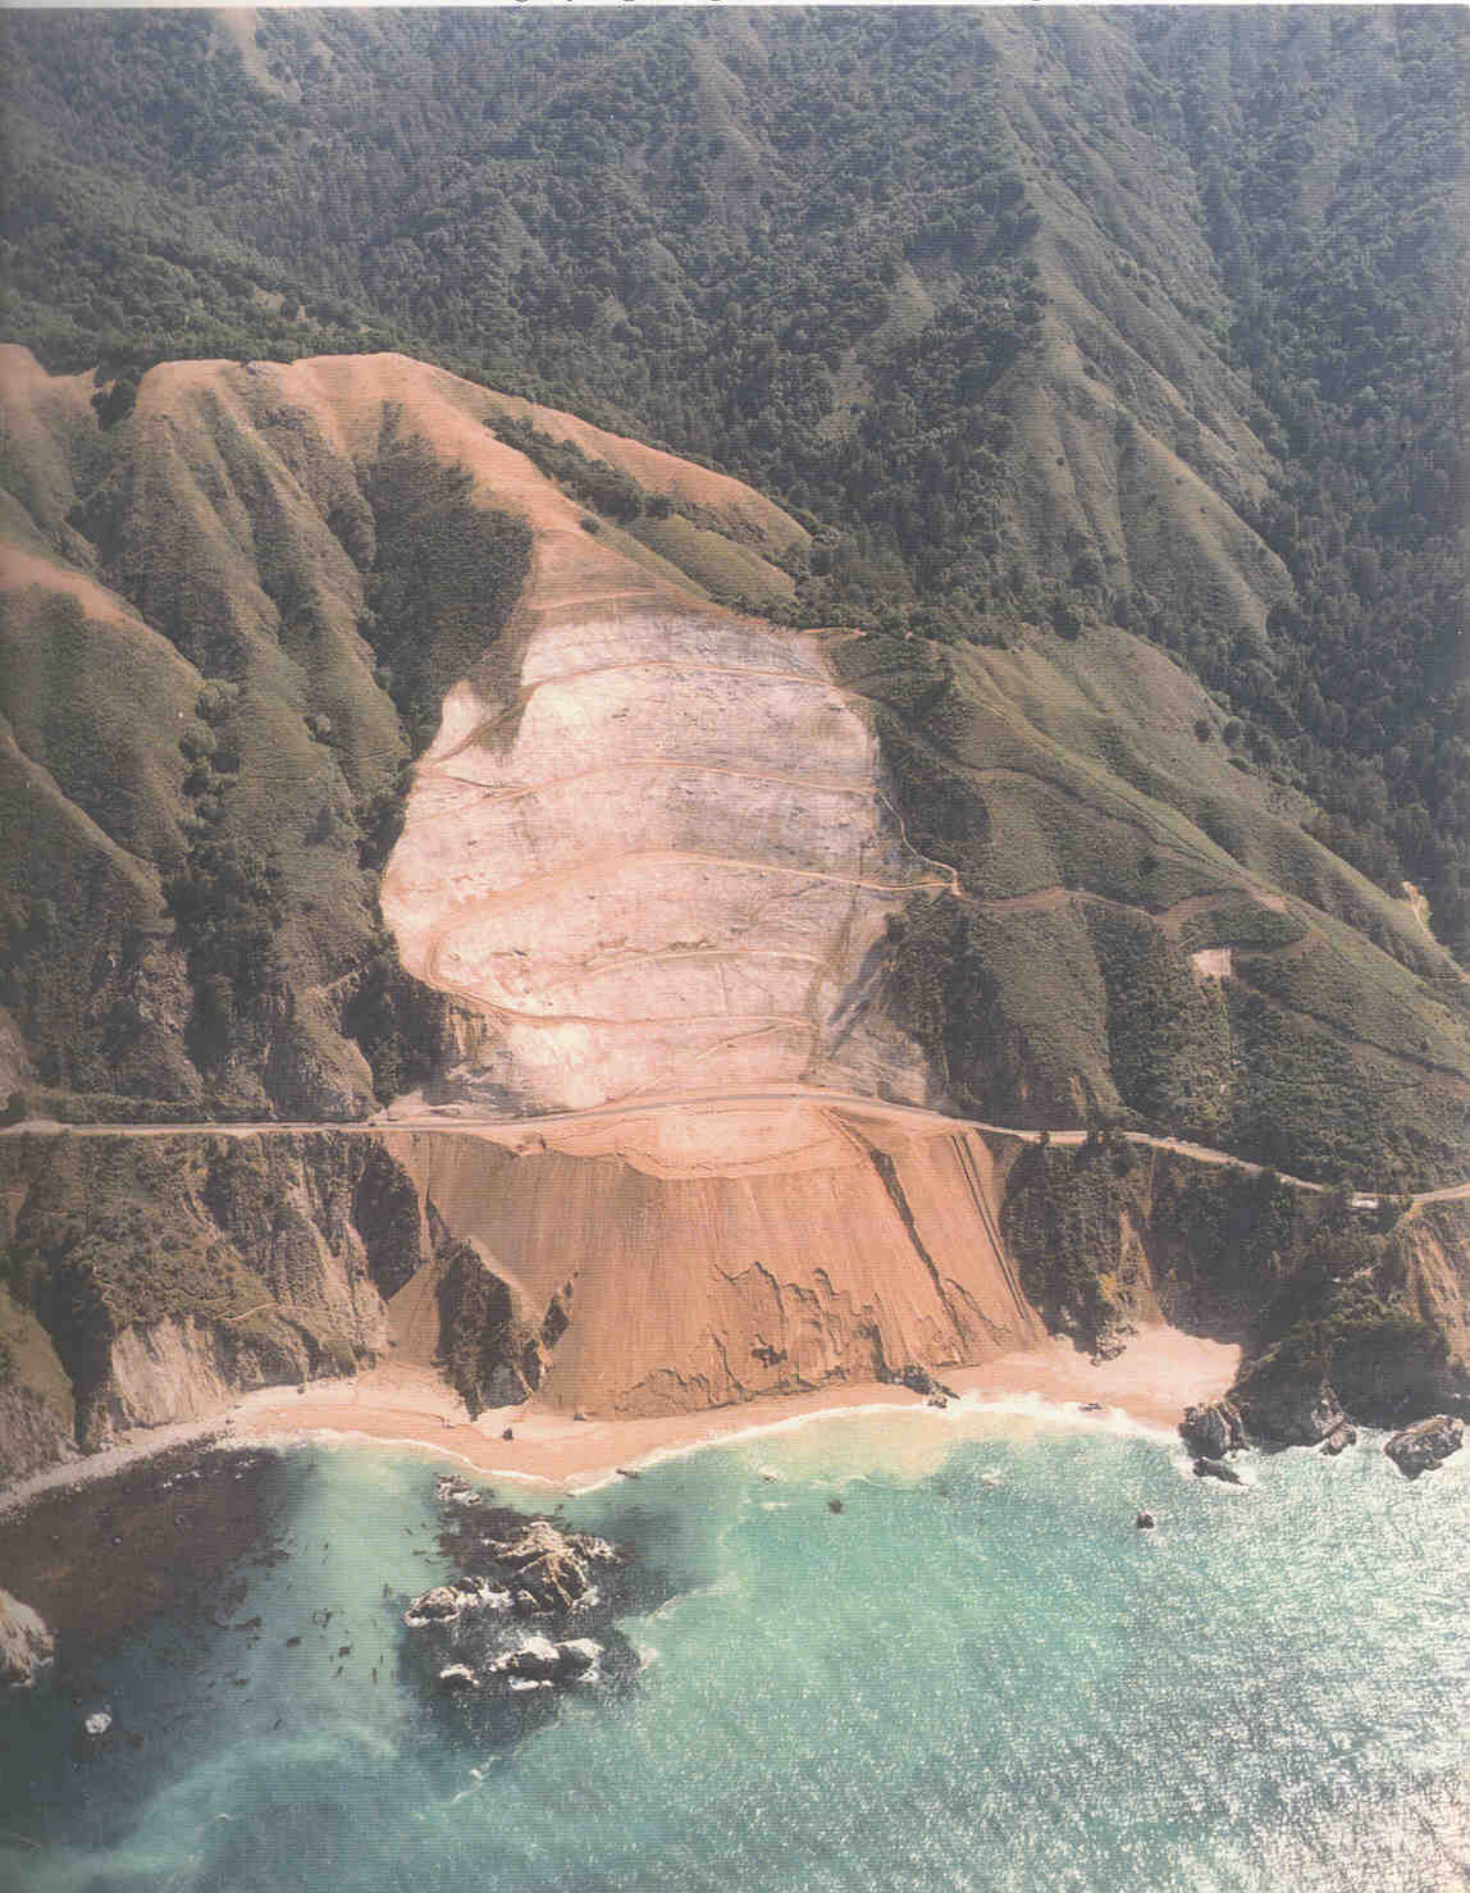
McWay landslide on May 18, 1984
Caltrans depositional event completed
Erosion of gully beginning from incorrect drainage

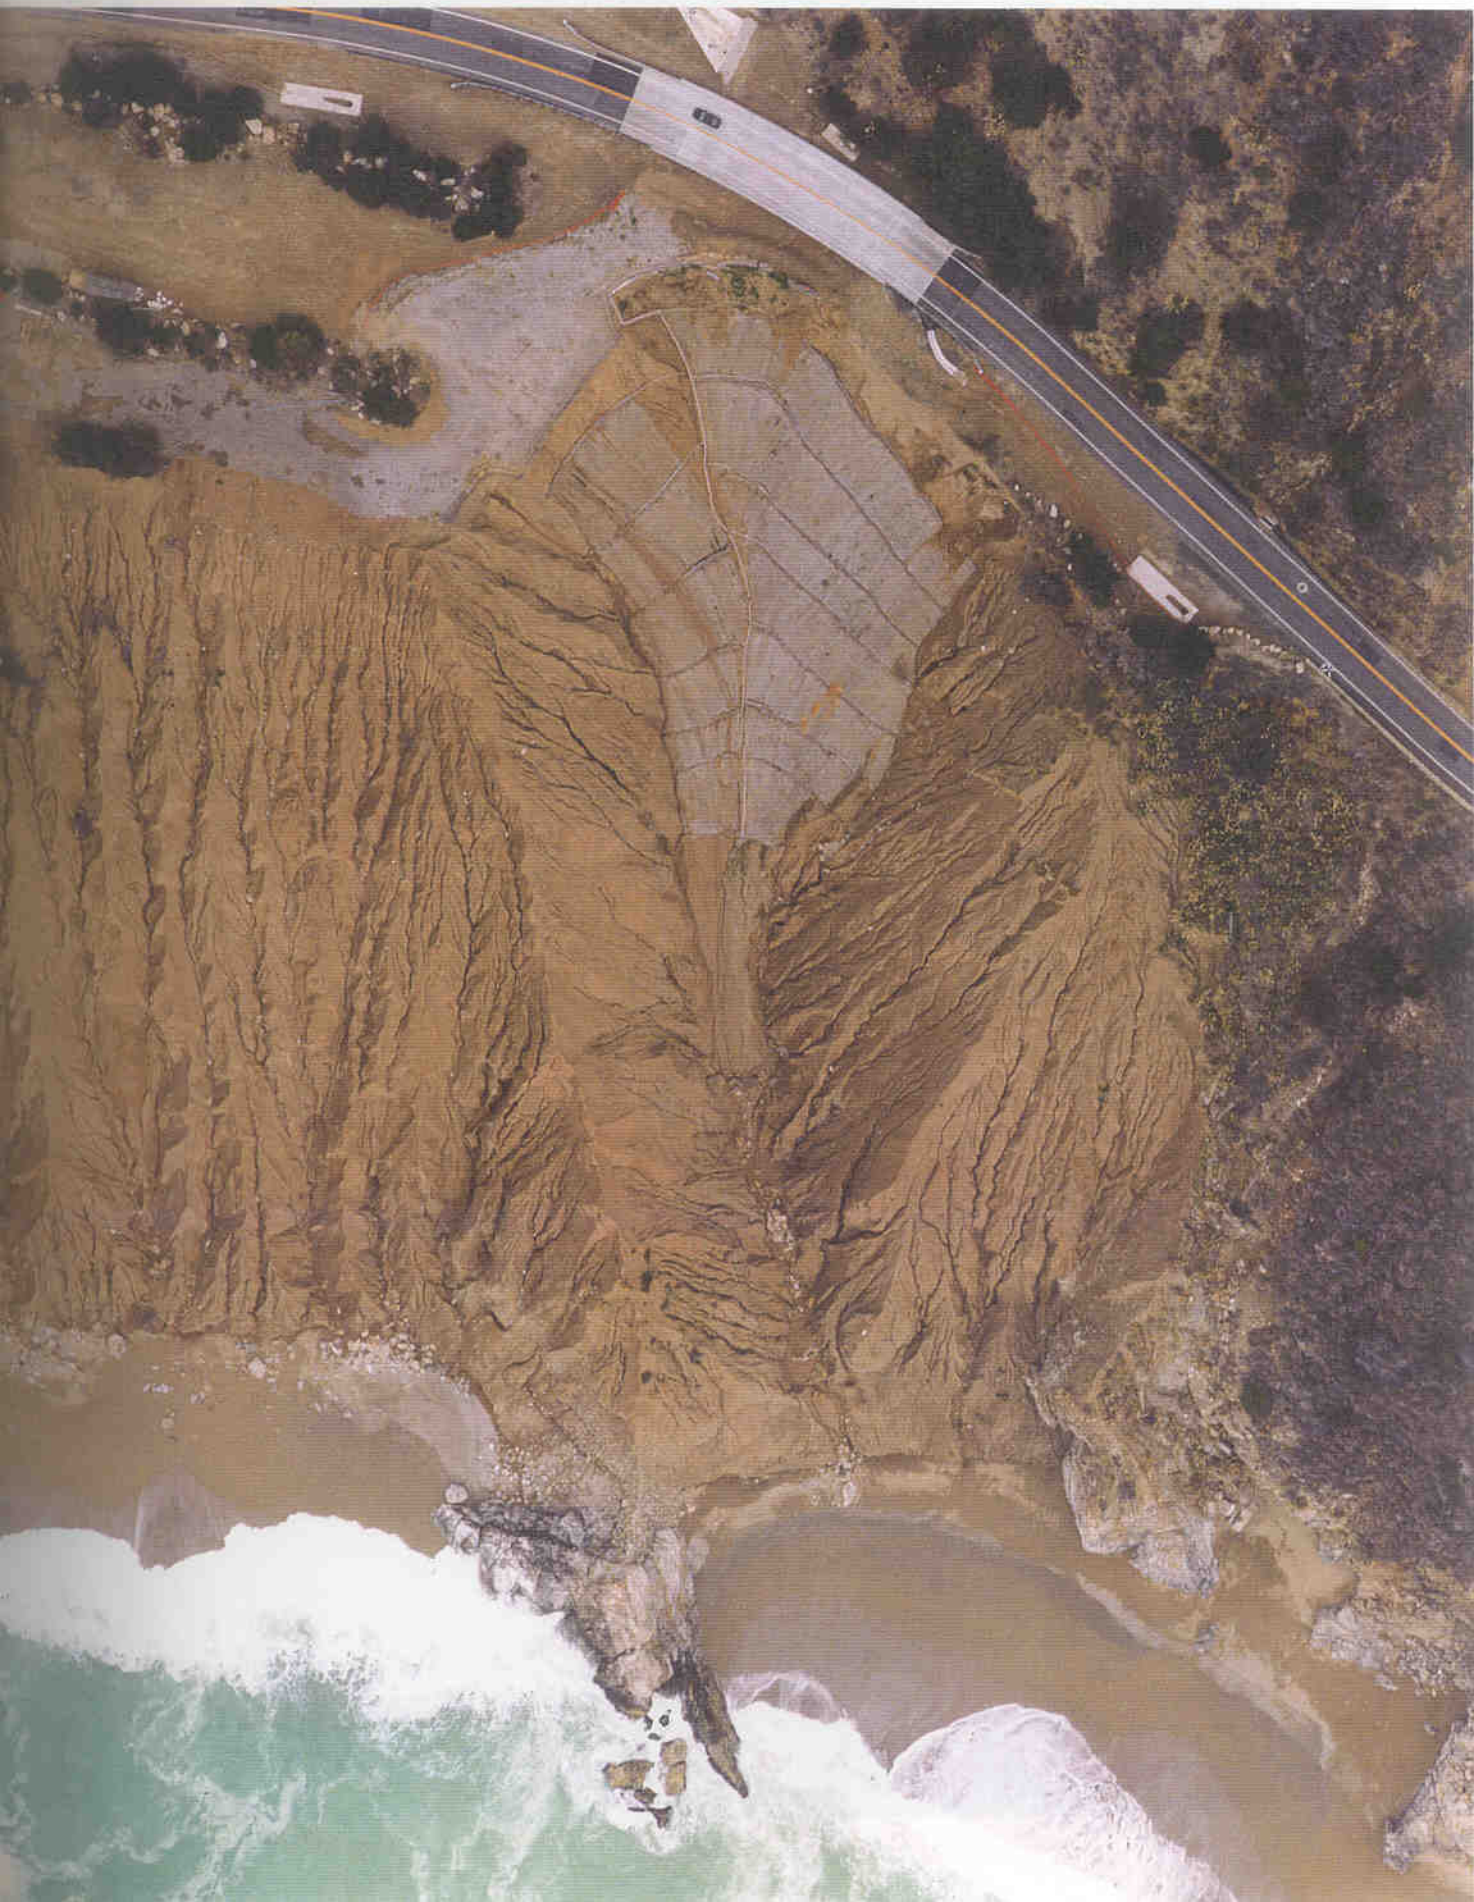
McWay landslide on November 21, 1997
Jute and haybale rows with irrigation pipes
Hay, seed, no nutrients except green patches near the bridge

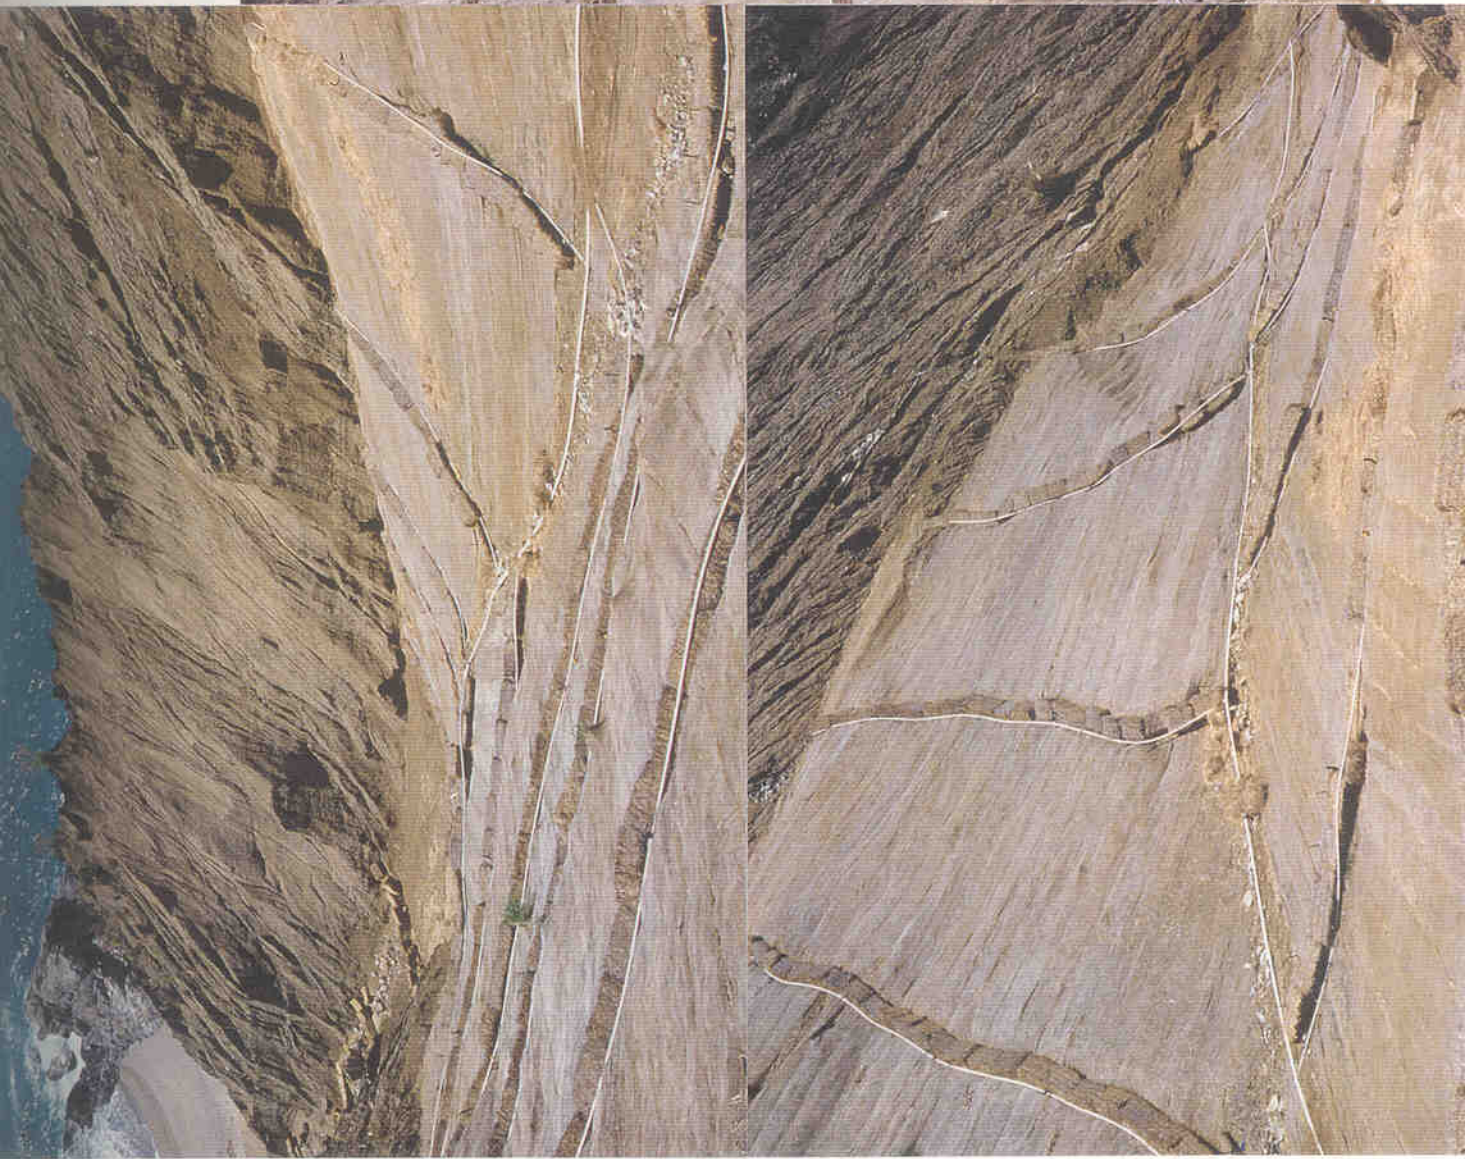
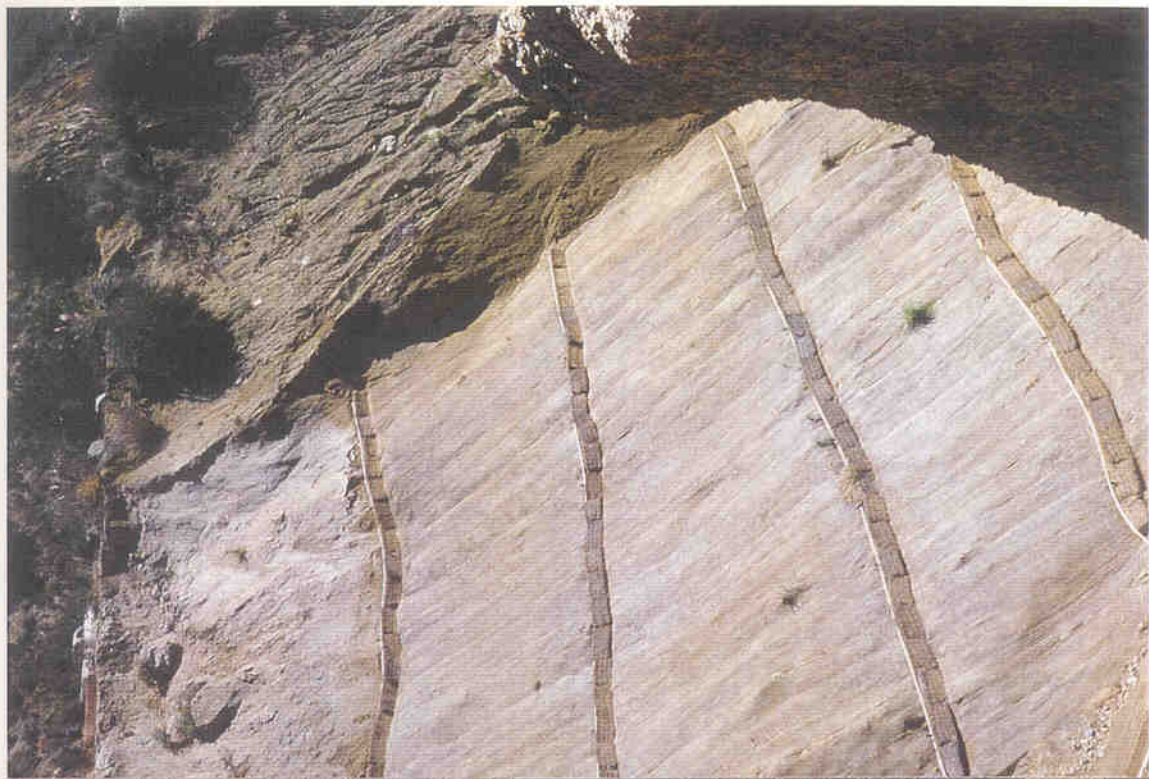
McWay Landslide in October 1997
Seed, Hay, Jute, Haybales and Irrigation
(no nutrients)

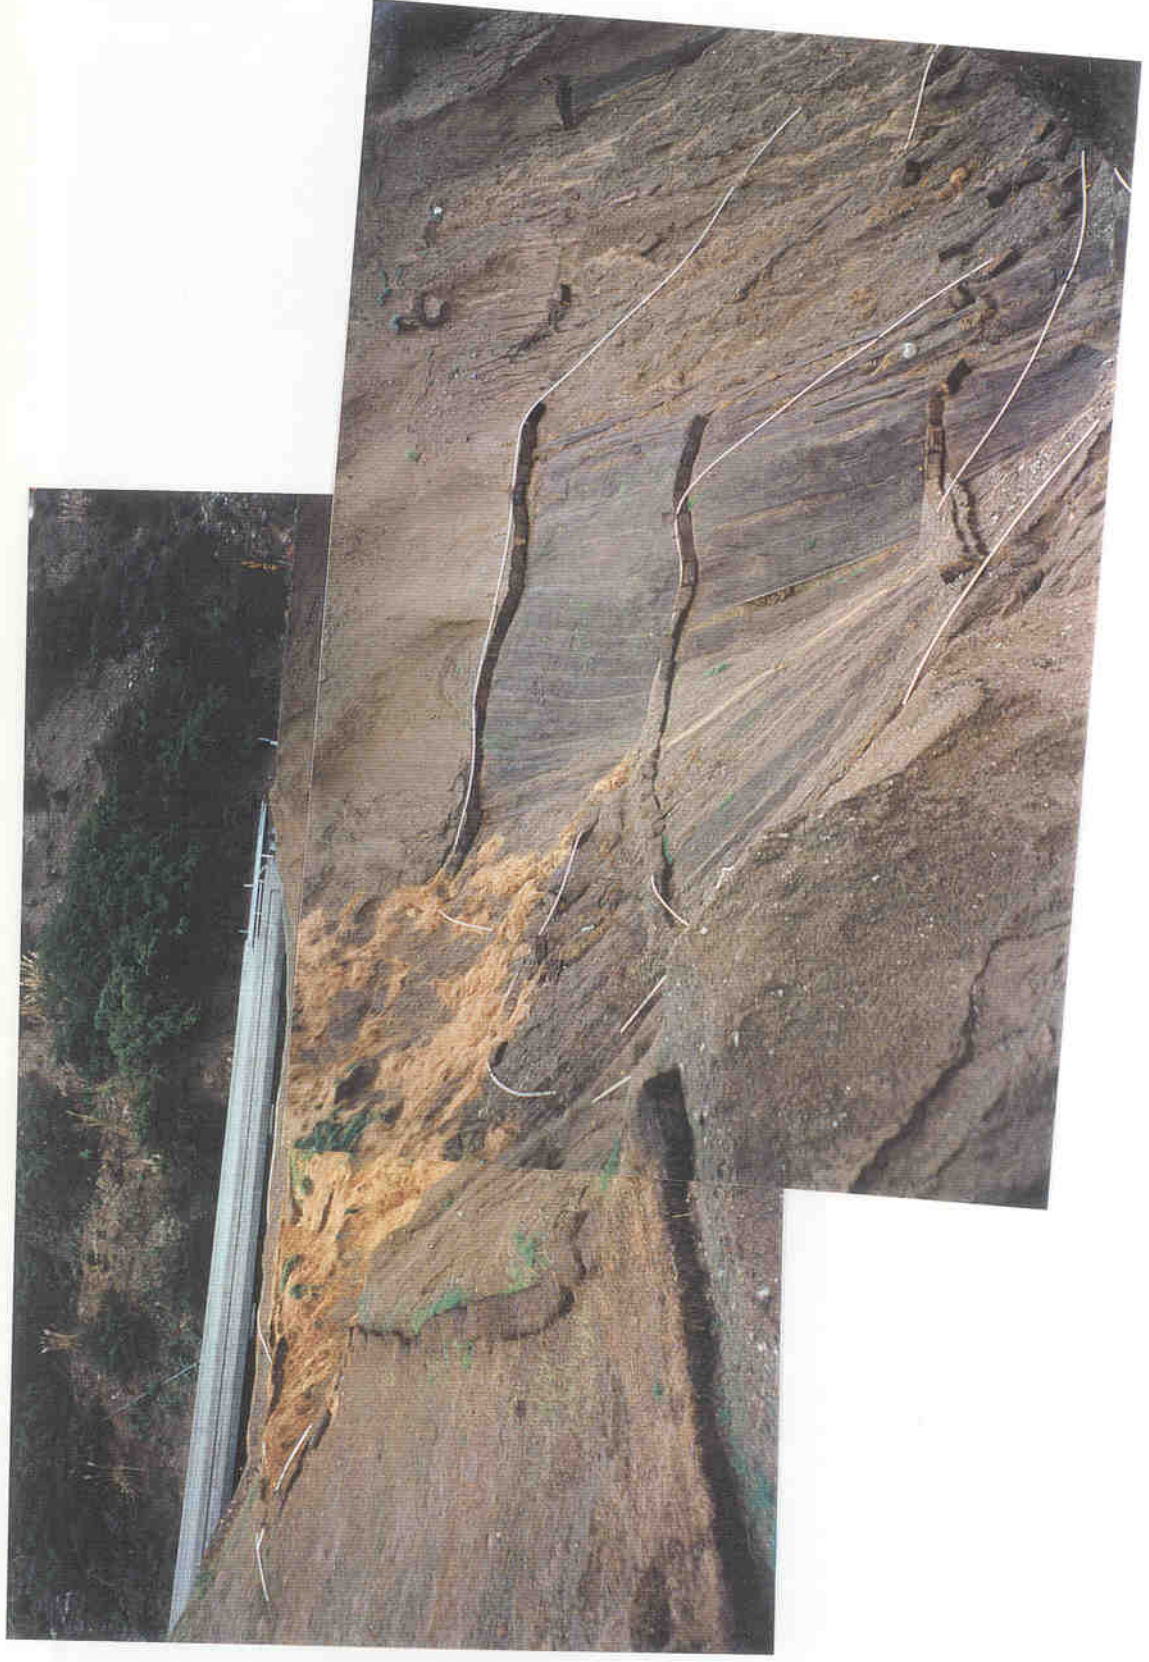
McWay landslide on December 9, 1997 after two major rains (1 and 2 inches),
jute slumped from southern portion, surviving irrigation,
first hay, seed, and nutrient treatment just beginning in the bowl.

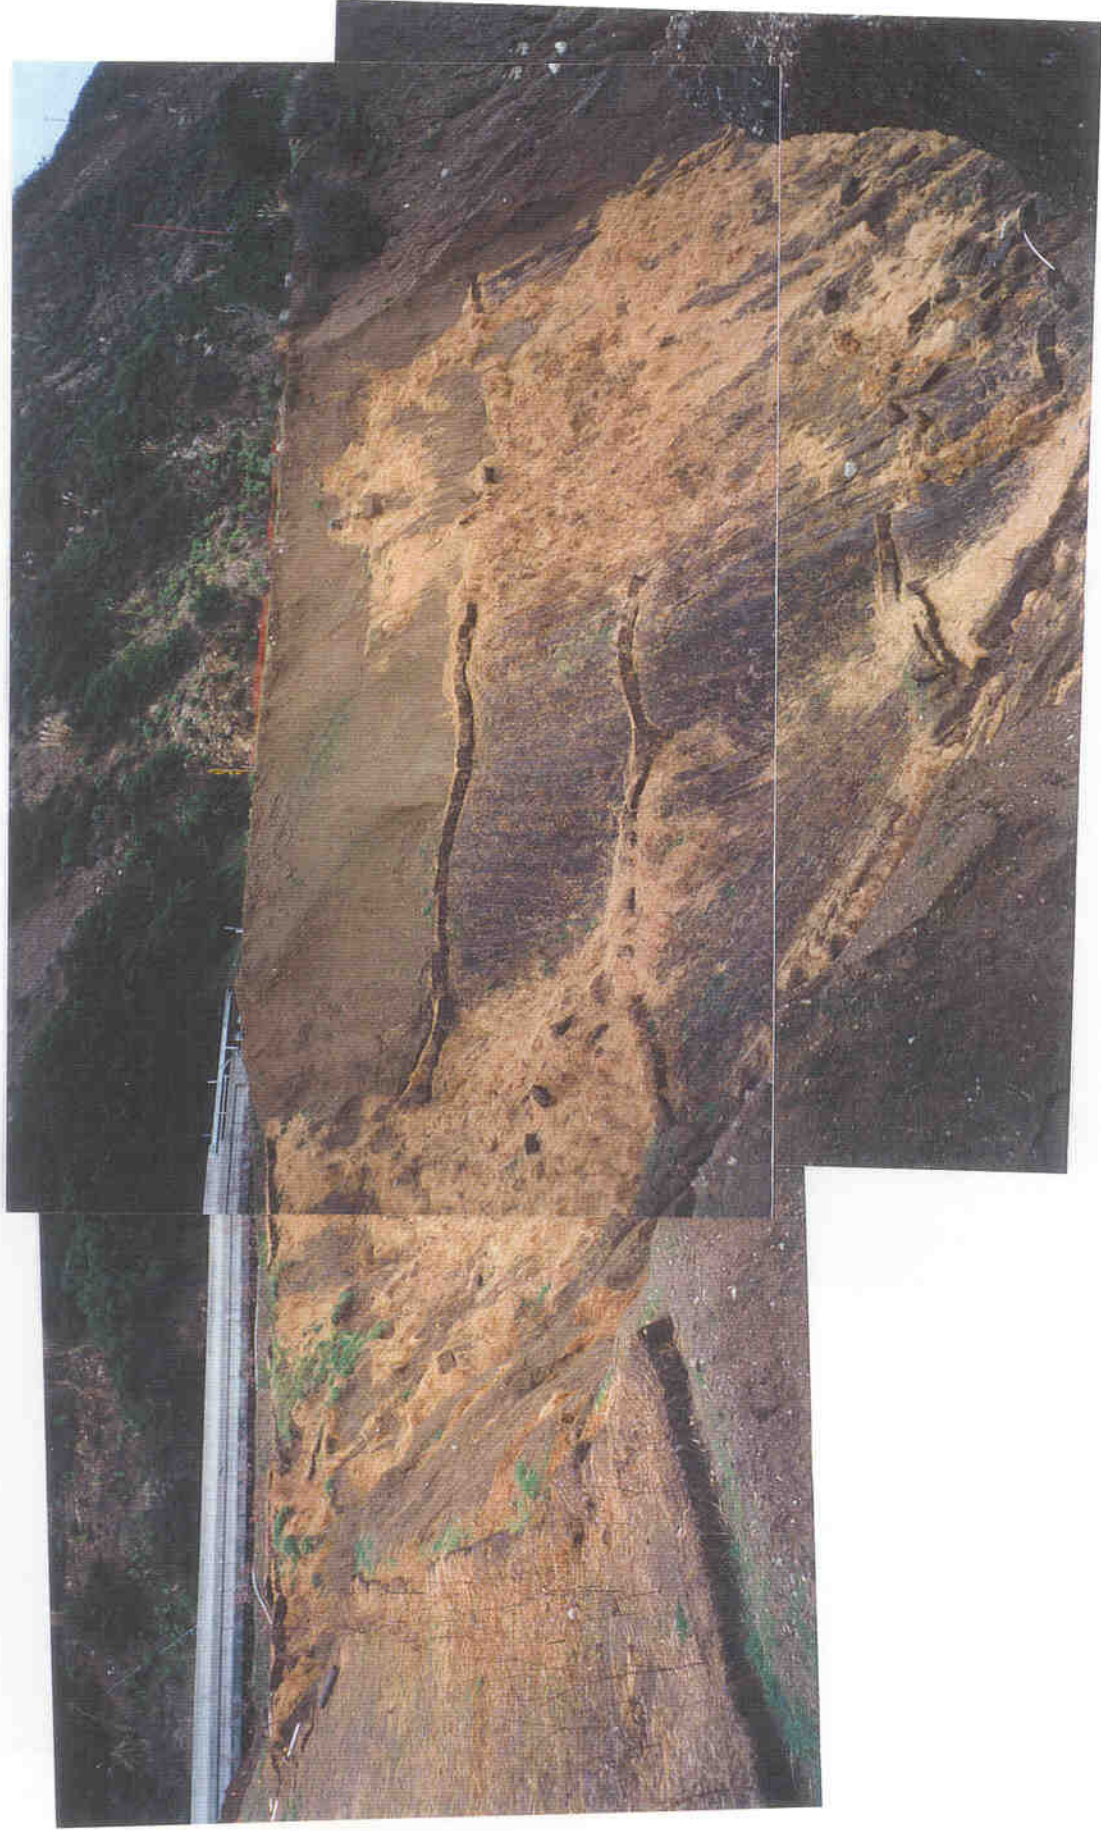
McWay landslide on January 4, 1998 after some rain damage,
willow cuttings plugged 3-4 feet apart
hay, seed, and nutrients spread over exposed soil.

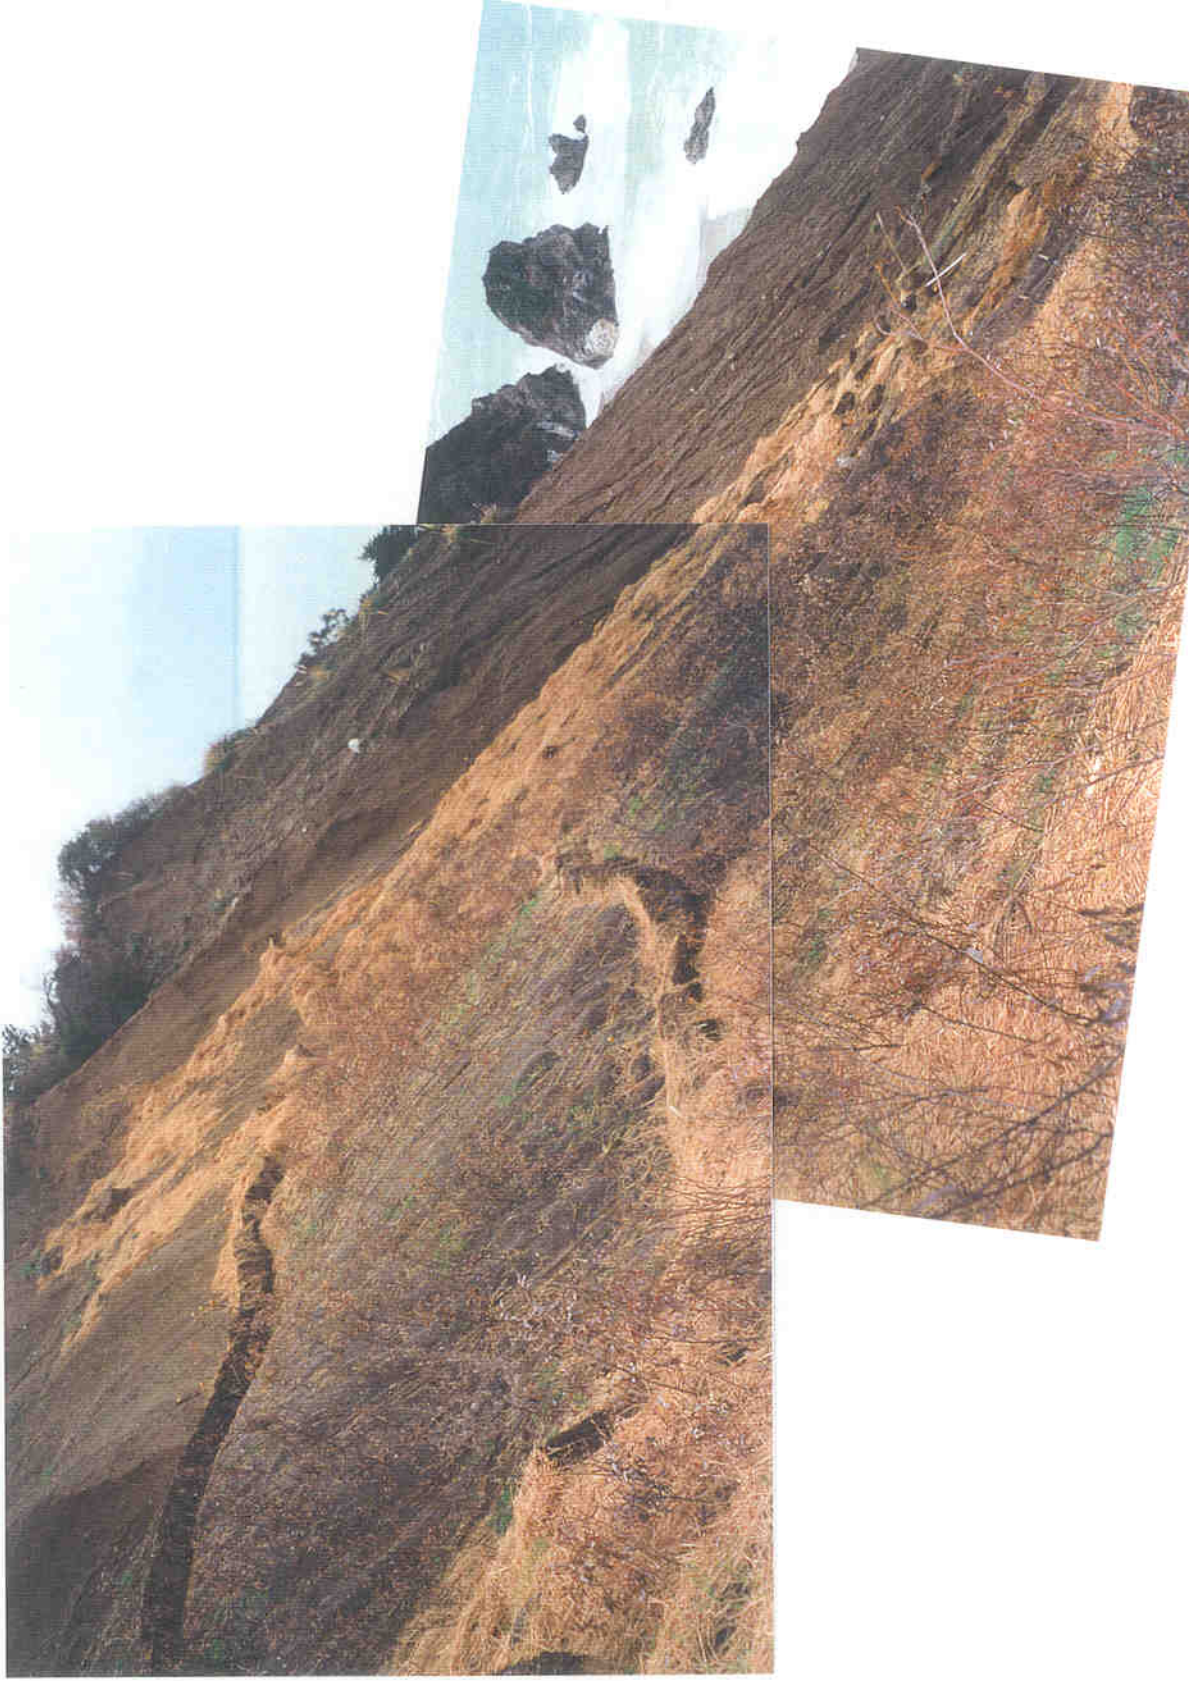
McWay landslide on January 4, 1998 after some rain damage,
willow cuttings plugged 3-4 feet apart
hay, seed, and nutrients spread over exposed soil.

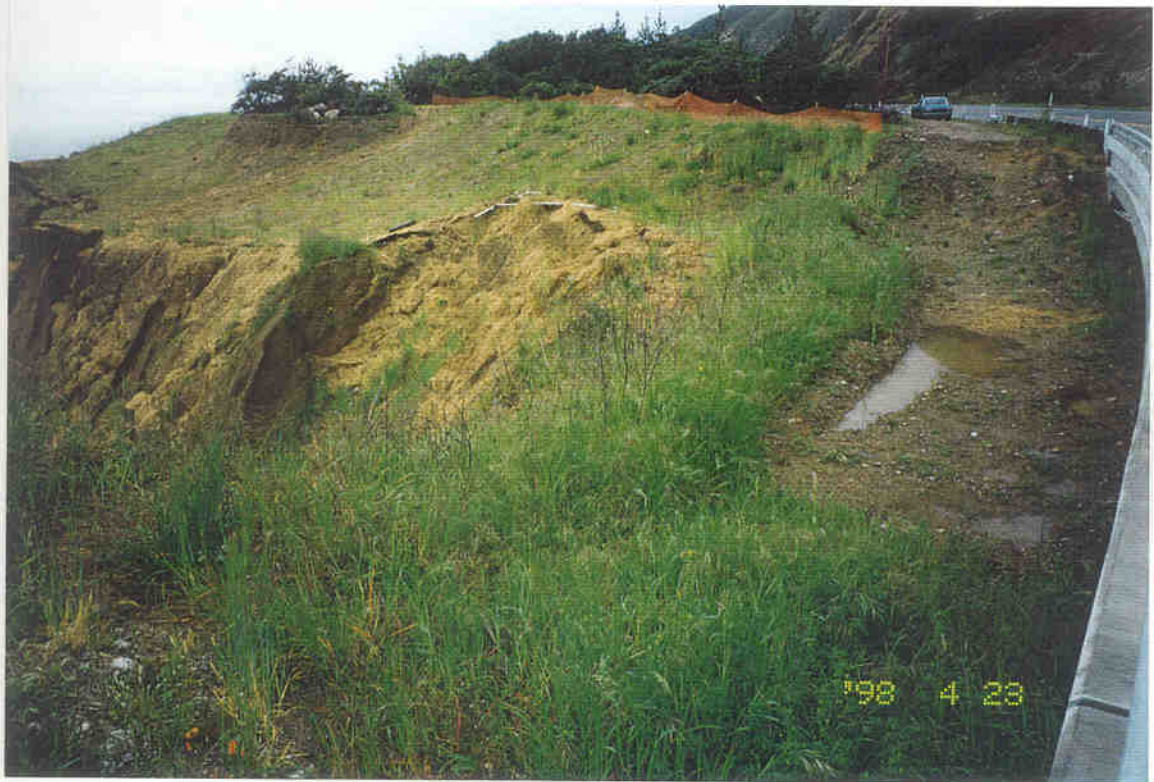
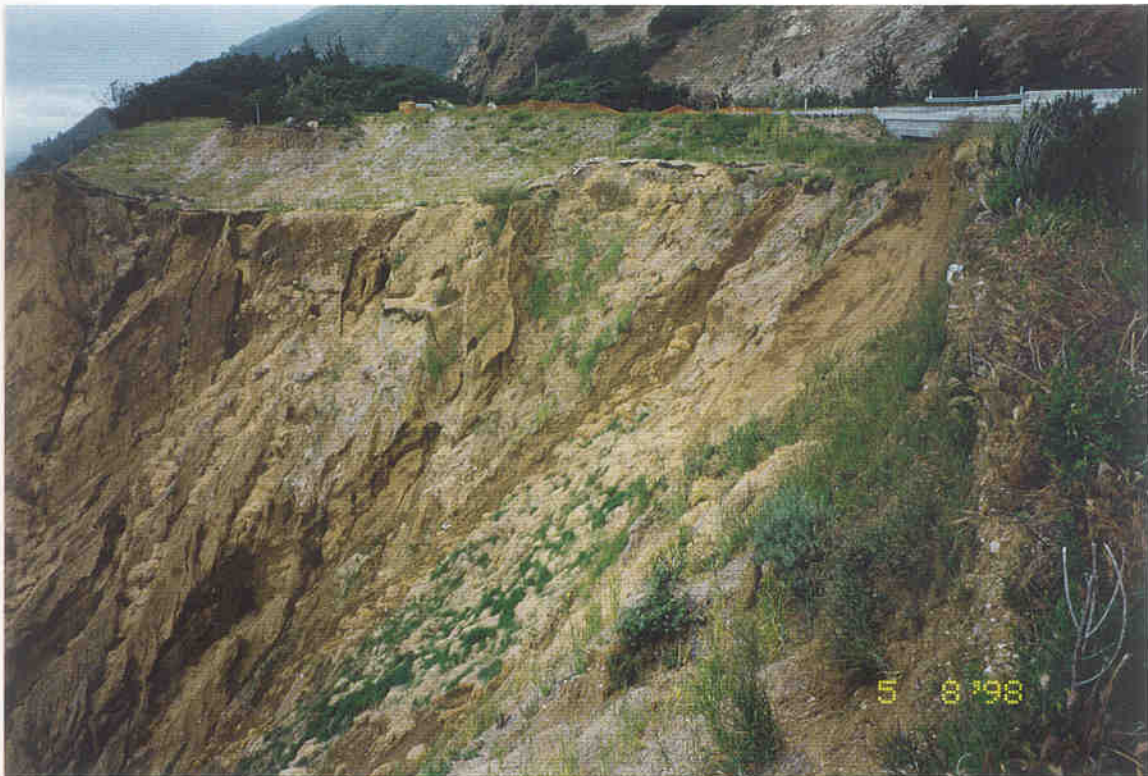
McWay landslide on April 23 (top) and May 8, 1998 (bottom) showing the growth of native plants around the upper rim of the bowl, where erosion control was centered. Soil erosion into the ocean was dramatically reduced and there was no highway damage.

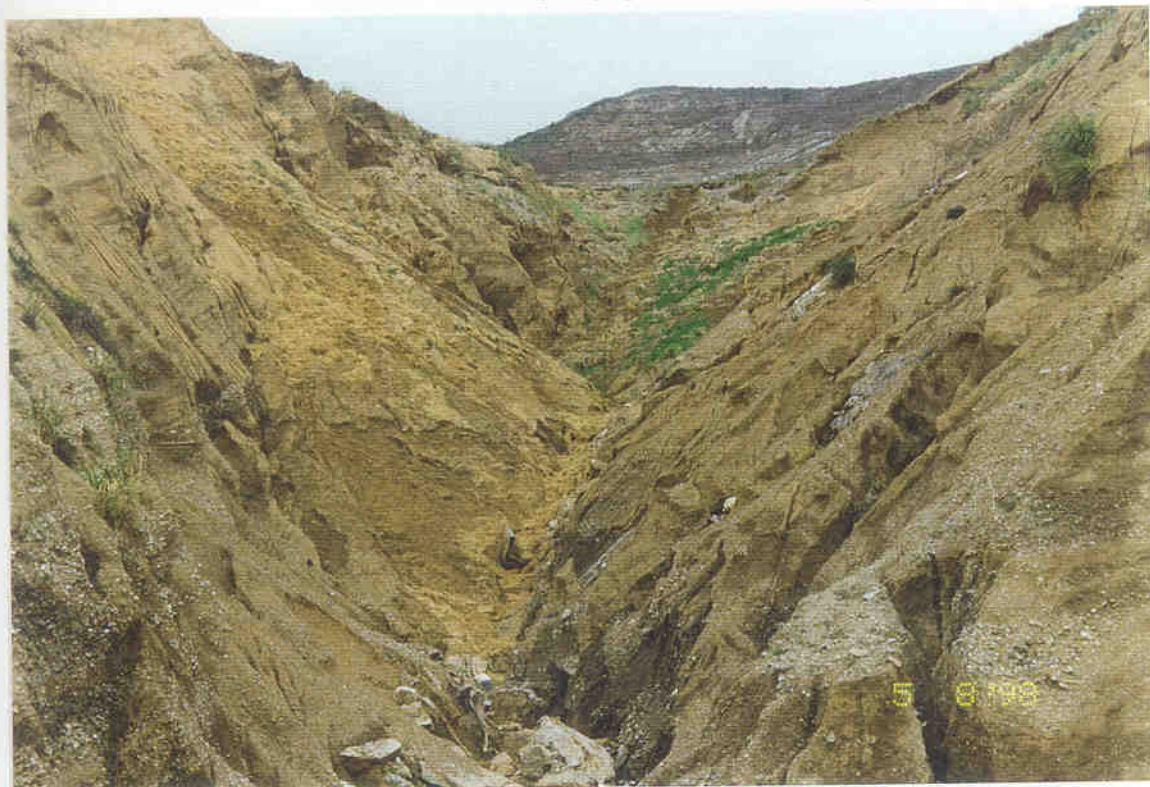
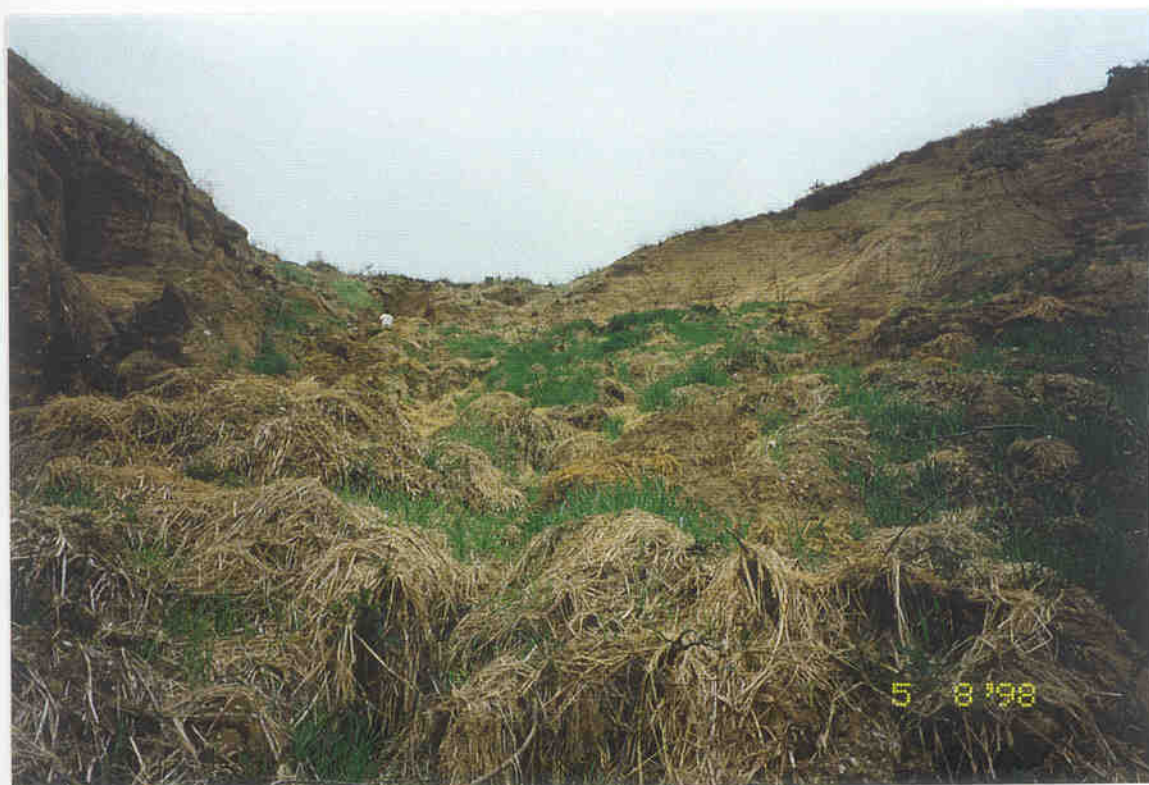
McWay landslide on May 8, 1998 looking up the bowl from the beach showing the establishment of native plants in the upper region and the deposition of over 95% of the winter eroded soil within the central bowl, not into the ocean (top). The bottom picture is a closer view of developing grasses and hay.

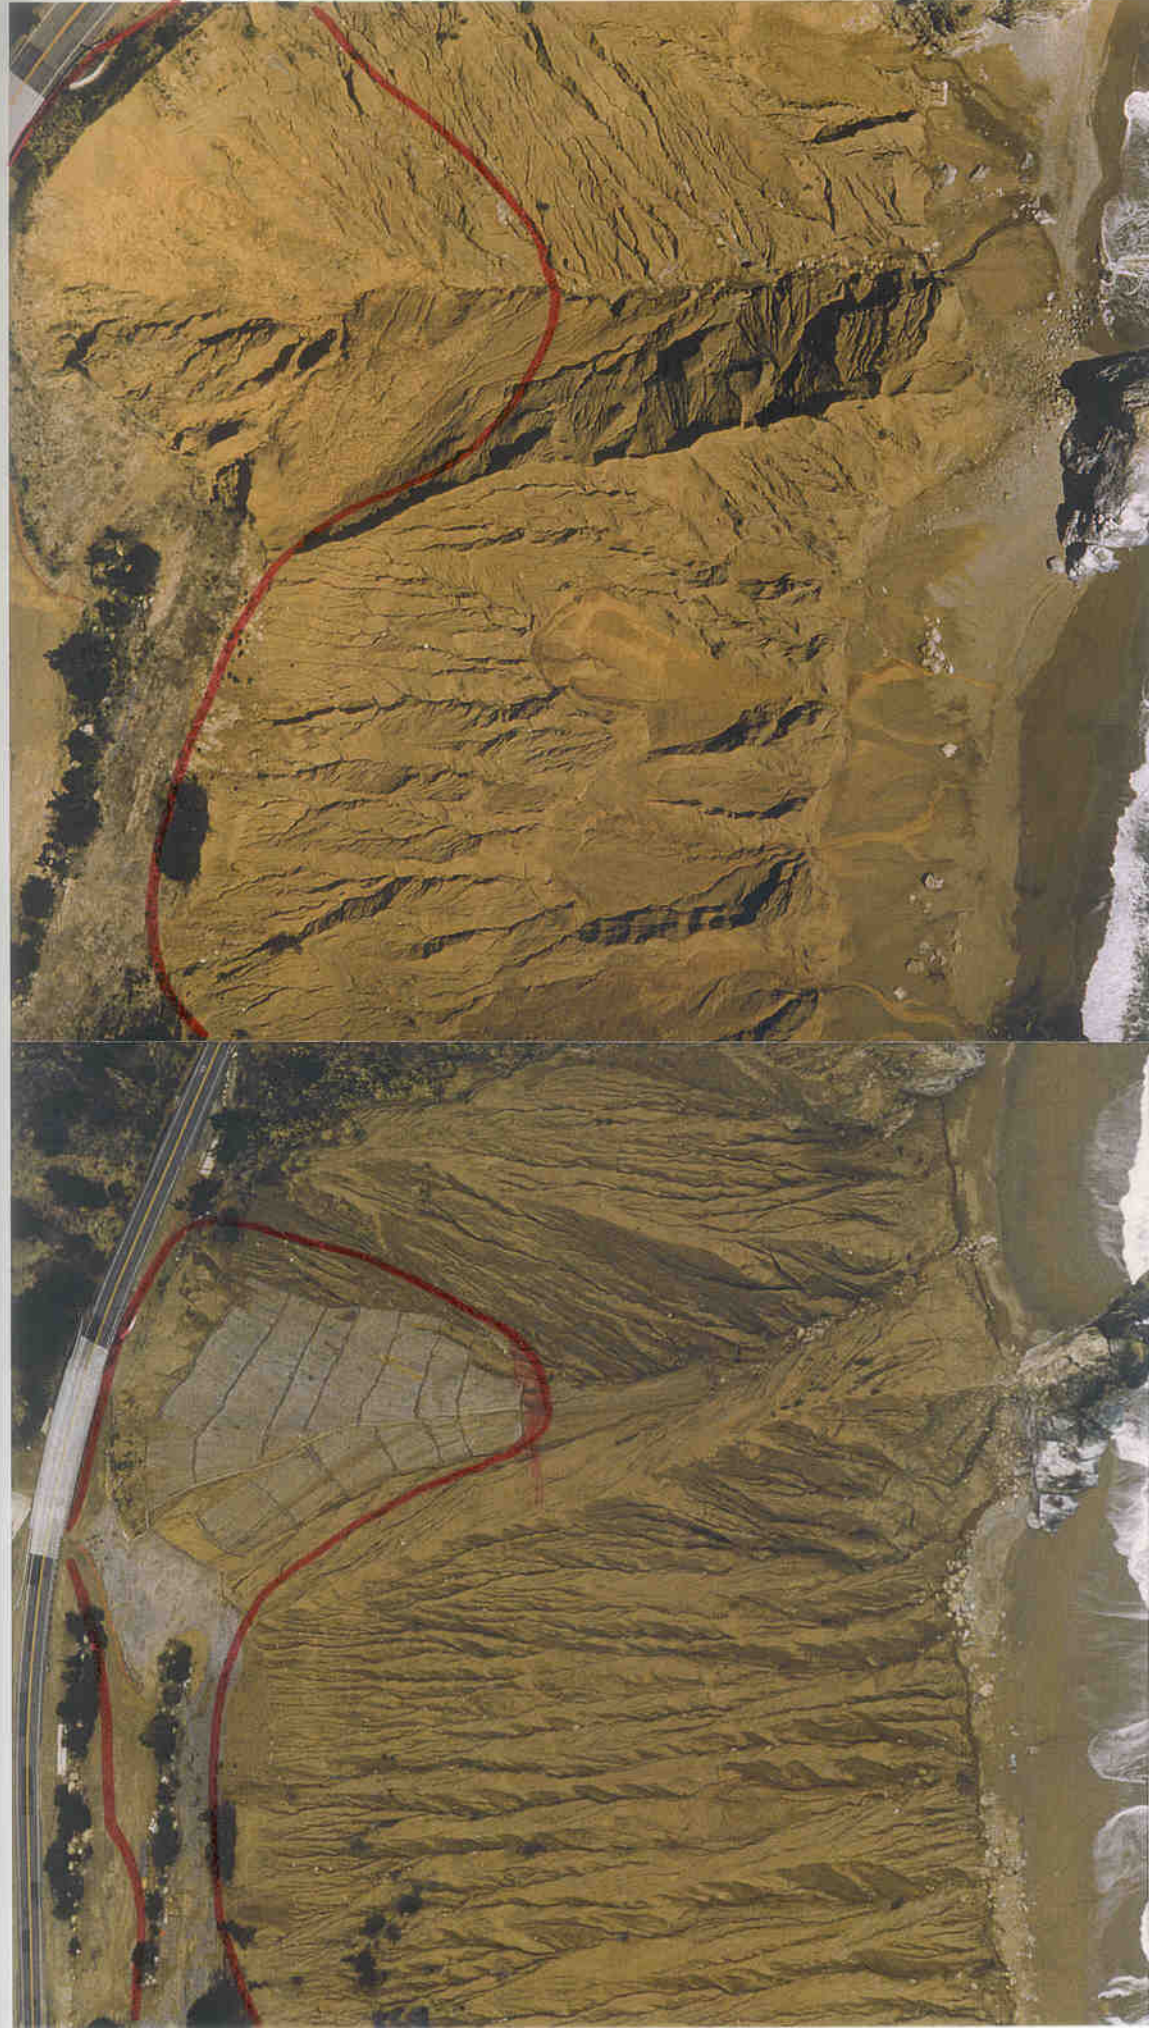
McWay landslide on November 25, 1997 (left) with jute covering the center of the erosion control area; and on April 17, 1998 (right) showing extreme erosion on the face of the landslide where there was no erosion control.
