Extreme Erosion Control at McWay Landslide

Winter Report - May, 1998

Prepared for CalTrans Environmental Planning San Luis Obispo

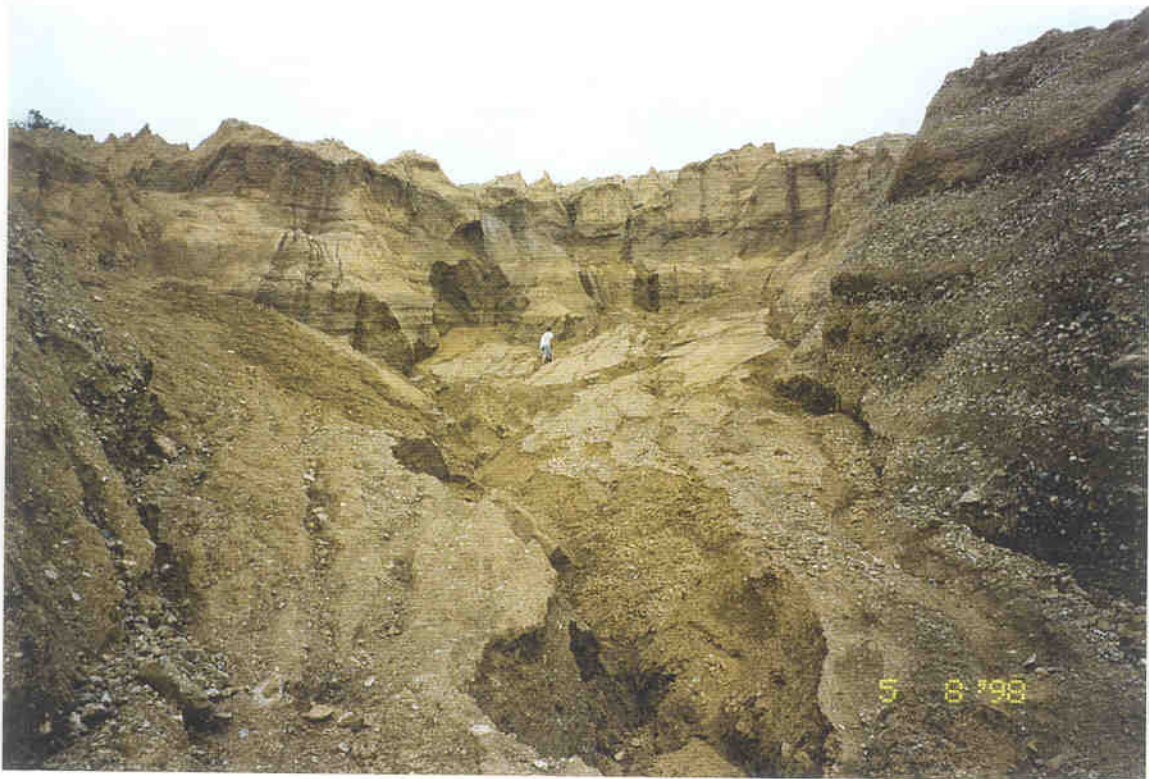
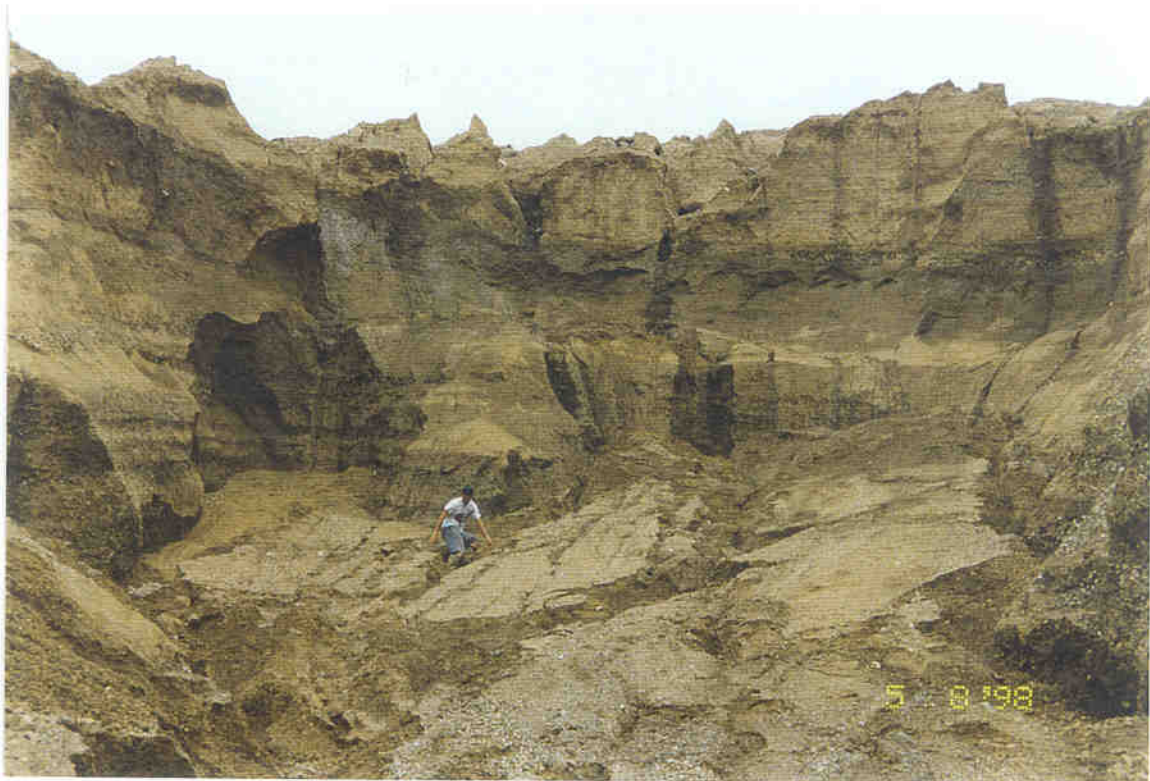
McWay landslide on May 8, 1998 showing extreme erosion on the face of the landslide where there was no erosion control and even significant erosion since the picture taken on 18 March.

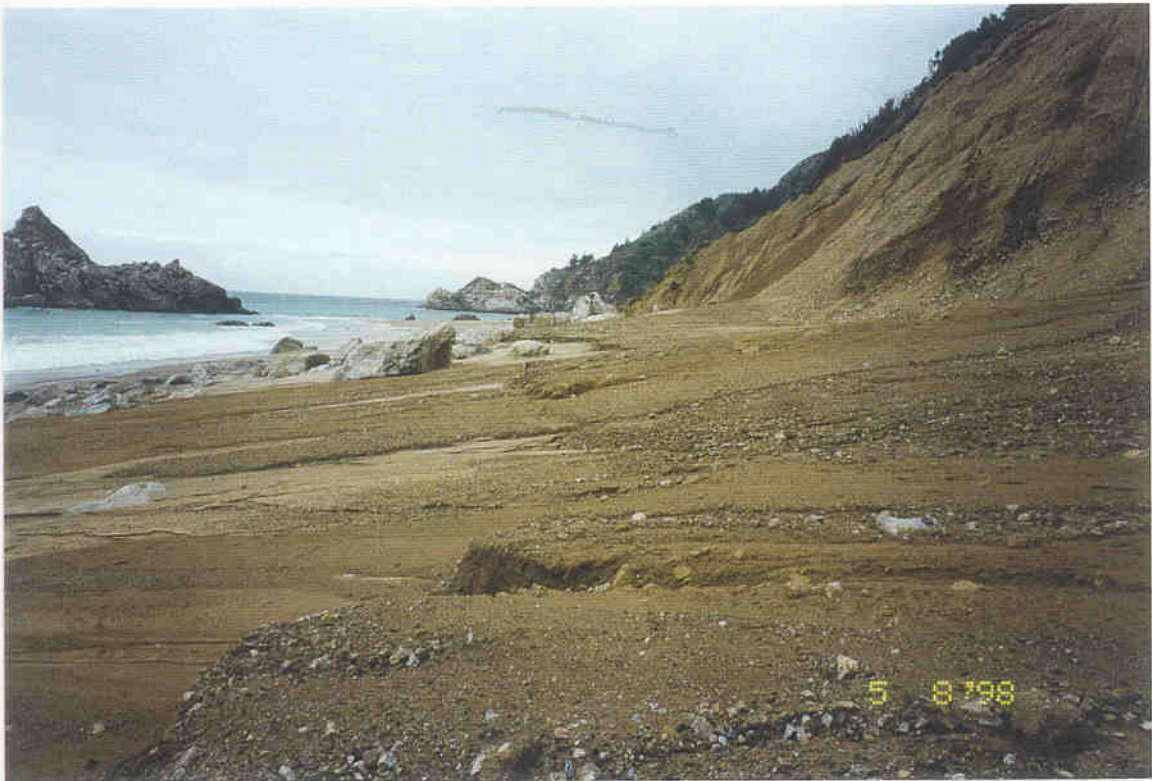
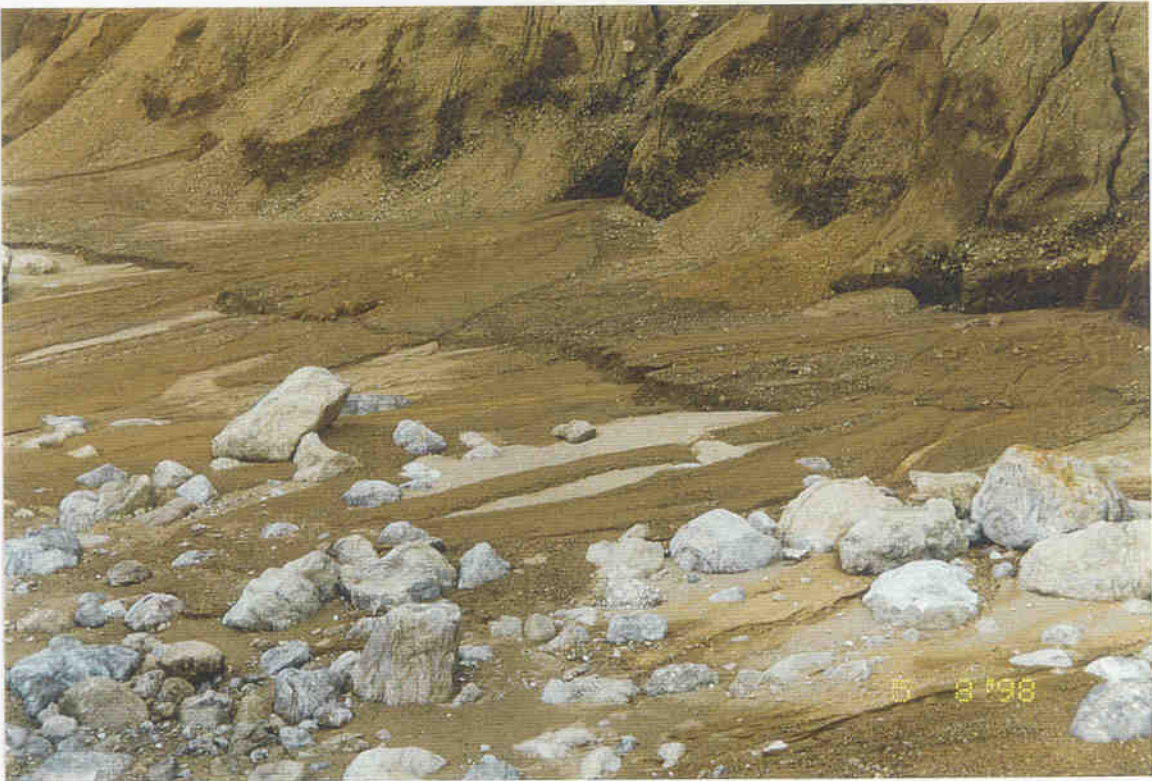
McWay landslide on May 8, 1998 showing the movement of soil eroded from the slide face into the Marine Sanctuary.
