# Implementation of the Moro Cojo Slough Management and Enhancement Plan: Restoration of the Core of the Watershed

PROJECT NAME: Implementation of the Moro Cojo Slough Management and Enhancement  
Plan: Restoration of the Core of the Watershed

AGREEMENT NO. : 04-140-533-01

Date: 3/28/08

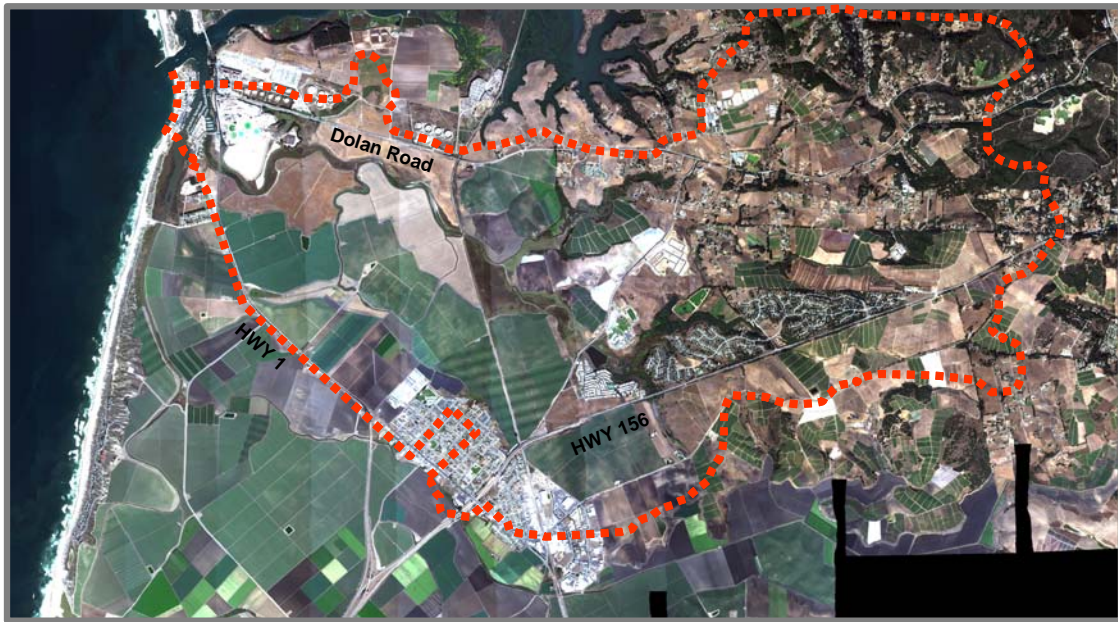
**Figure 1.** Overview of the Moro Cojo Watershed.

The Elkhorn Slough Foundation, Monterey County Agricultural & Historic Land Conservancy, and several private landowners are dedicated to restoring, enhancing, and protecting natural habitats within the Moro Cojo Slough watershed (Figure 1). Properties within the Moro Cojo Watershed have varied histories, but all have been subject to farming, grazing, diking, or other anthropogenic impacts for the last century or more. As such, their habitat value has been substantially degraded. The Moro Cojo Slough has been identified as an impaired water body and is listed as such on the current California 303d list. The Central Coast Regional Toxic Hot Spot Cleanup Plan (1998) identifies Moro Cojo Slough and its tributaries (Castroville Slough) as an important source of sediments and pesticides to Moss Landing Harbor, which is a State listed Toxic Hot Spot. The Toxic Hot Spot Plan Assessment of Actions required to remedy and restore Moss Landing Harbor identifies restoration of the floodplains as a means for reducing associated runoff into the Harbor.

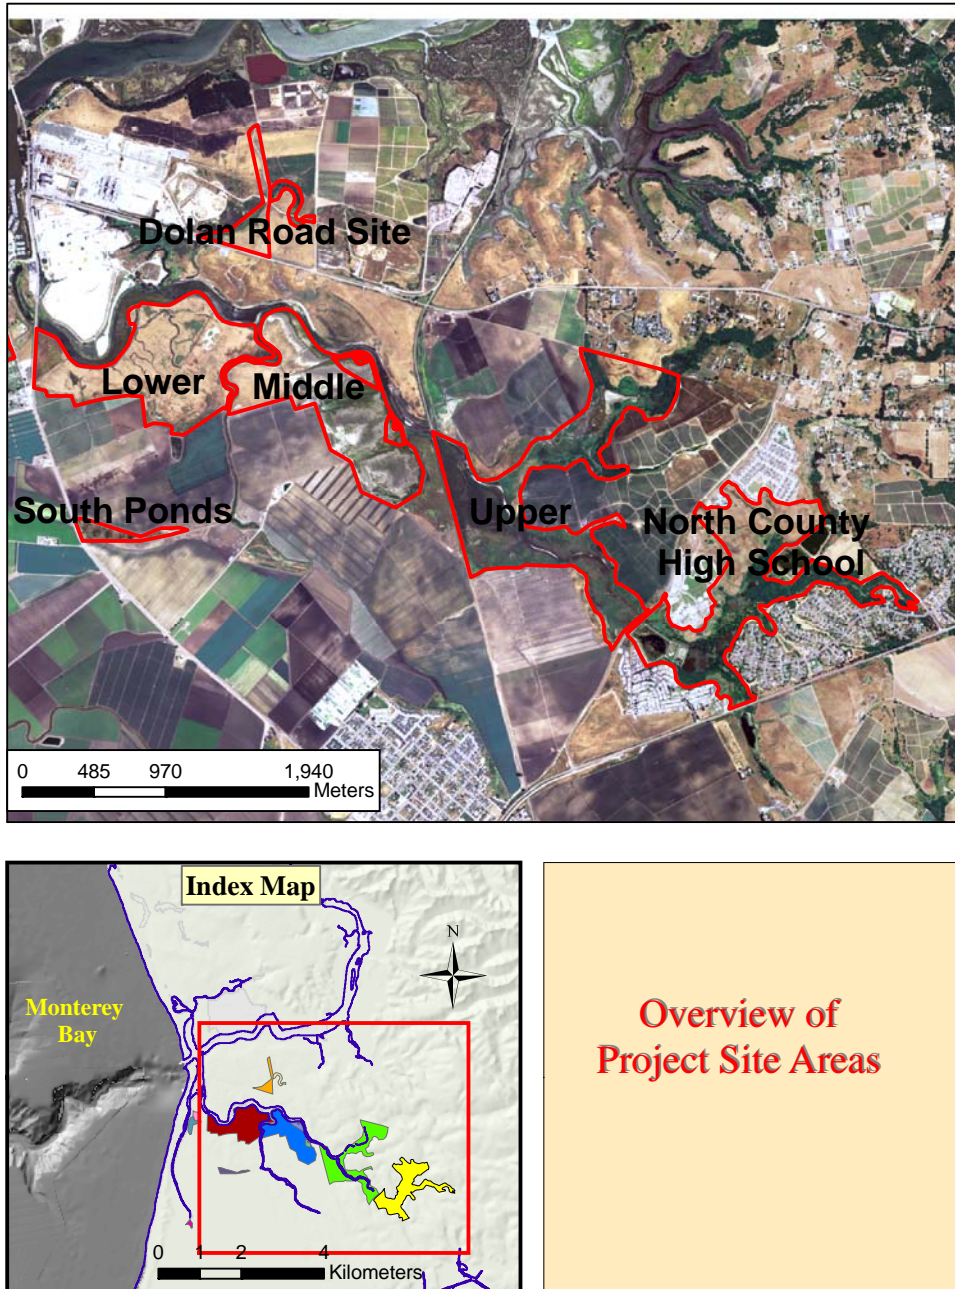
**Figure 2.** Project sites.

This section documents the monitoring and management practices implemented during our project. Rather than use USGS 7.5-minute quadrangle maps for our mapping figures we used digitized aerial images and have included graphics with corresponding coordinates. Each implementation measure (i.e. water sampling point, bird survey point, restoration area, etc.) has a unique symbol with corresponding coordinate data in tabular format. This system provides a precise method for the documenting the localities of the various project sites, implementation measures, and sampling points that will enable others to return to localities to monitor long-term changes. We have isolated general tasks (i.e. restoration, water, quality, etc.) into individual sub-sections in order to clearly convey each subject. Figure 2 provides an overview of the sites we conducted work on during the project period.

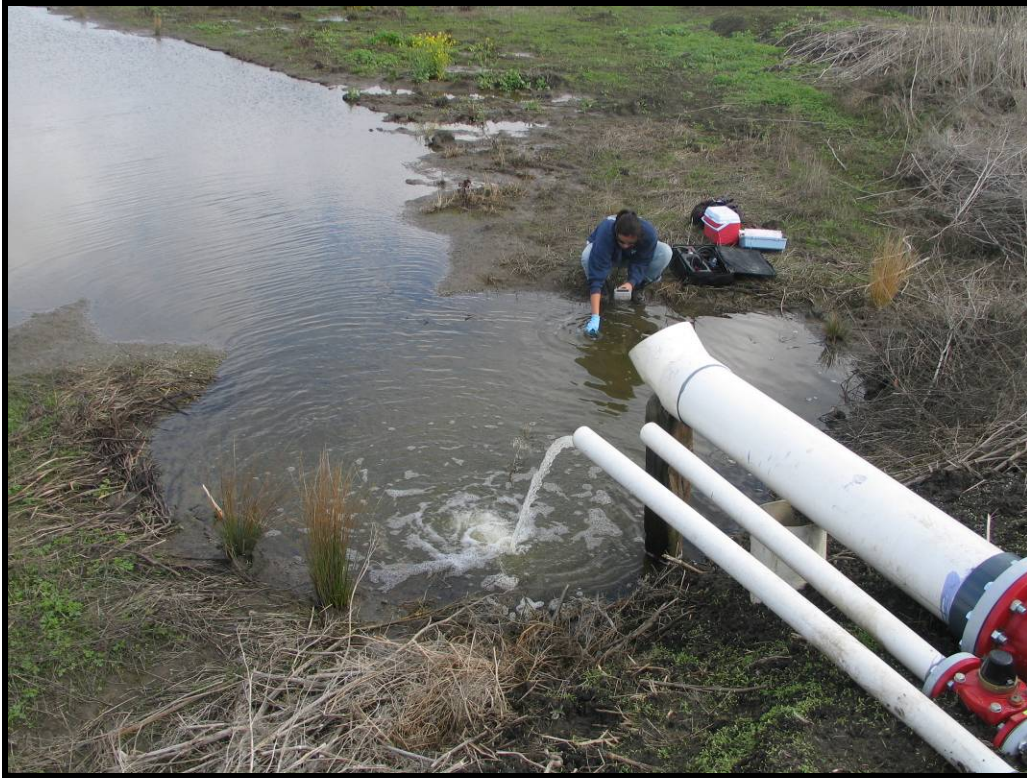
**Figure 3.** Water sampling at Middle Moro Cojo.

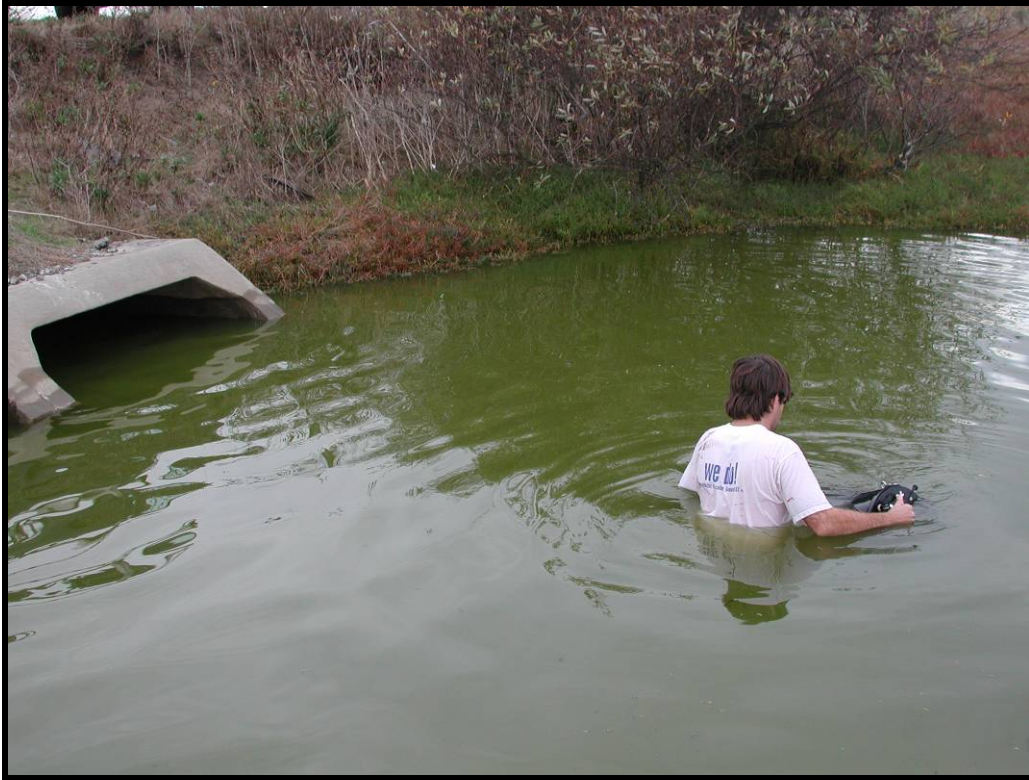
**Figure 4.** Placing the YSI automated data loggers in the Moro Cojo Slough.

We also analyzed nitrate concentrations and water chemistry (temperature, salinity, and dissolved oxygen) in the Moro Cojo at the HWY 1 culvert using a YSI 9600 Nitrate analyzer laboratory and a YSI 6600 extended deployment system. This varies from the other ambient monitoring as we were able to use a continuous data logger in a collaborative effort with Monterey Bay Aquarium Research Institute Scientists.

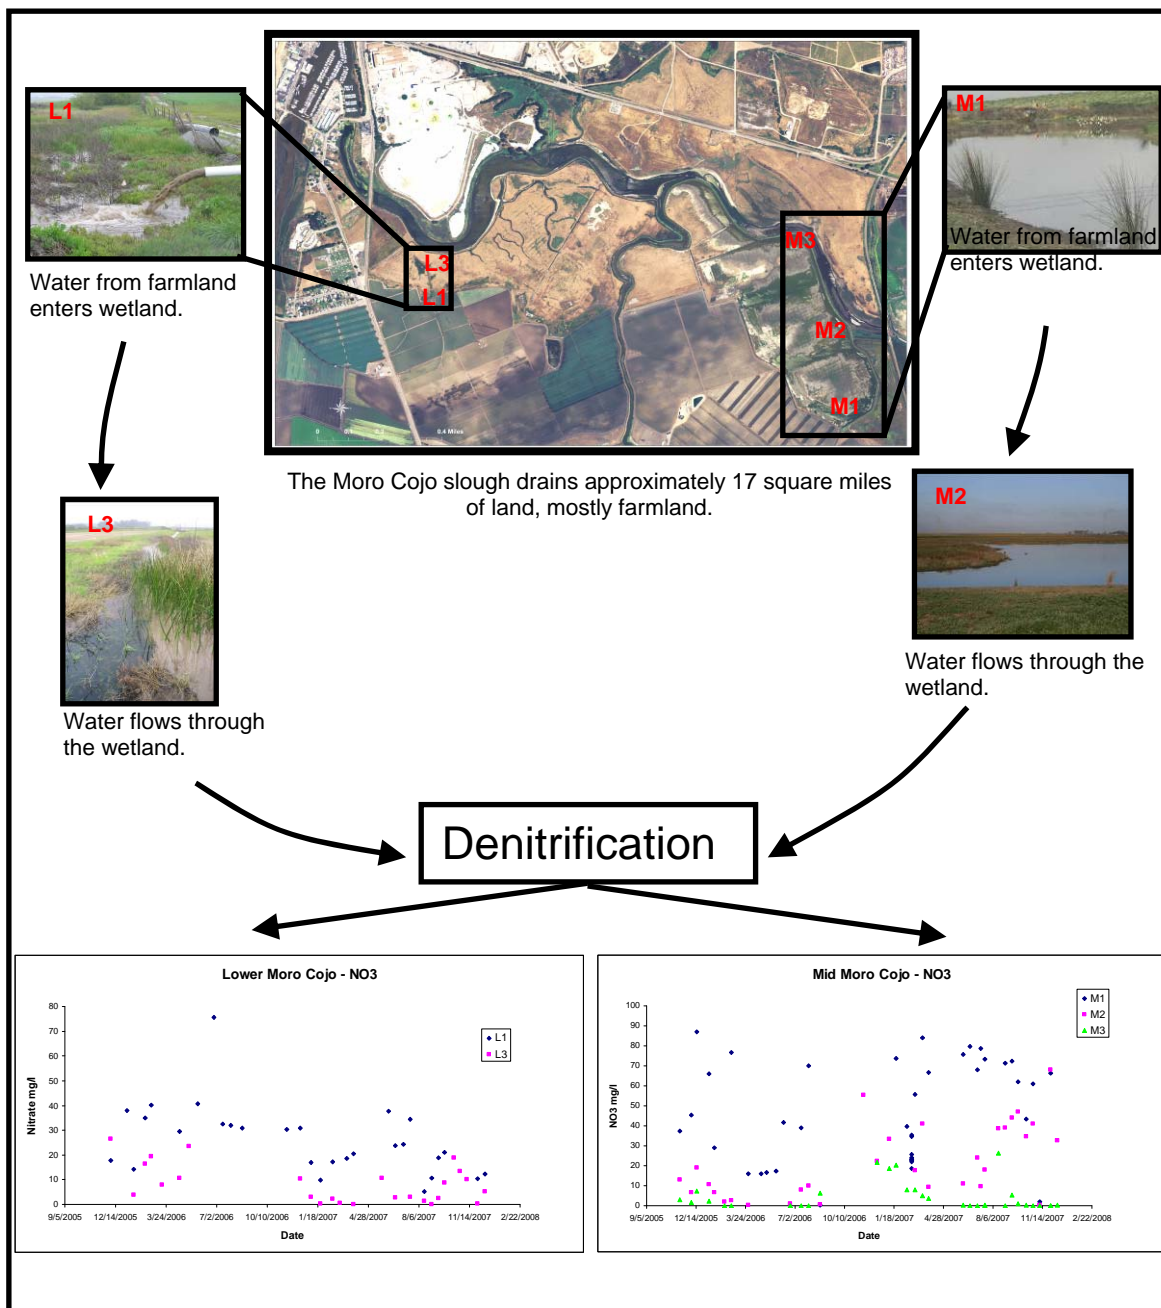
**Figure 5.** Conceptual model of denitrification at Lower and Middle Moro Cojo.

A primary objective of our study was to examine the role wetlands play in reducing nutrient concentrations. The Lower and Middle Moro Cojo sites provide the best opportunity to quantify how water quality parameters change along a gradient as water enters and moves through a wetland. We observed a strong pattern of decreased nitrate concentrations as agricultural runoff moved through these wetlands (Appendices 7-8). Furthermore, although there was tremendous variation in water quality parameters throughout the sampling period the pattern of decreased nitrates down the spatial gradient of the wetlands remained constant (Appendices 7-8). These results strongly suggest that nitrate levels are significantly reduced as water moves across the wetlands and supports the theory that wetland buffers can serve as Best Management Practices to remove nitrates. Results for ammonia and phosphate did not show strong trends of reduction (Appendices 7-12).

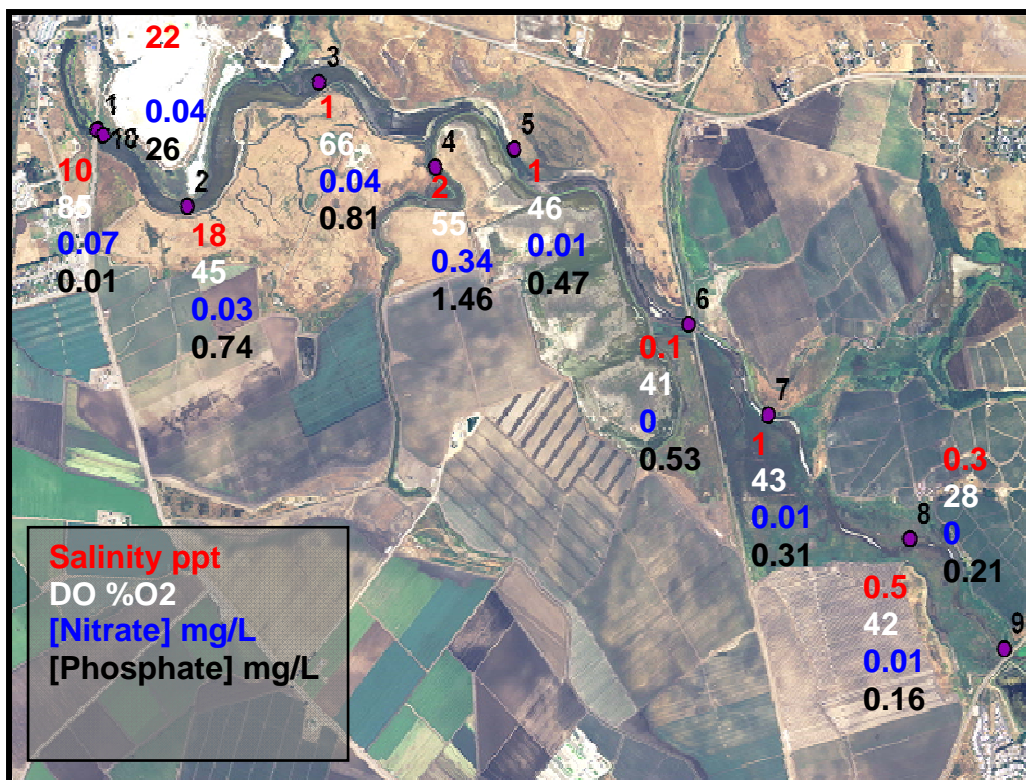
**Figure 6.** Results from water sampling event up the Moro Cojo over a 4 hour period from 9:00-13:00 in April 2005.

The variation in water quality is to be expected and highlights the need for intensive monitoring efforts over discrete periods of time. The intensive sampling efforts conducted throughout our grant period provide an extensive view of ambient water quality conditions within the Moro Cojo. In instances when numerous samples were collected over relatively short time periods, such as in Moro Cojo Slough at HWY 1 (Appendices 19-27) and at Middle site #1 (Appendix 12), we observed significant fluctuations in water quality parameters. These results highlight how variable water quality can be over short periods and caution making statements about water quality conditions based on sparse sampling over long temporal periods.

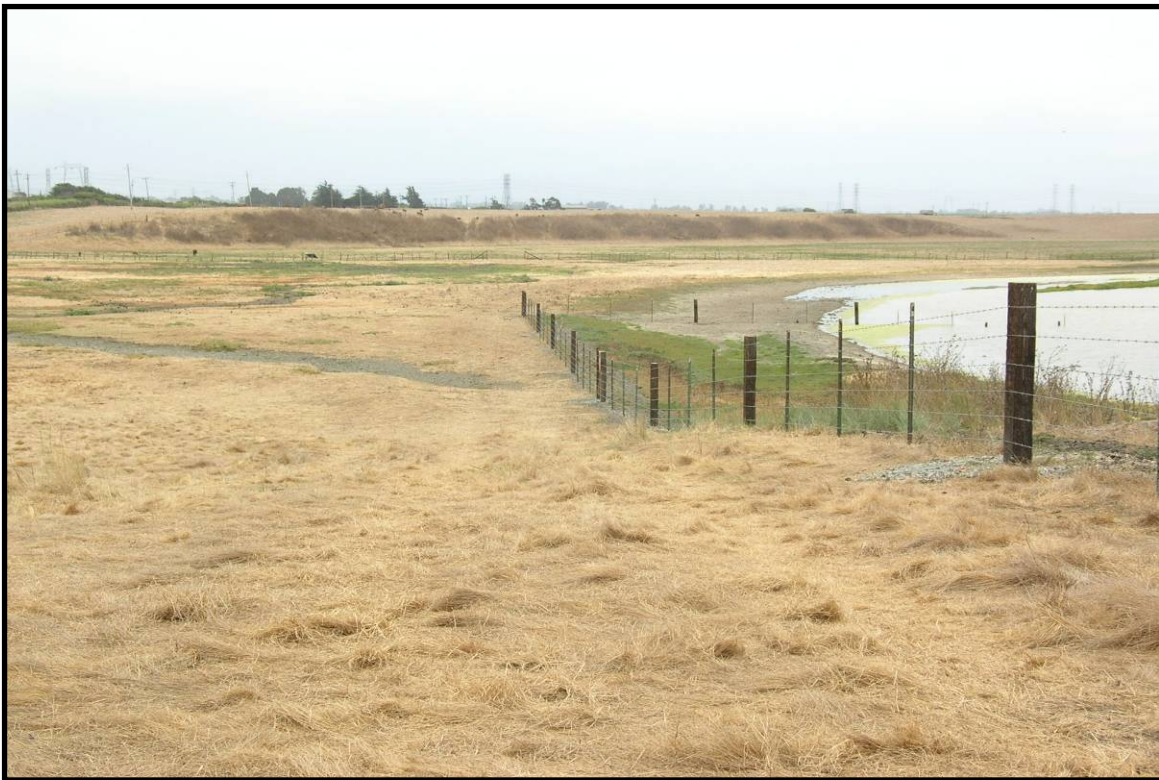
**Figure 15.** Cattle exclusion fence at the Calcagno site along the Moro Cojo.

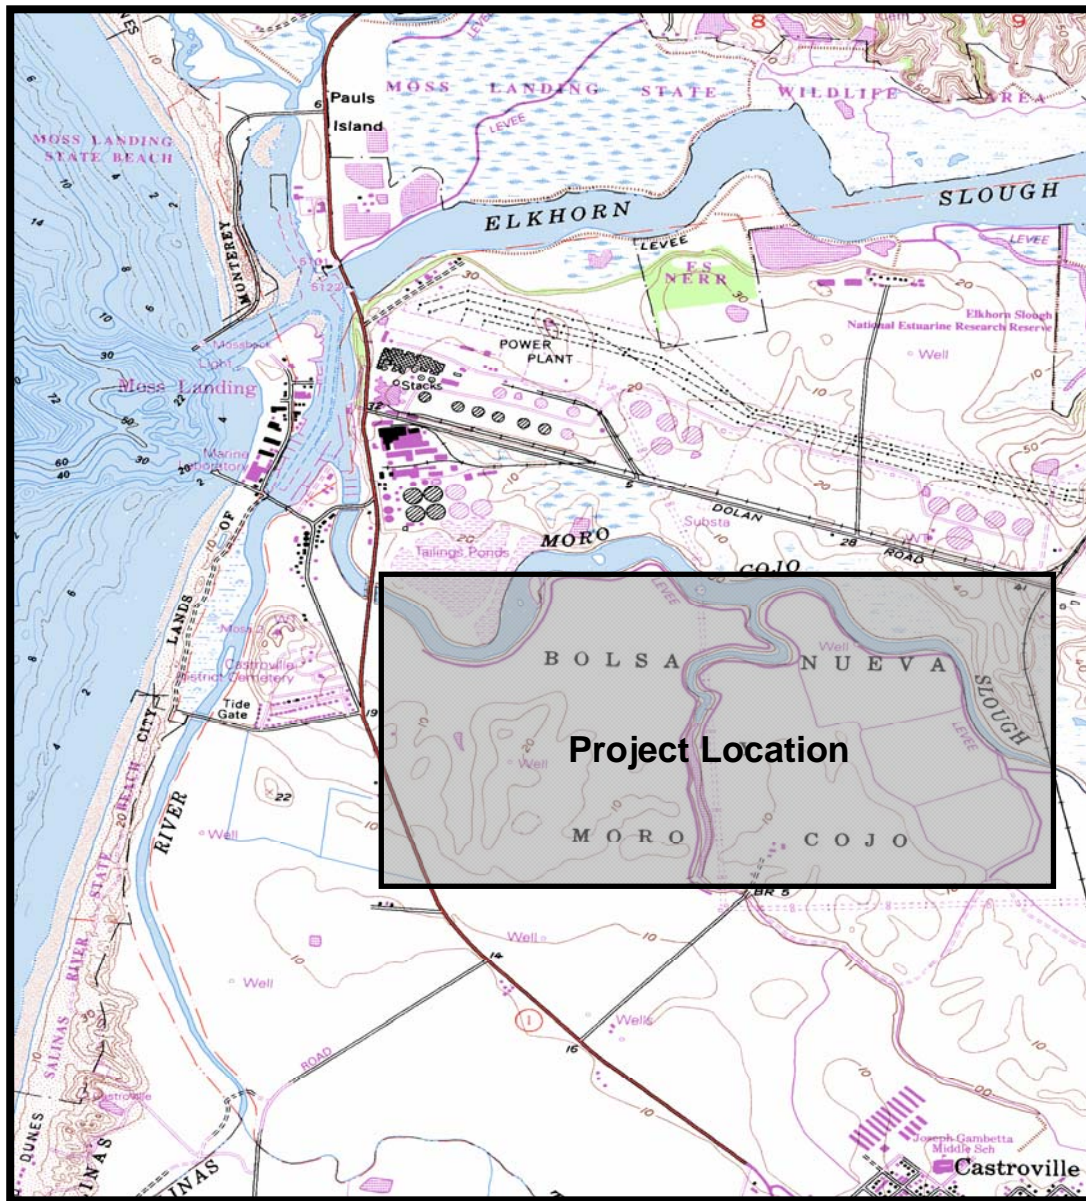
**Figure 27.** Overview of project location.

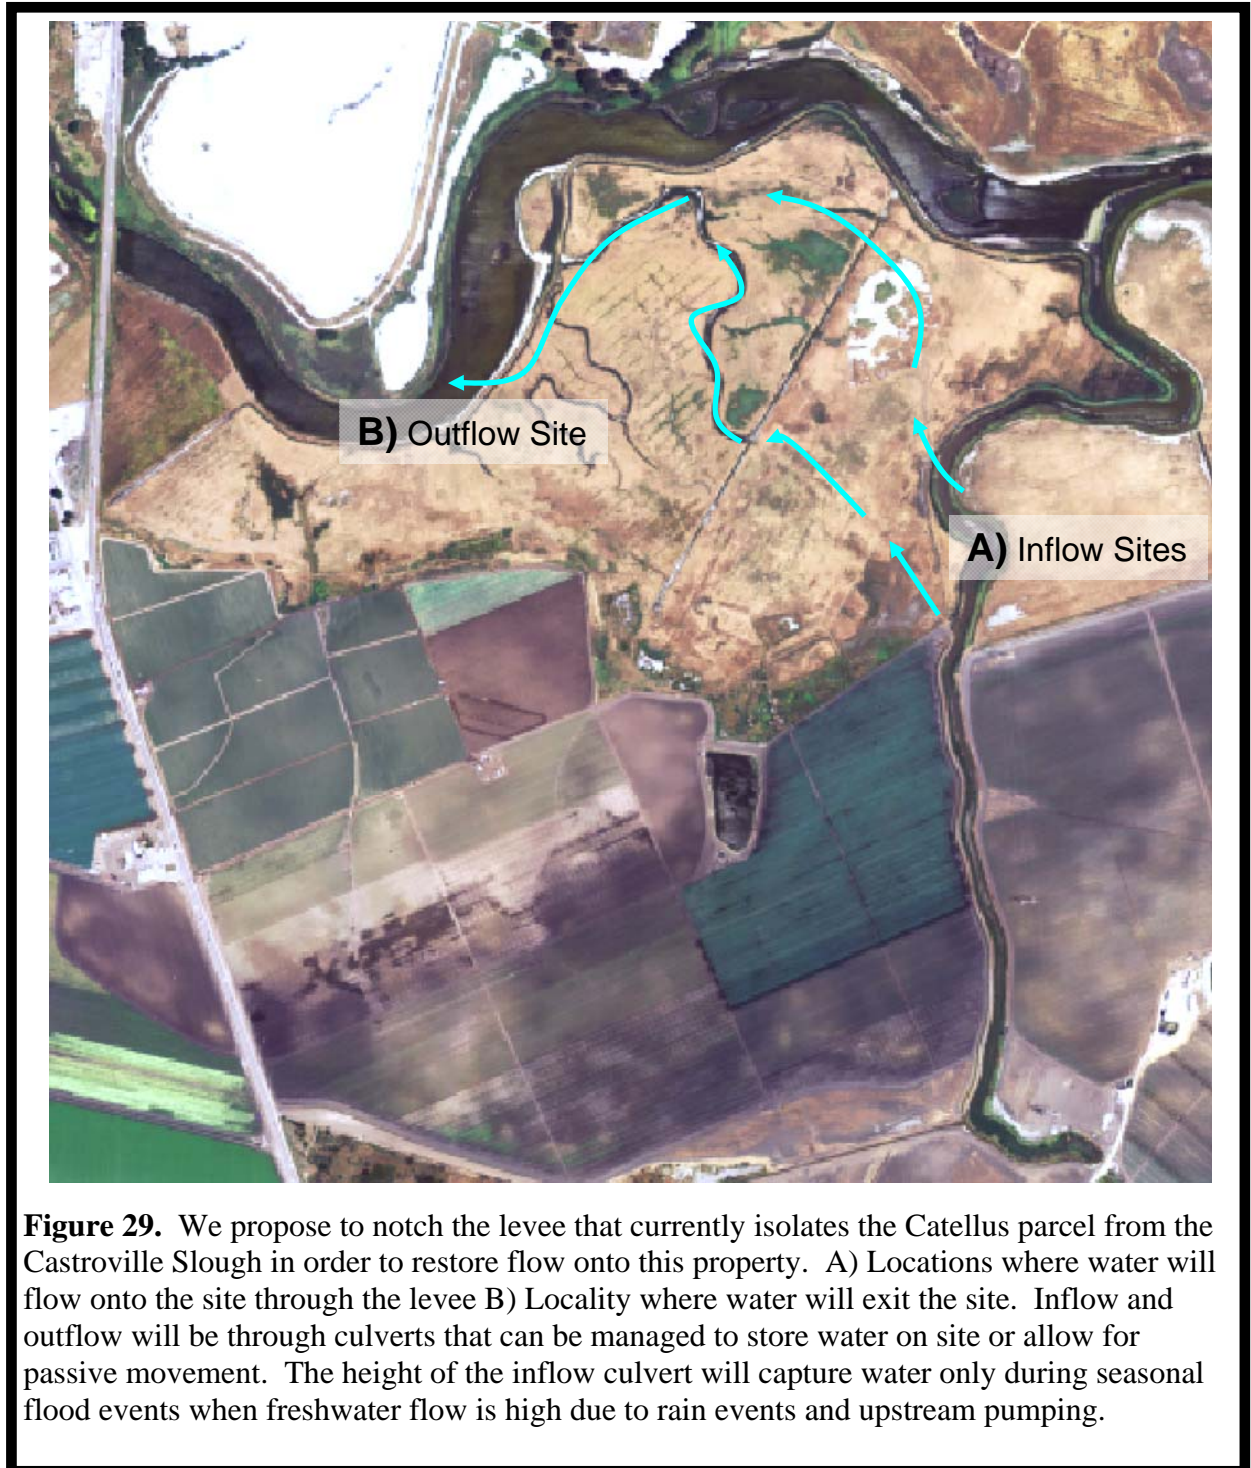
**Figure 29.** We propose to notch the levee that currently isolates the Catellus parcel from the Castroville Slough in order to restore flow onto this property. A) Locations where water will flow onto the site through the levee B) Locality where water will exit the site. Inflow and outflow will be through culverts that can be managed to store water on site or allow for passive movement. The height of the inflow culvert will capture water only during seasonal flood events when freshwater flow is high due to rain events and upstream pumping.

The inflow site at the upper end of the parcel would permit fresh water to flow onto the wetland during winter storm events. Water entering the parcel will flow through the extensively restored wetland before it exits the outflow site which is at the low point of the property (Figure 28). On the Lower Moro Cojo Parcel (Cattelus) water will flow into the parcel at two points and move across the parcel before it exits at a low point along the north western boundary of the property (Figure 29). Permitting water to flow naturally across these sites will serve several functions: 1) water will impound on the parcels which will drastically increase freshwater habitat and enhance native wetland associated flora and fauna; 2) “clean” farm runoff emanating from agricultural land up slough of the parcel; and 3) provide flood storage during extreme storm events. We will place culverts in the levee at locations that we have breached. Each culvert will have a control structure that will allow for management of flow which will provide flexibility for future management regimes.

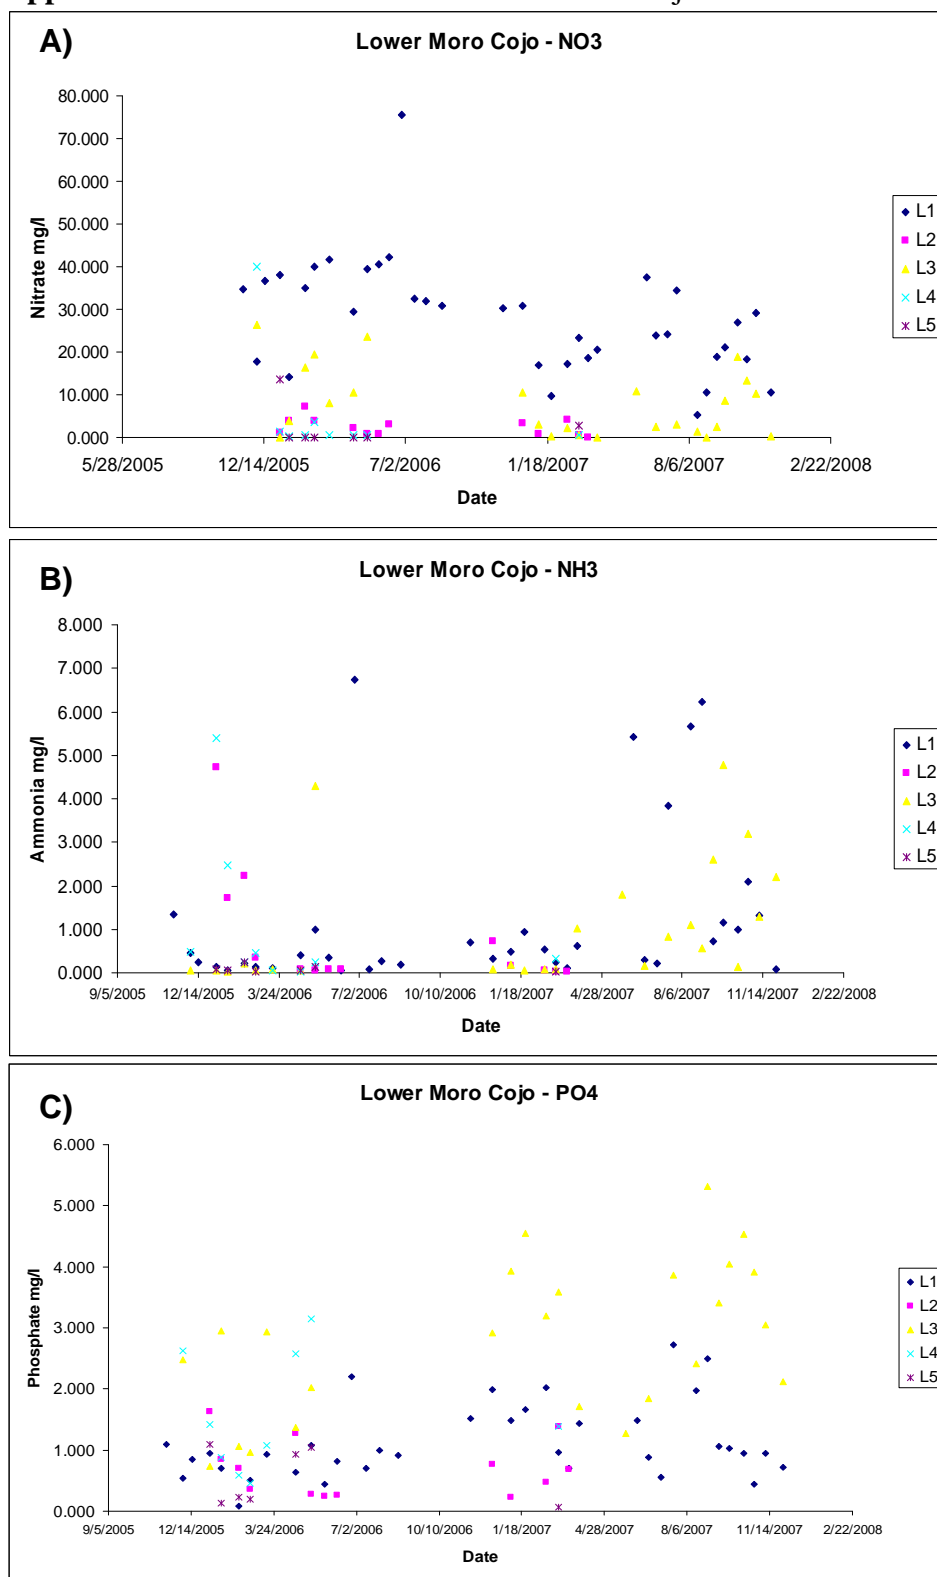
**Appendix 7.** Nutrients results from Lower Moro Cojo sites.

A) Nitrate, B) Phosphate, and C) Ammonia.

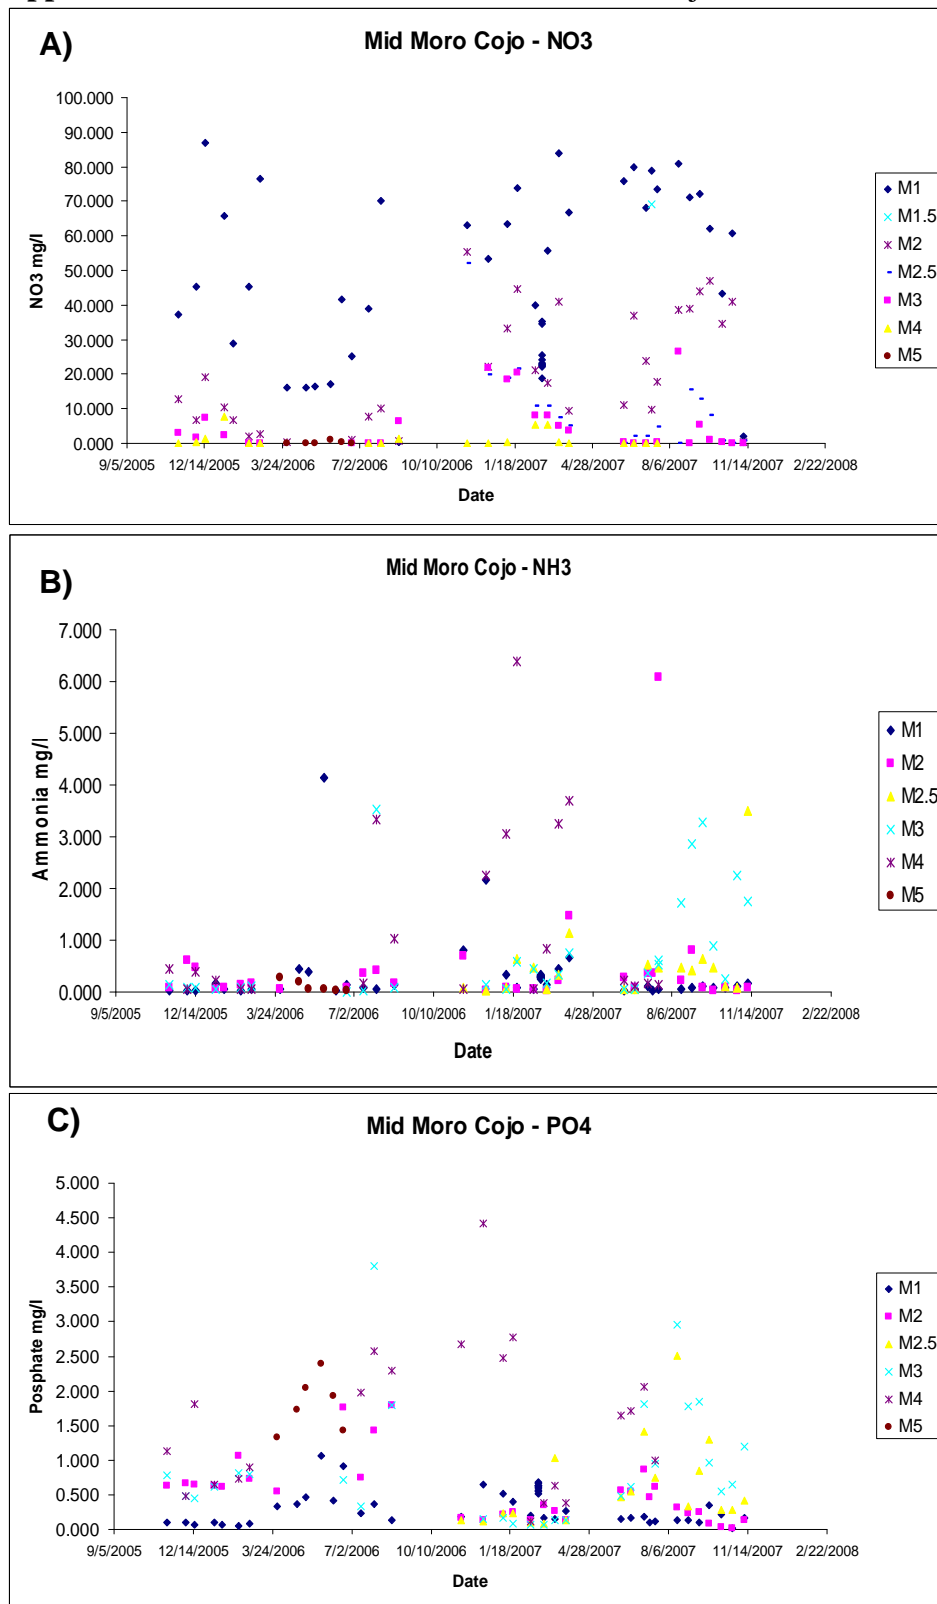
**Appendix 8.** Nutrients results from Middle Moro Cojo sites.

A) Nitrate, B) Phosphate, and C) Ammonia.

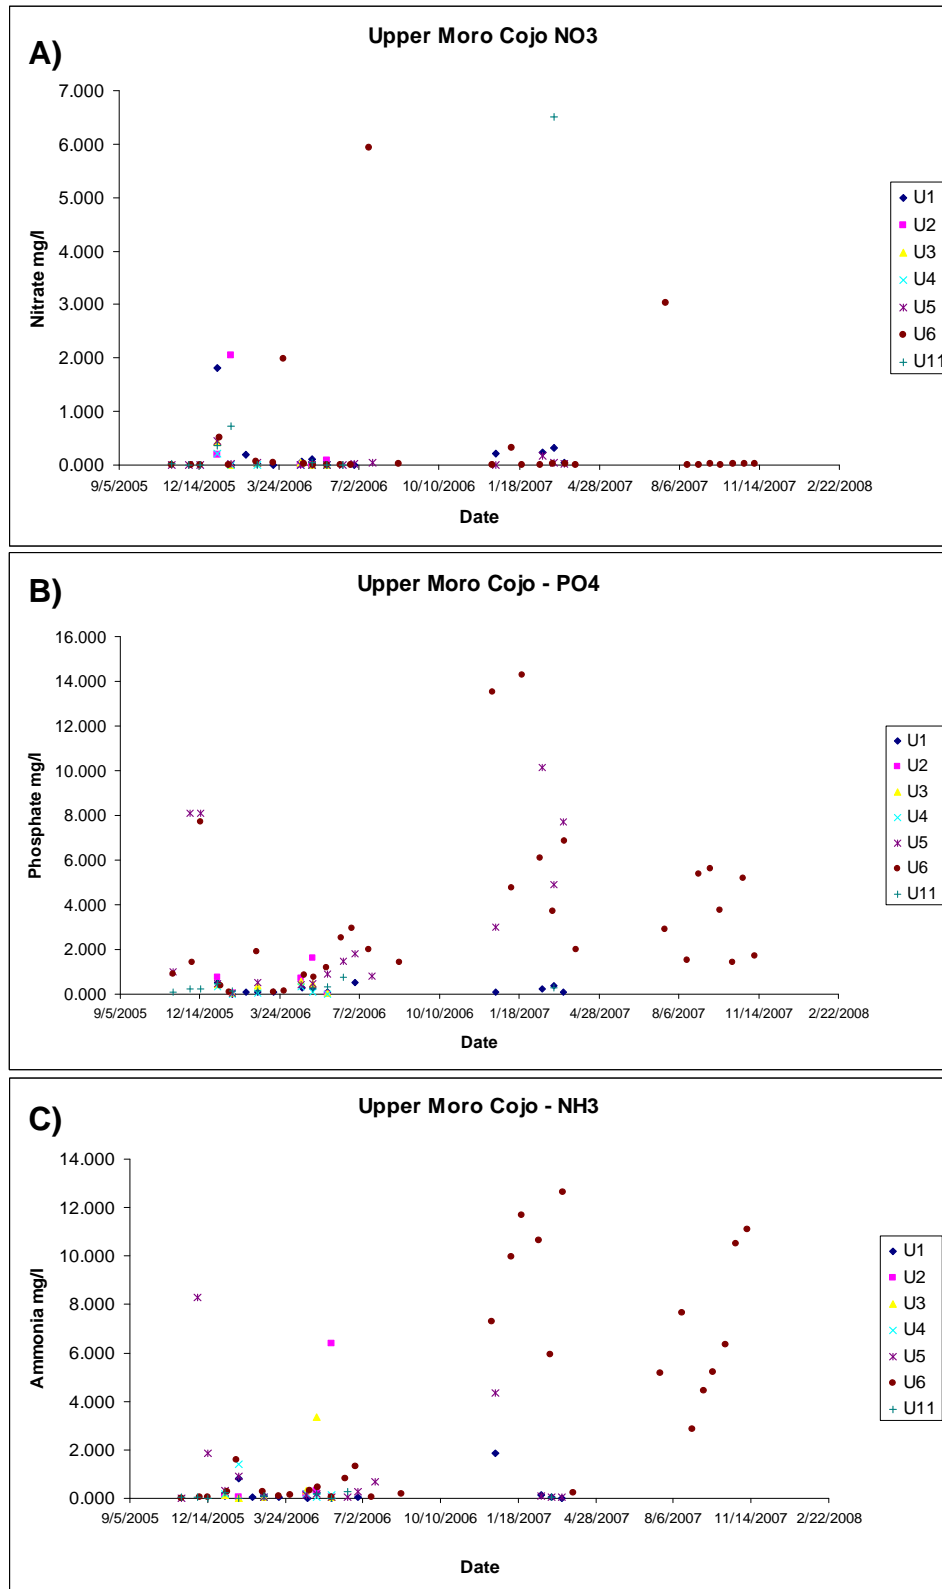
**Appendix 9.** Nutrients results from Upper Moro Cojo sites.

A) Nitrate, B) Phosphate, and C) Ammonia.

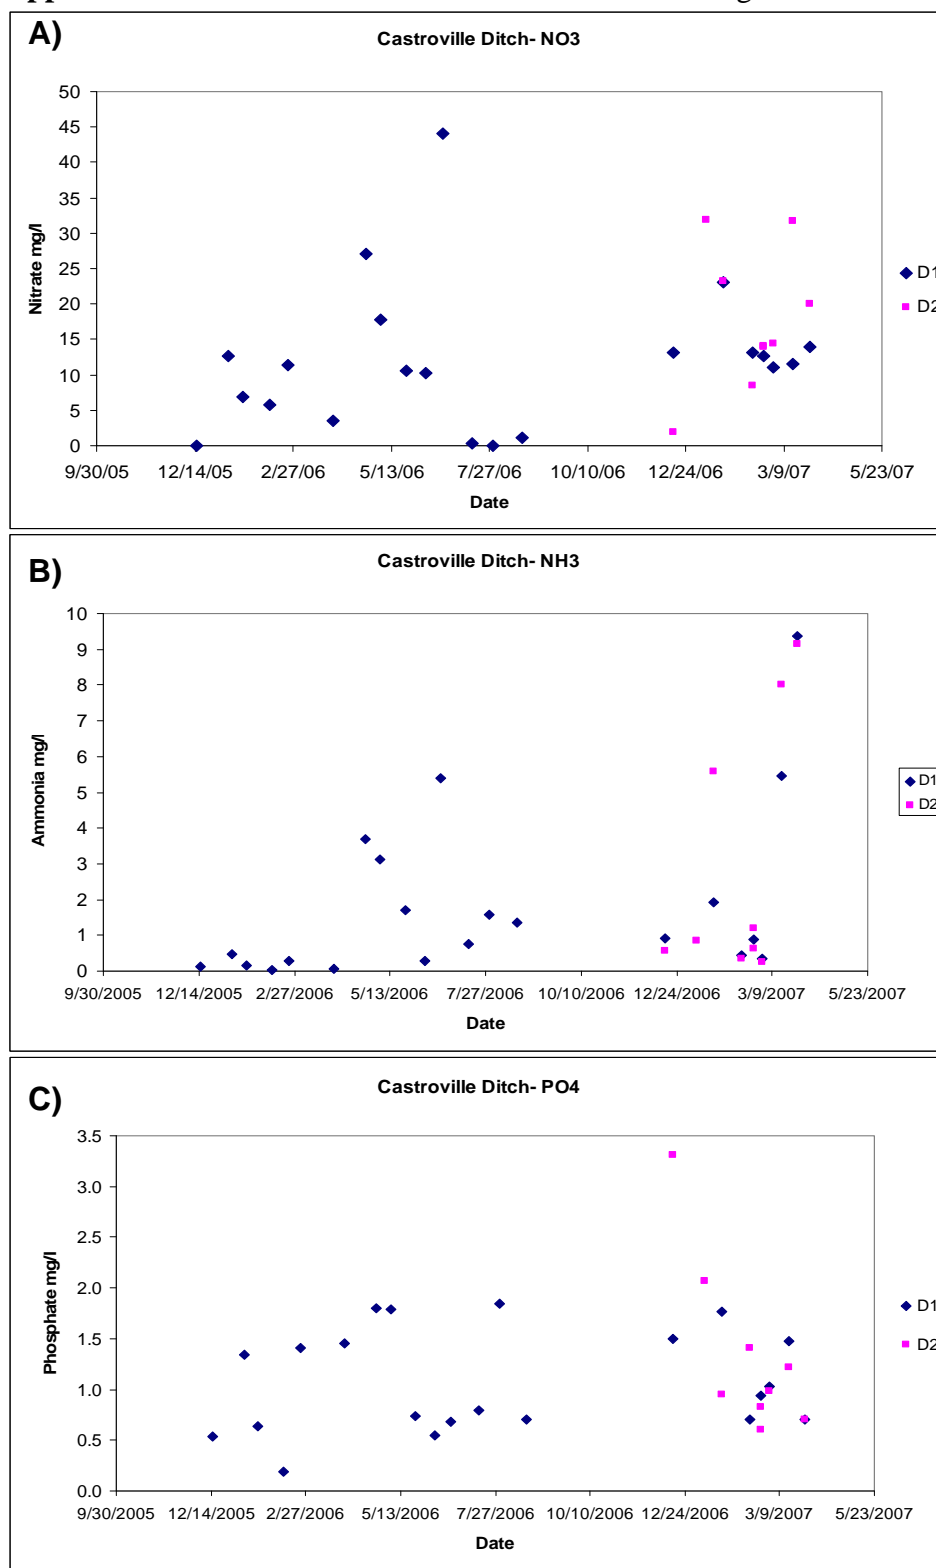
**Appendix 10.** Nutrients results from the Castroville Slough.

A) Nitrate, B) Phosphate, and C) Ammonia.

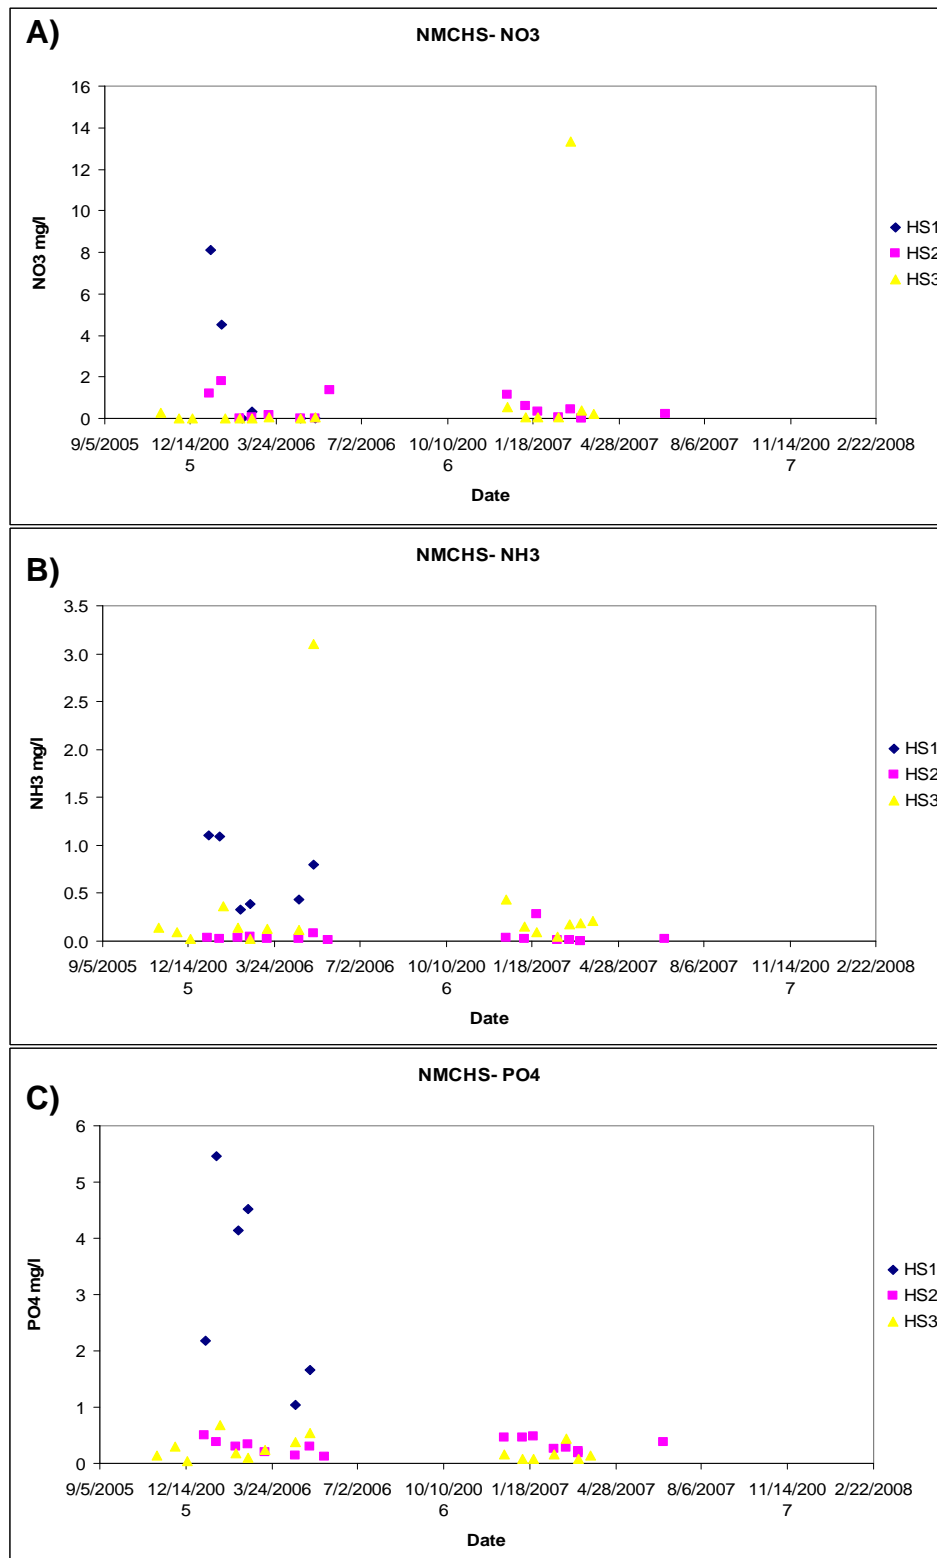
**Appendix 11.** Nutrients results from the North County High School.

A) Nitrate, B) Phosphate, and C) Ammonia.

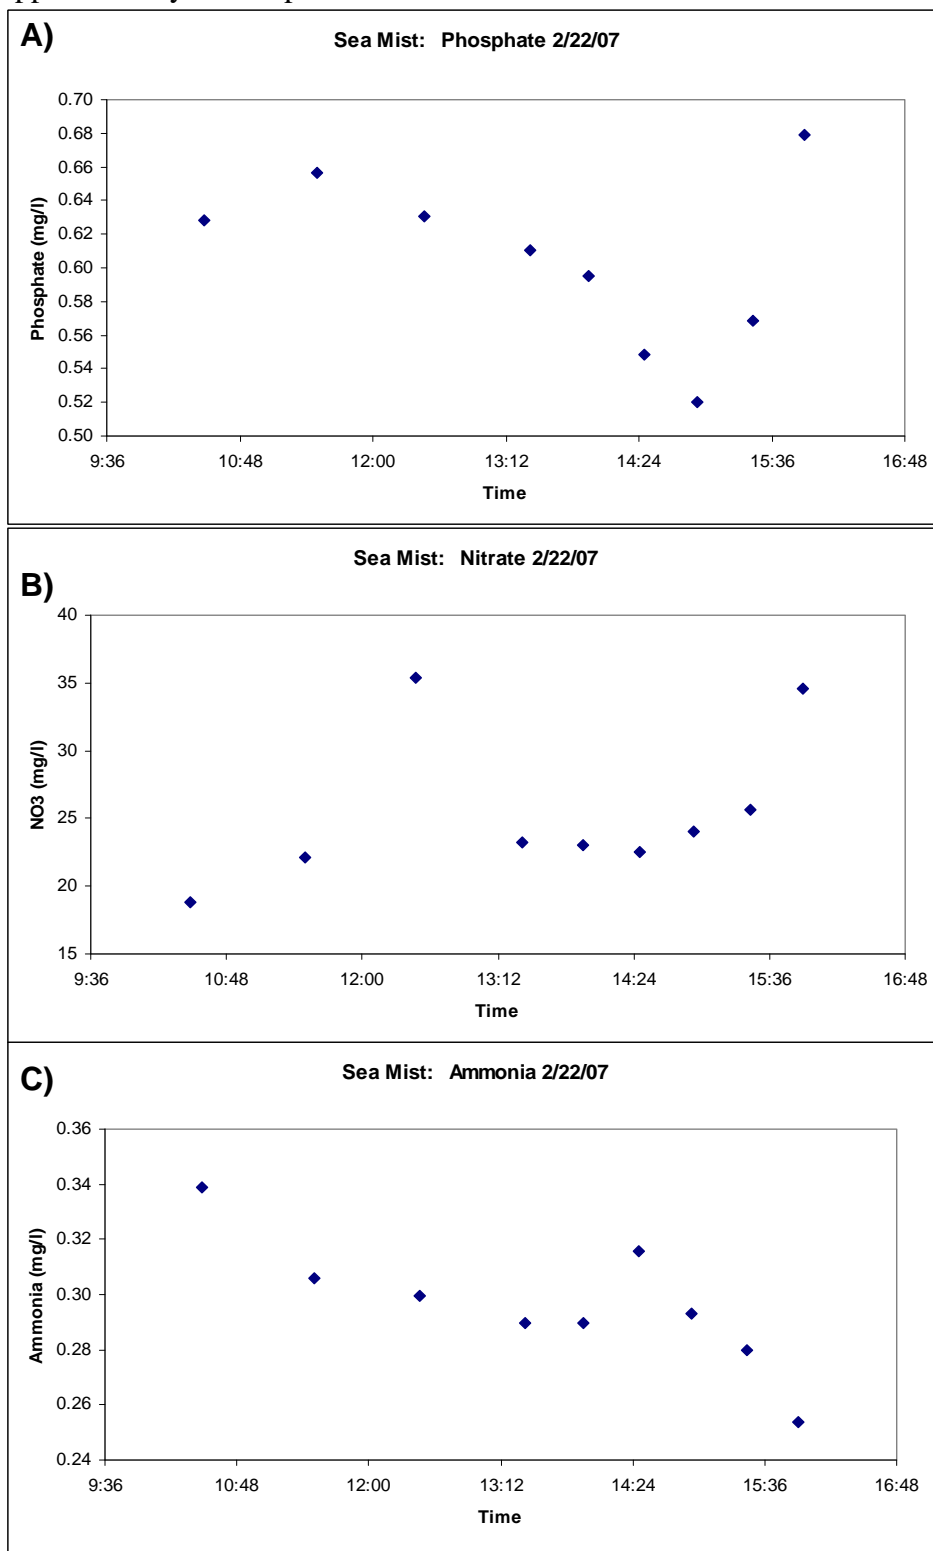
**Appendix 12.** Nutrients results from the Middle Moro Cojo (Sea Mist) over an approximately 6 hour period.

A) Nitrate, B) Phosphate, and C) Ammonia

concentrations in water sampled at the same locality (Mid 1) over a 6-hour period ranged from approximately 18 mg/L to 36 mg/L. Over the same period ammonia varied from < 0.26 mg/L to 0.34 mg/L and phosphate ranged from approximately 0.52 mg/L to 0.68 mg/L. These data highlight the tremendous variation in water quality over relatively short time periods.

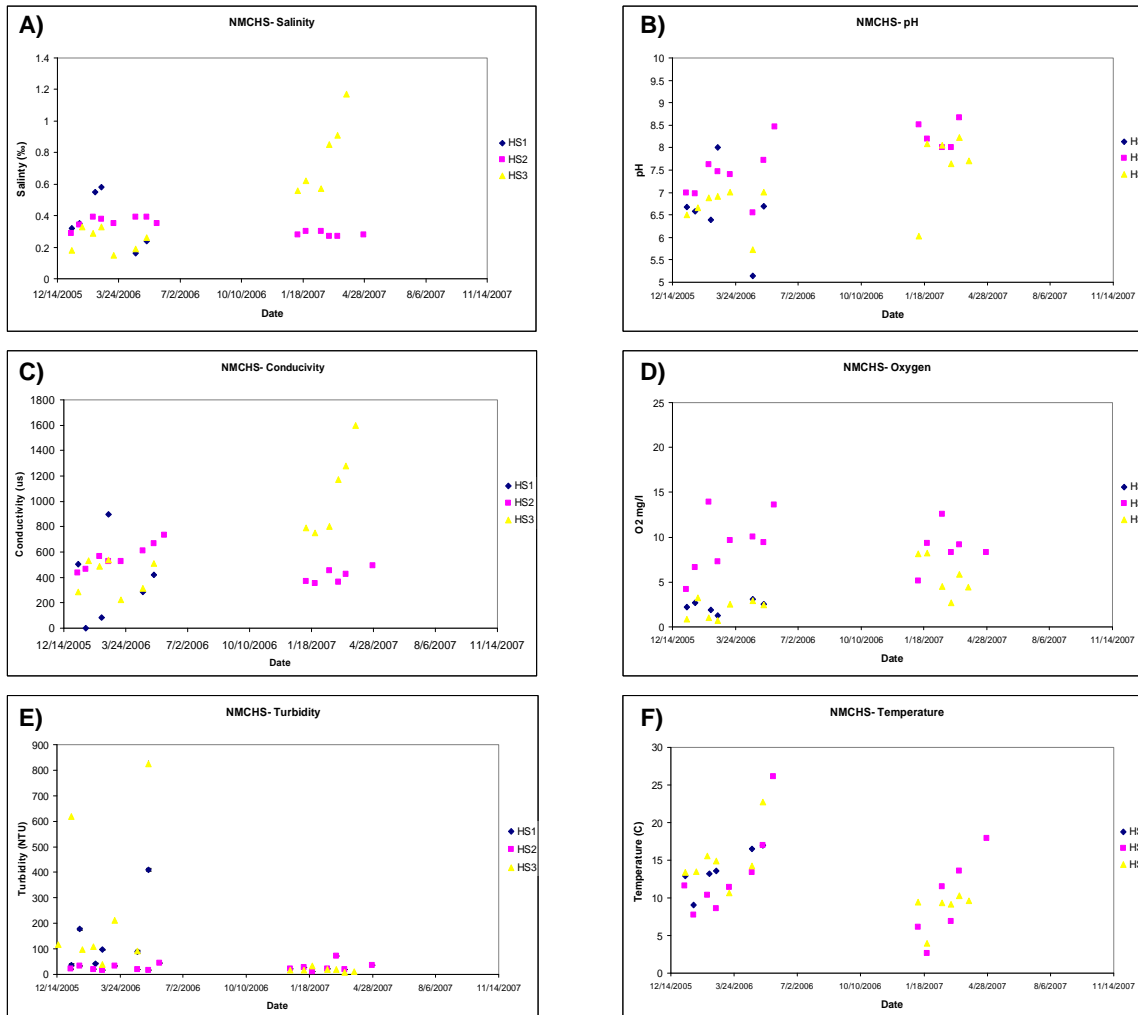
**Appendix 13.** Water chemistry data for North County High School.

A) Salinity, B) pH, C) conductivity, D) Oxygen, E) Turbidity, F) Temperature.

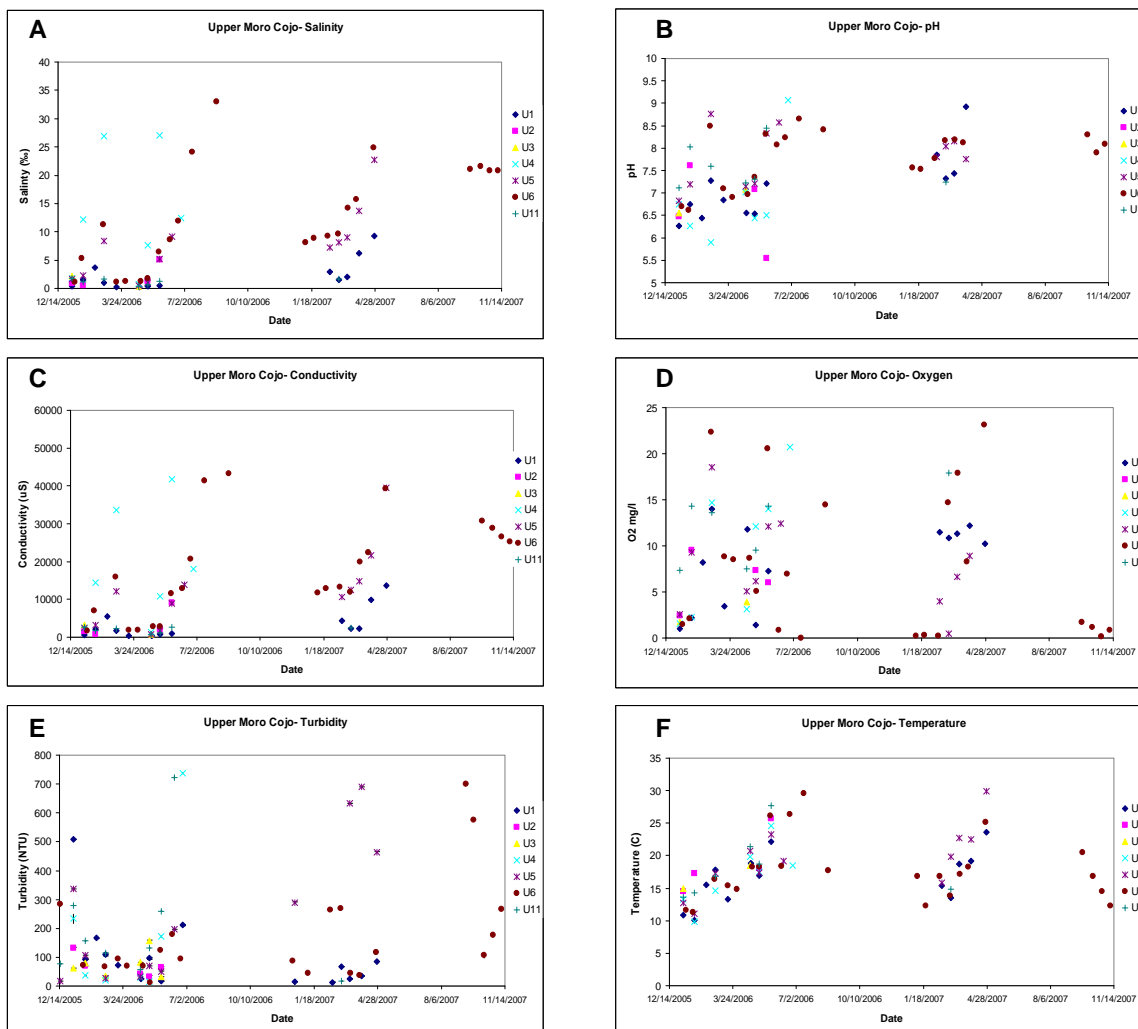
## Appendix 14. Water chemistry data for Upper Moro Cojo.

A) Salinity, B) pH, C) conductivity, D) Oxygen, E) Turbidity, F) Temperature.
