# Implementation of the Moro Cojo Slough Management and Enhancement Plan: Restoration of the Core of the Watershed

PROJECT NAME: Implementation of the Moro Cojo Slough Management and Enhancement  
Plan: Restoration of the Core of the Watershed

AGREEMENT NO. : 04-140-533-01

Date: 3/28/08

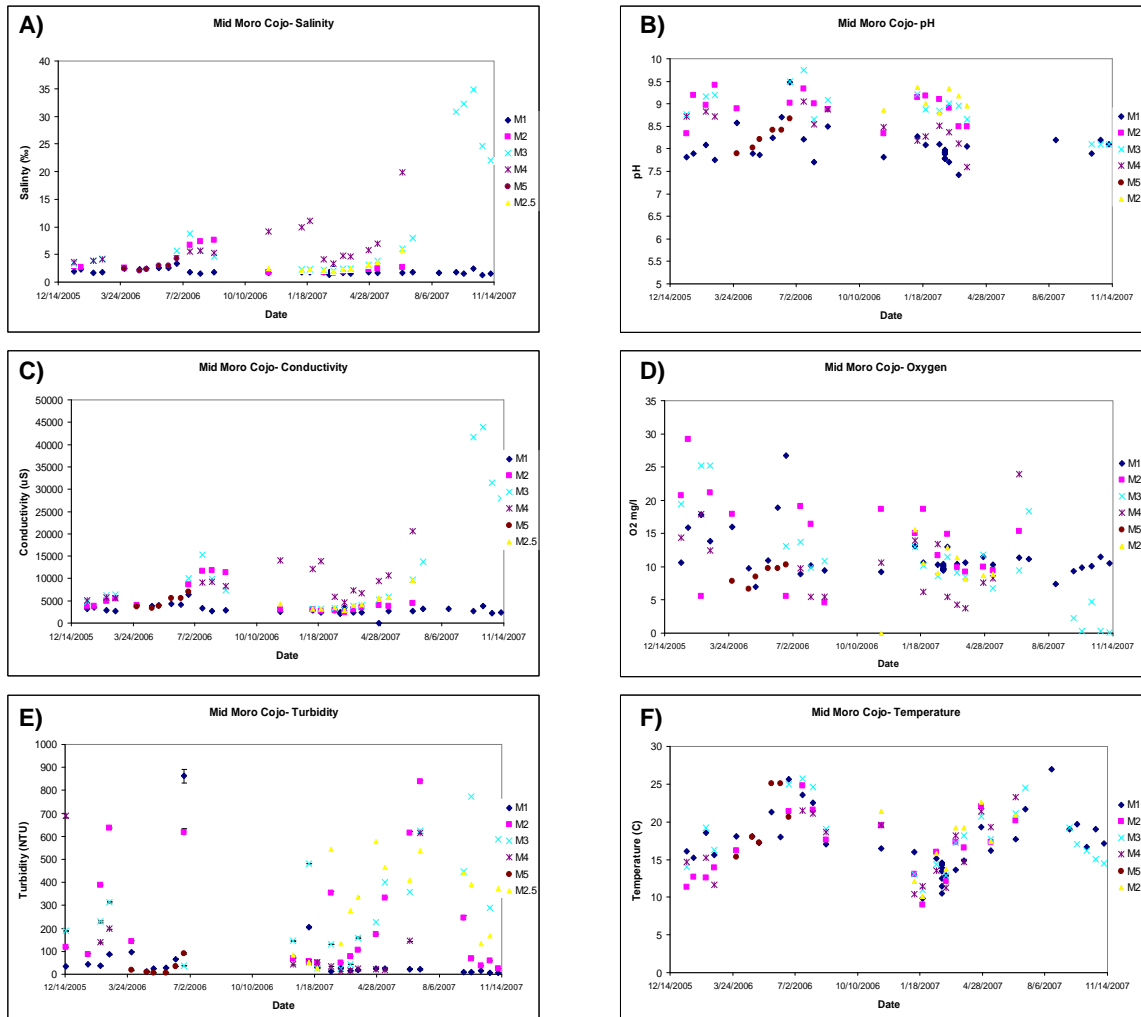
# Appendix 15. Water chemistry data for Middle Moro Cojo.

A) Salinity, B) pH, C) conductivity, D) Oxygen, E) Turbidity, F) Temperature.

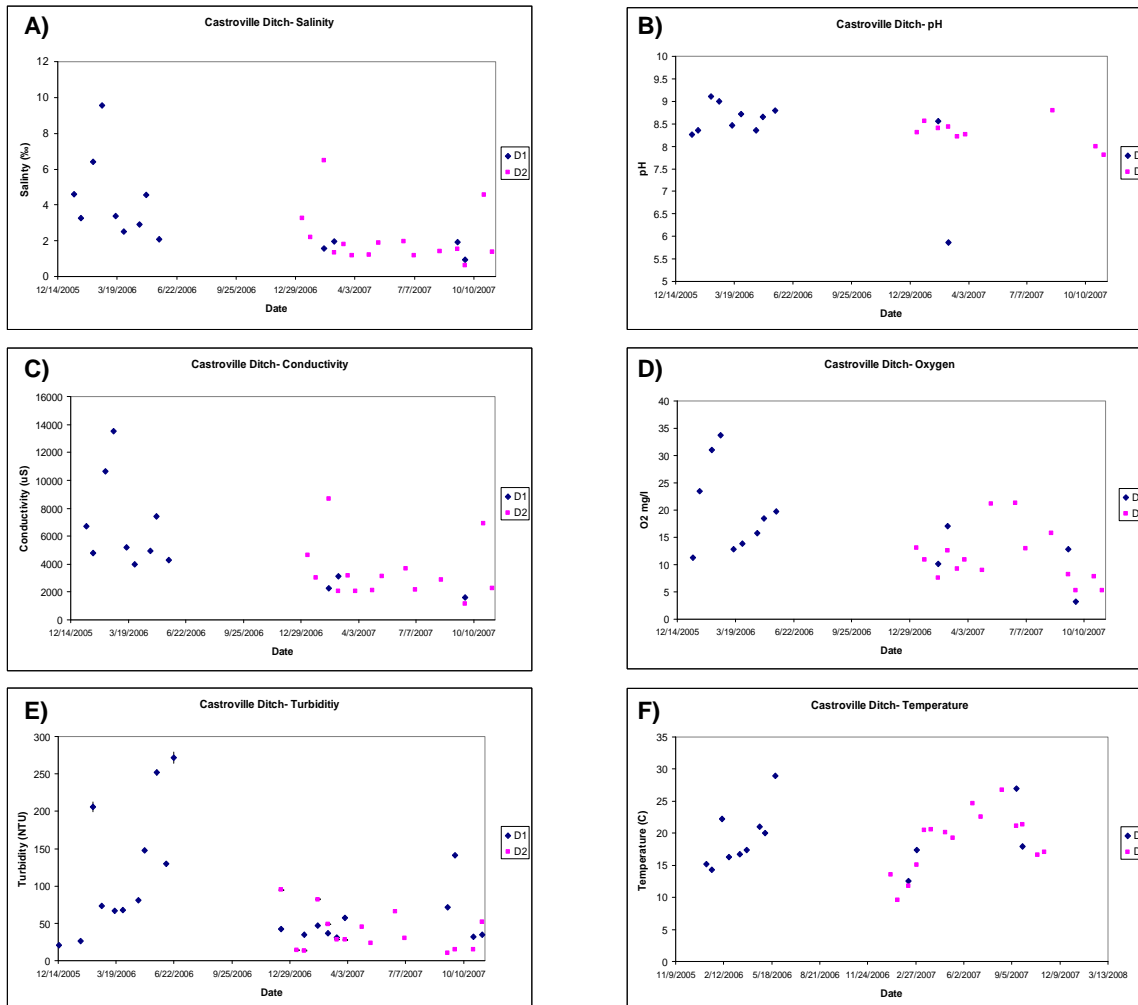
## Appendix 16. Water chemistry data for the Castroville Slough.

. A) Salinity, B) pH, C) conductivity, D) Oxygen, E) Turbidity, F) Temperature.

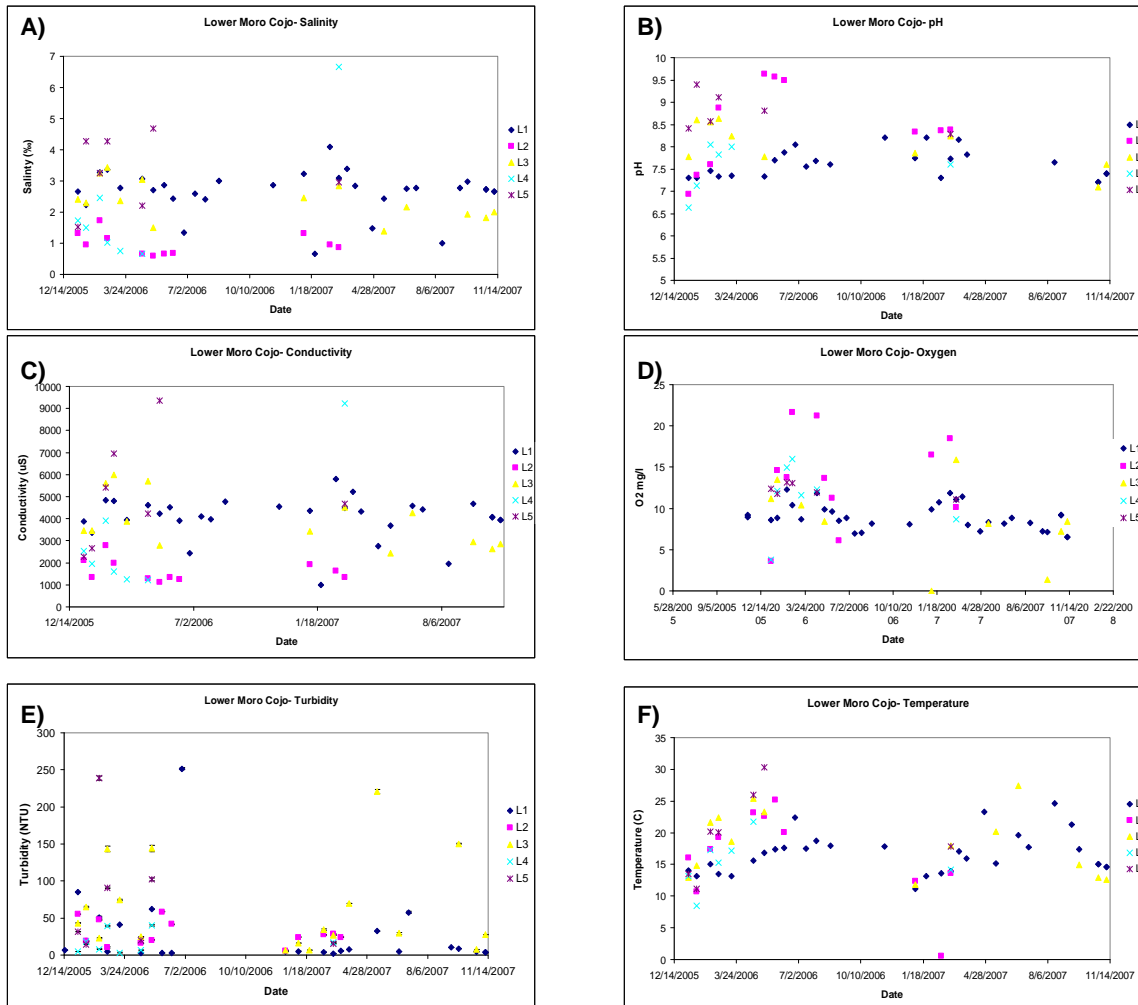
## Appendix 17. Water chemistry data for Lower Moro Cojo.

A) Salinity, B) pH, C) conductivity, D) Oxygen, E) Turbidity, F) Temperature.

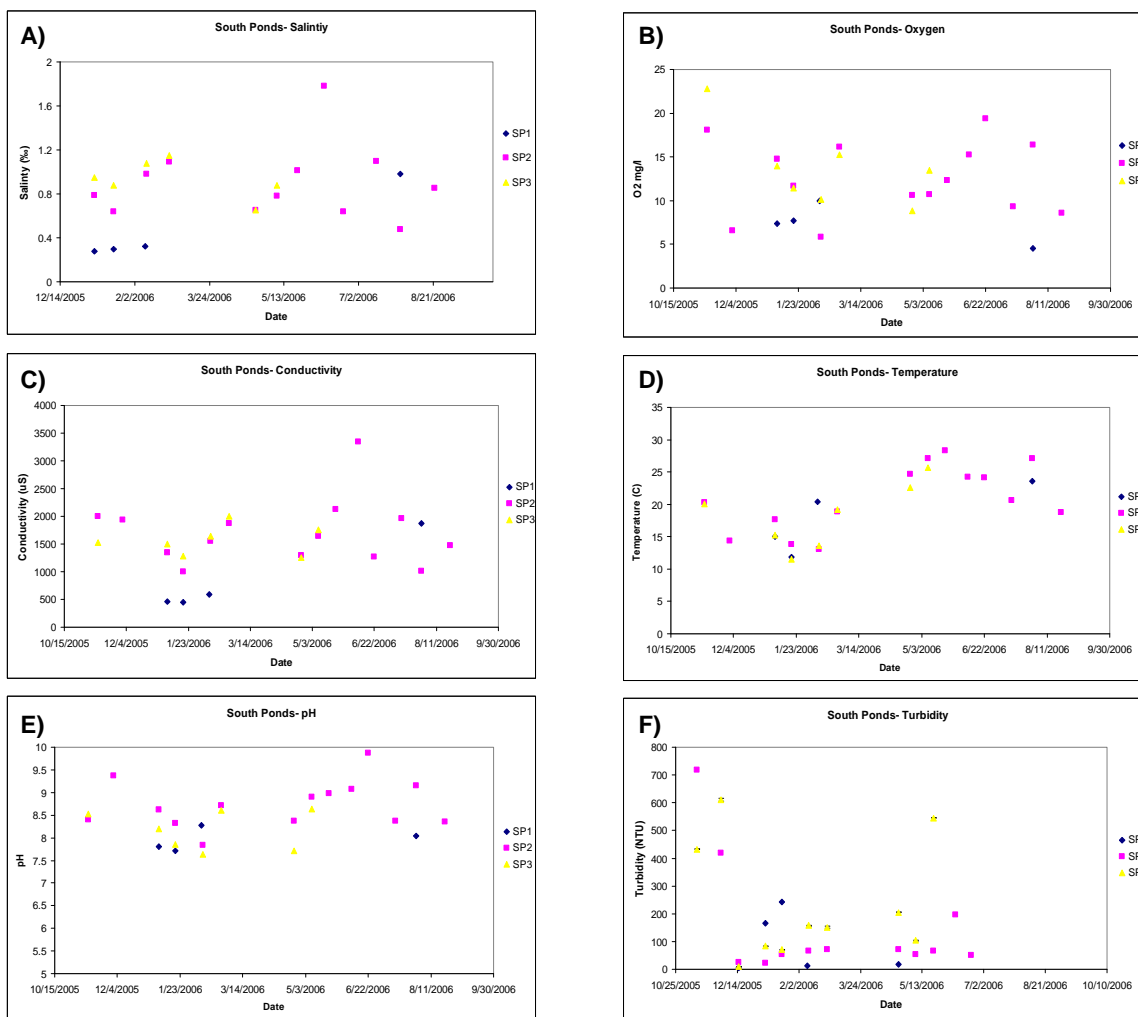
## Appendix 18. Water chemistry data for South Ponds.

A) Salinity, B) pH, C) conductivity, D) Oxygen, E) Turbidity, F) Temperature.

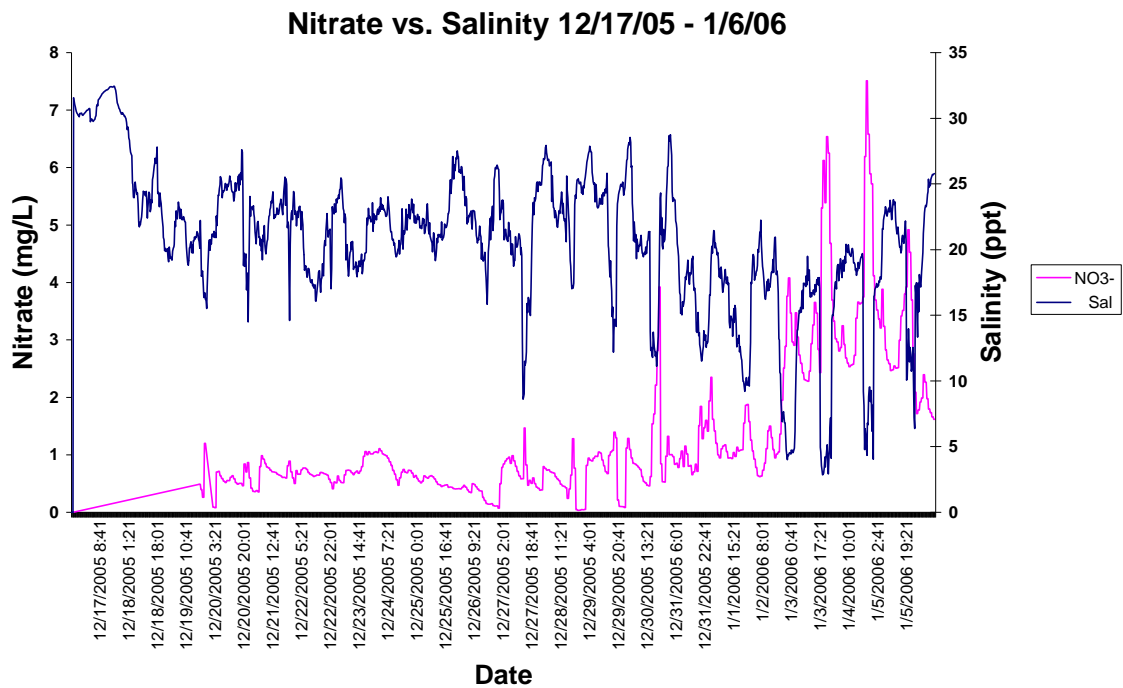
**Appendix 19.** Nitrate salinity relationships in the Moro Cojo from 12/17/05 – 1/6/06.

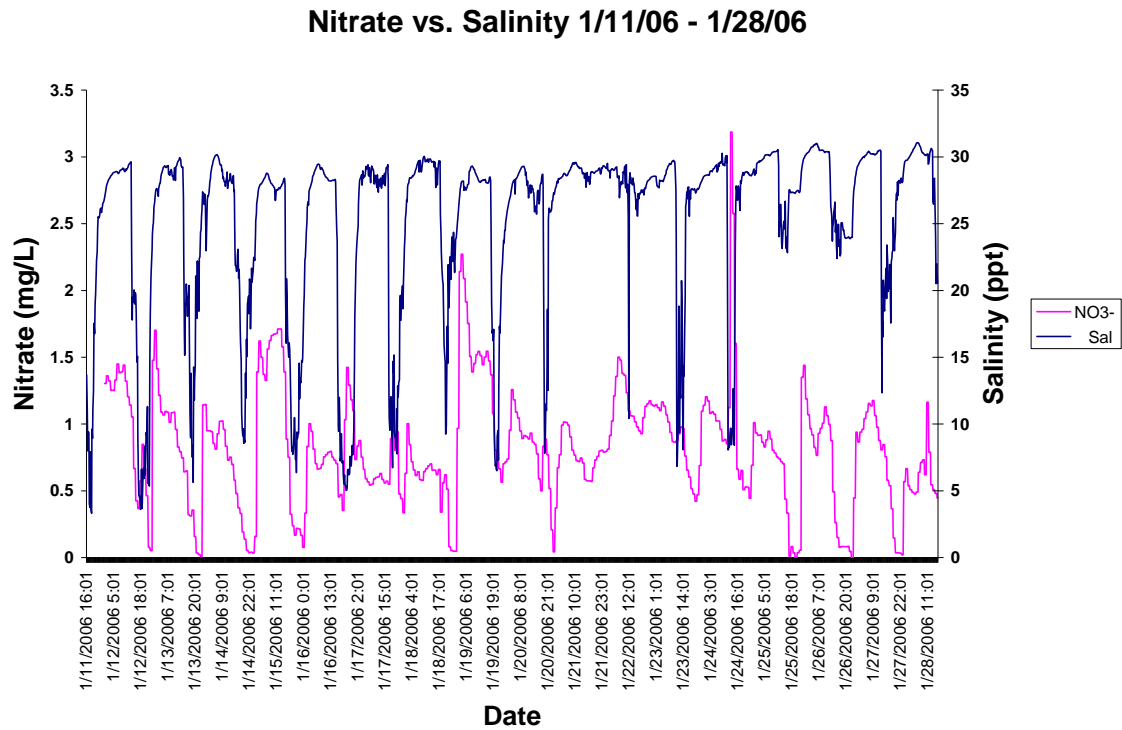
**Appendix 20.** Nitrate salinity relationships in the Moro Cojo from 1/11/06 – 1/28/06.

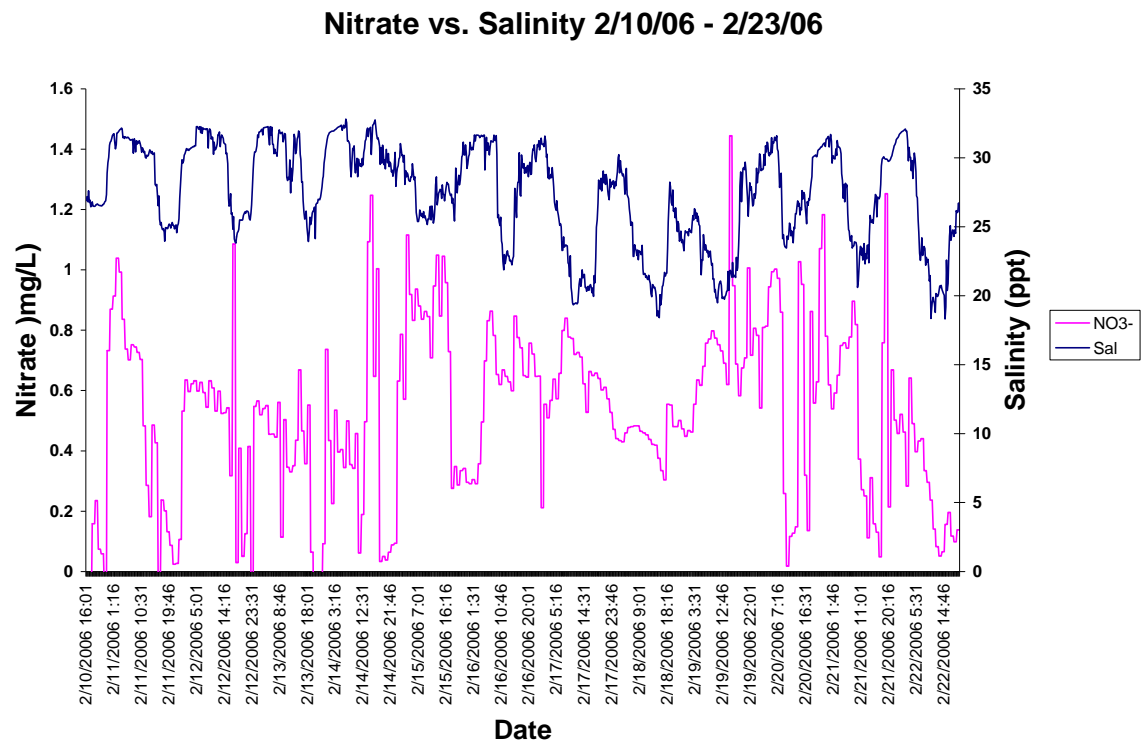
**Appendix 21.** Nitrate salinity relationships in the Moro Cojo from 2/10/06 – 2/23/06.

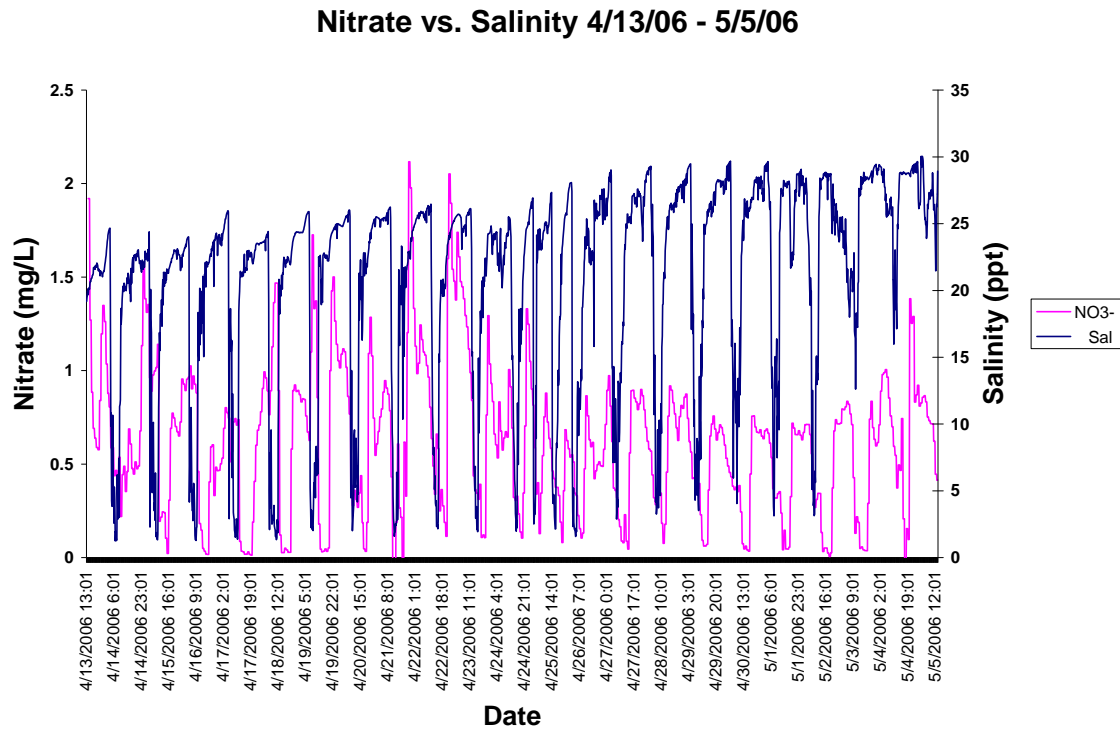
**Appendix 22.** Nitrate salinity relationships in the Moro Cojo from 4/13/05 – 5/5/06.

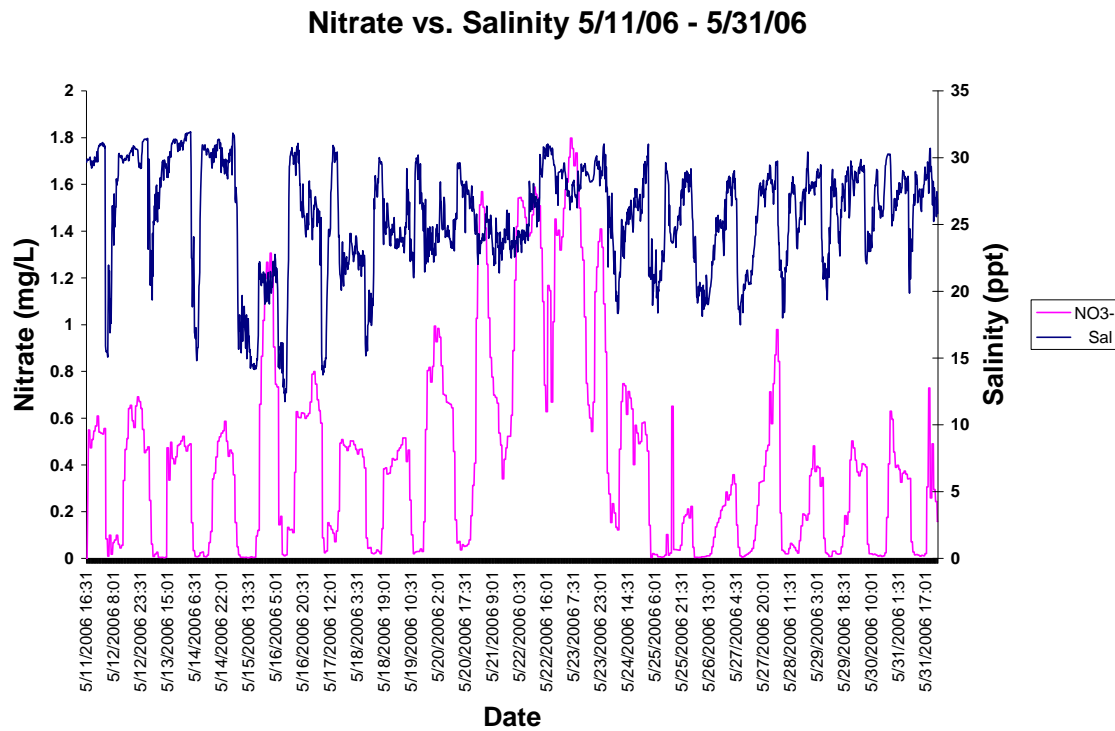
**Appendix 23.** Nitrate salinity relationships in the Moro Cojo from 5/11/05 – 5/31/06.

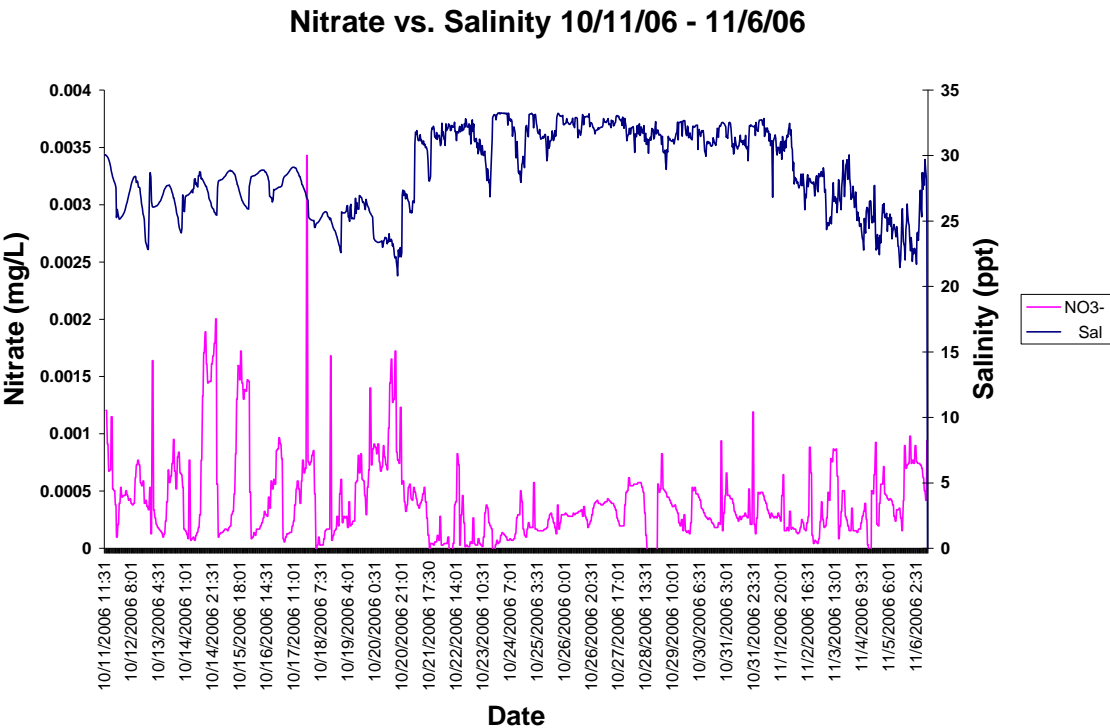
**Appendix 24.** Nitrate salinity relationships in the Moro Cojo from 10/11/05 – 11/6/06.

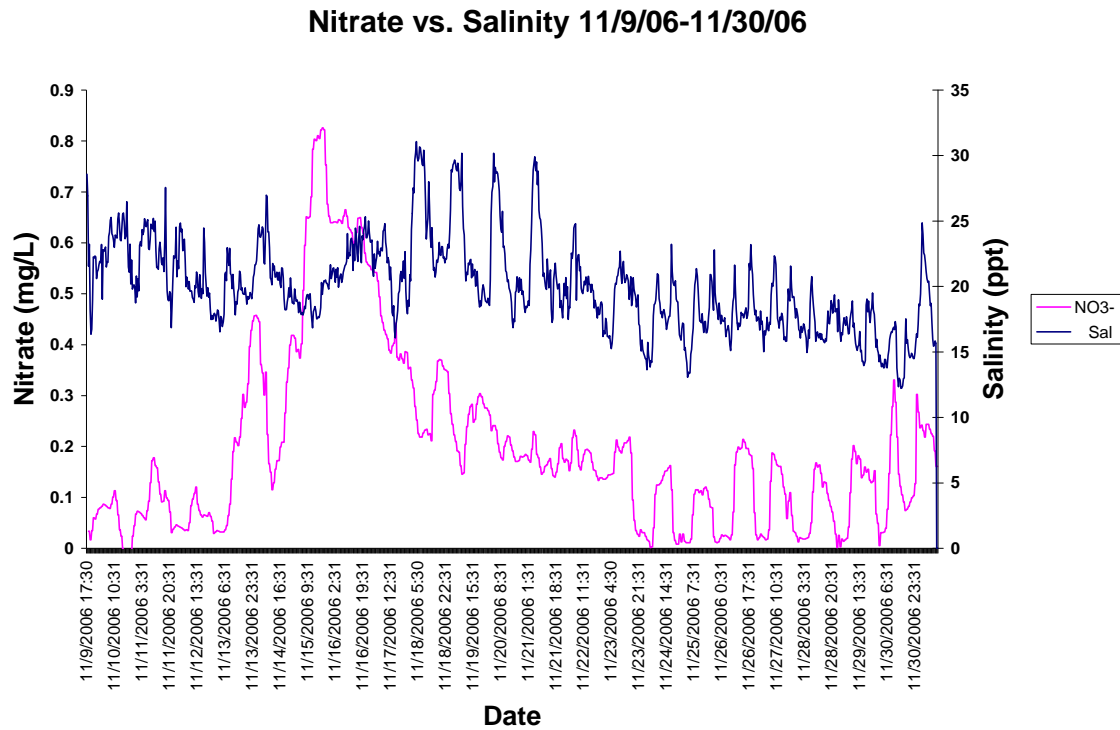
**Appendix 25.** Nitrate salinity relationships in the Moro Cojo from 11/9/05 – 1/30/06.

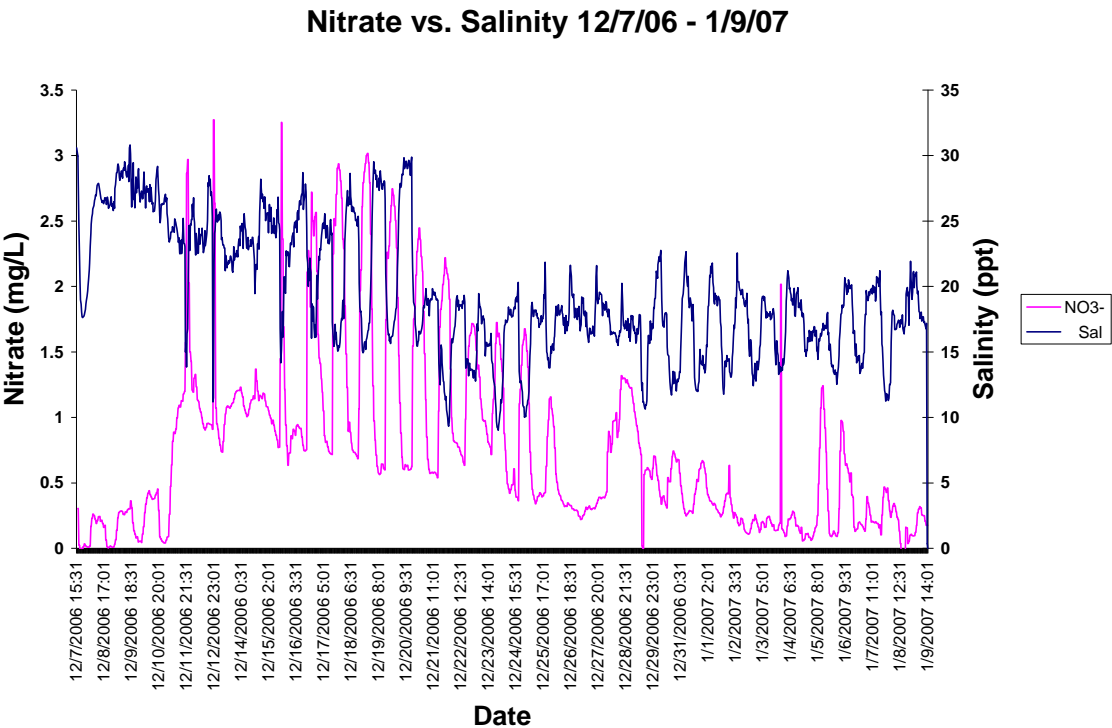
**Appendix 26.** Nitrate salinity relationships in the Moro Cojo from 12/7/65 – 1/9/07.

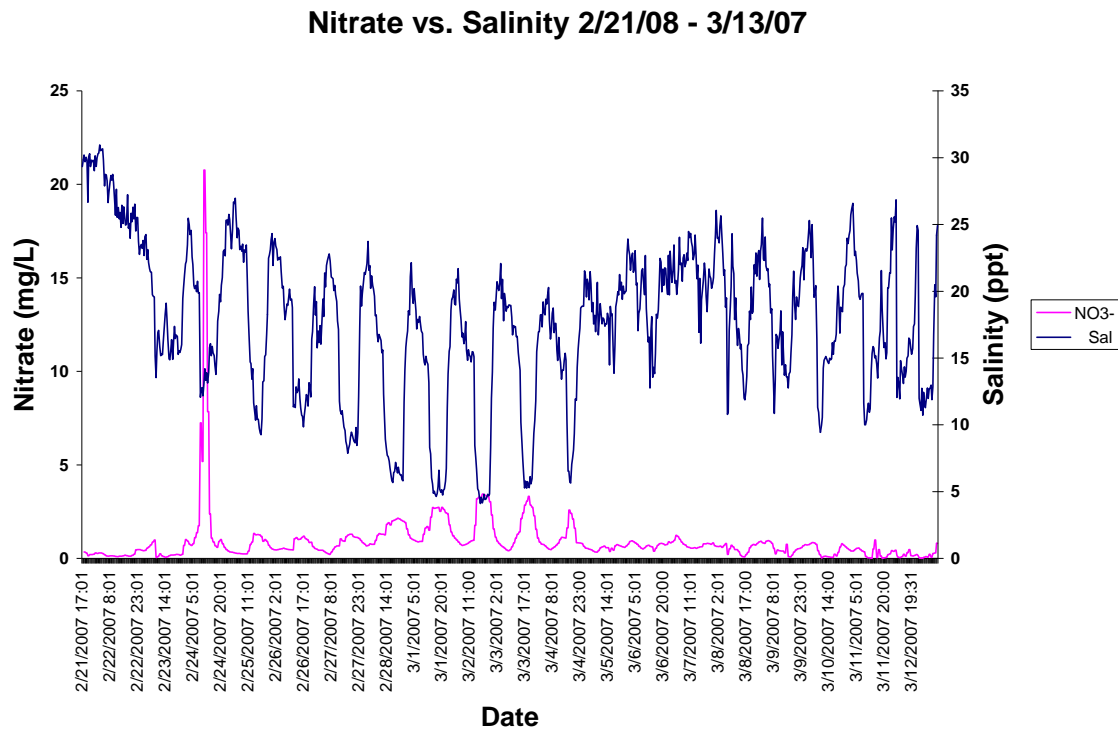
**Appendix 27.** Nitrate salinity relationships in the Moro Cojo from 2/21/07 – 3/13/07.
