Revegetation and Monitoring Program
for
Moss Landing South Harbor
Restoration Project

The Moss Landing Harbor District
Mr. Craig Winter, Harbor Manager

The Habitat Restoration Group

September 21, 1990

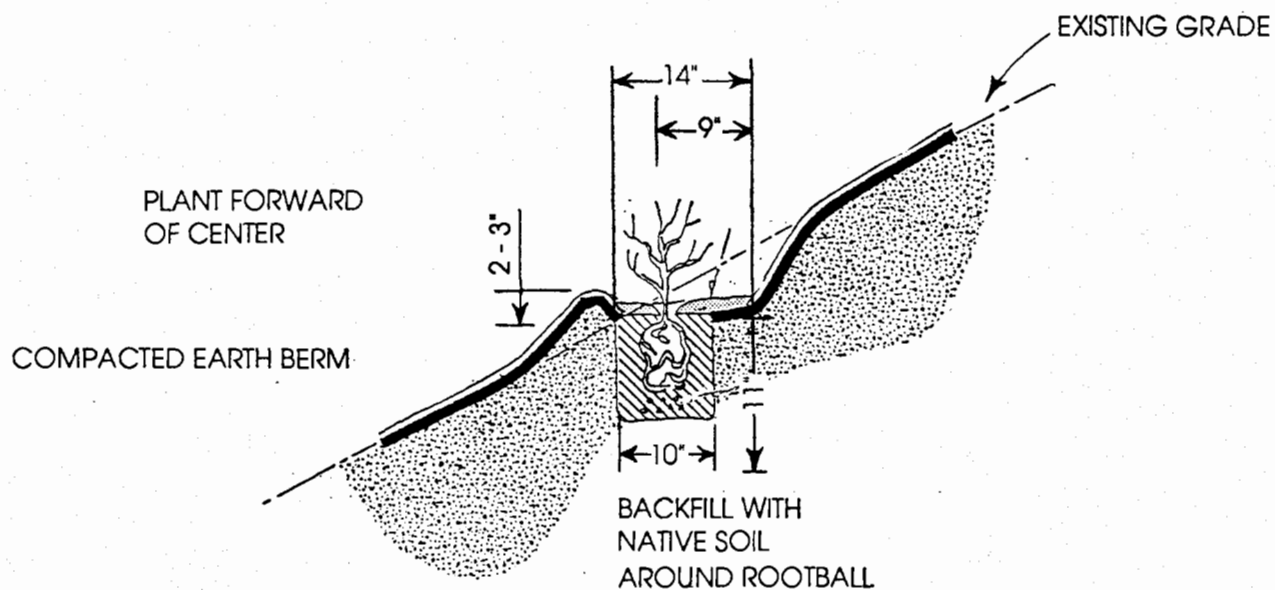
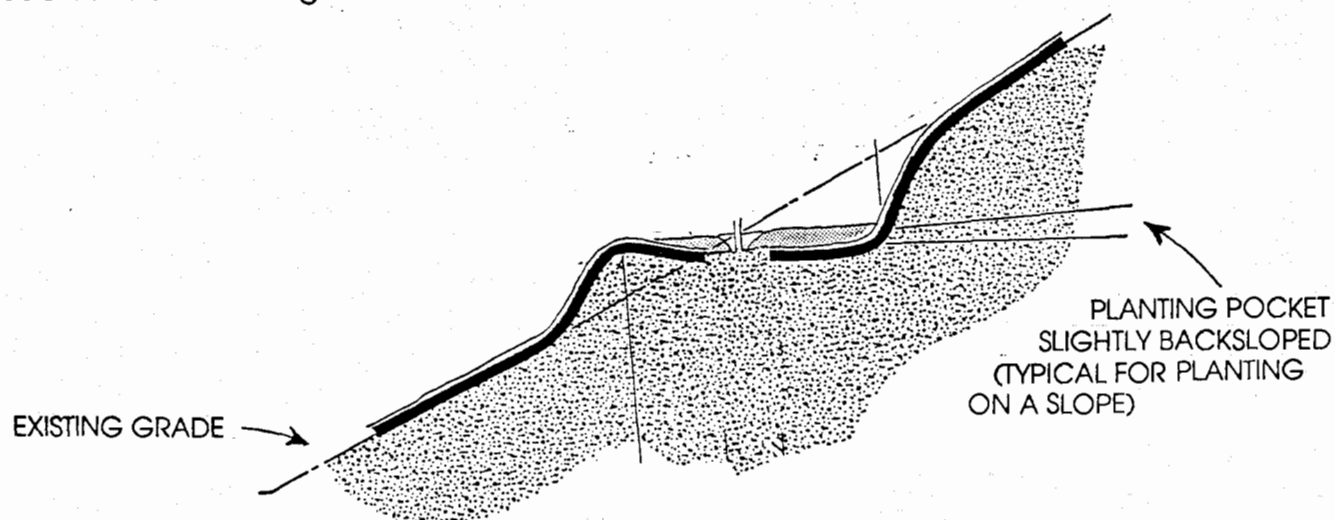
Figure 3

PLANTING ON SLOPE

Liner Planting & One Gallon Stock

Sod Section Planting

MOSS LANDING HARBOR
Planting Details

To install the one-gallon container plants on sloping grounds, planting terraces 18 by 12 inches were constructed. The planting holes were excavated large enough to receive the root ball. Native soil backfill with a slightly elevated berm was constructed at the foot of the planting terrace. On level ground, berms were 30" in diameter and 3" inches high. The root crowns were set at 1" above grade to allow for settling.

Elymus, *Atriplex* and *Spergularia* were cut into four-inch squares and transported to the project site in grow flats. Planting holes were excavated large enough to receive the sod sections of salvaged plant material. Backfill of native soil, with a slightly elevated berm constructed around the planting holes was used to install the sod sections.

To install the one-gallon container plants on sloping ground, a planting terrace, 18" by 12", was constructed. The planting holes were excavated large enough to receive the root balls. Backfill was native soil with a slightly elevated berm constructed at the front of the planting terrace. On level ground, berms were 30" in diameter and 3" high. The root crowns were set at 1" above grade to allow for settling.

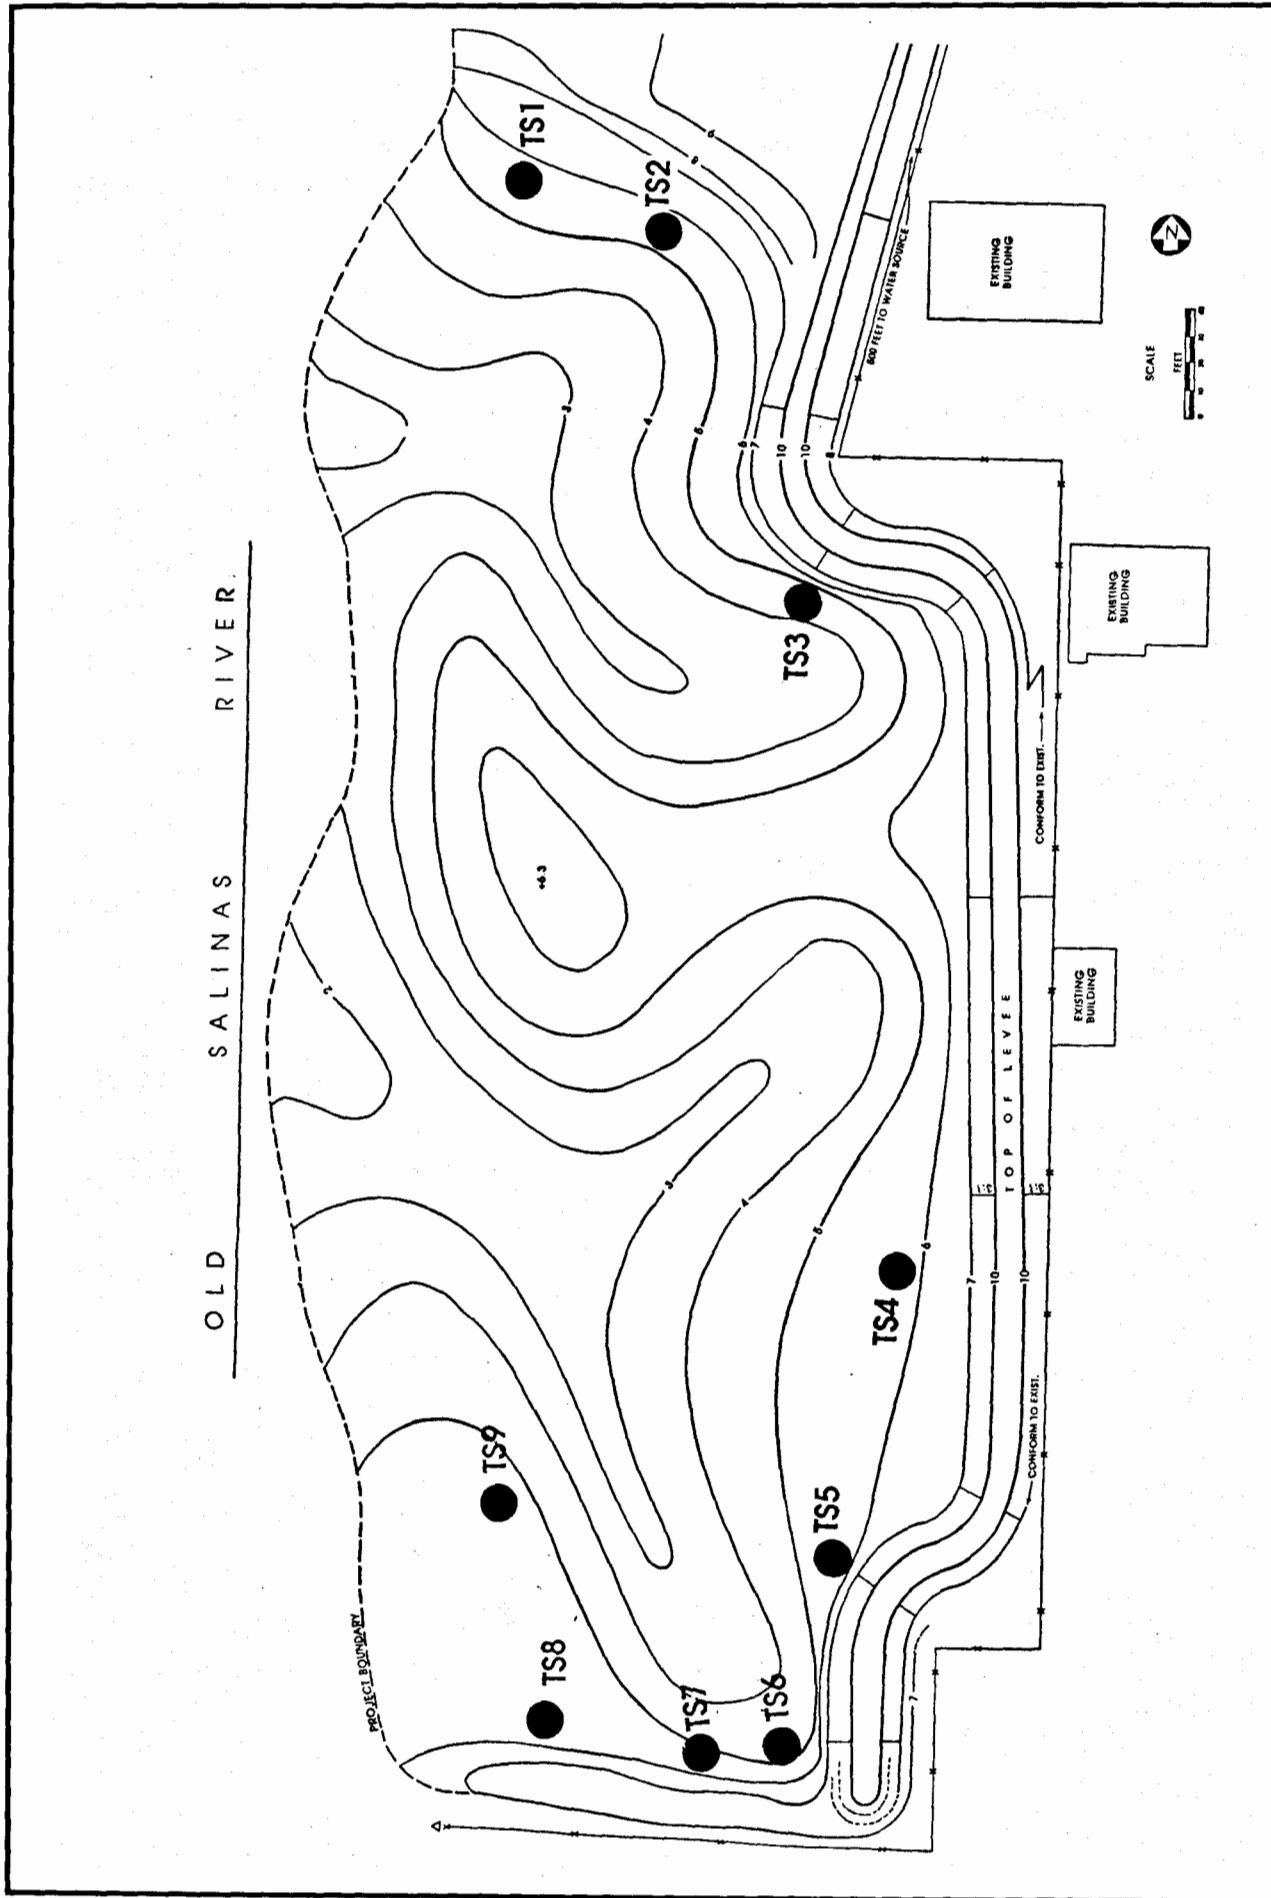
Figure 4

MOSS LANDING HARBOR
Location of plots where salvaged
Pickleweed marsh topsoil is placed.

After completion of the grading operation, eight plots, each with an average area of approximately 300 square feet, were established within the pickleweed marsh restoration area (between 4.5 and 6 feet elevation). The stockpiled topsoil was then transported back to the restoration site and placed near the plots with a front-loader tractor.

The topsoil was spread by hand within each plot to within four to six inches above the finished grade. After application, the topsoil was covered with jute netting and secured in place by driving 9-inch stakes around its periphery to provide erosion protection from tidal actions. Each plot received an average of nine cubic yards of salvaged topsoil.

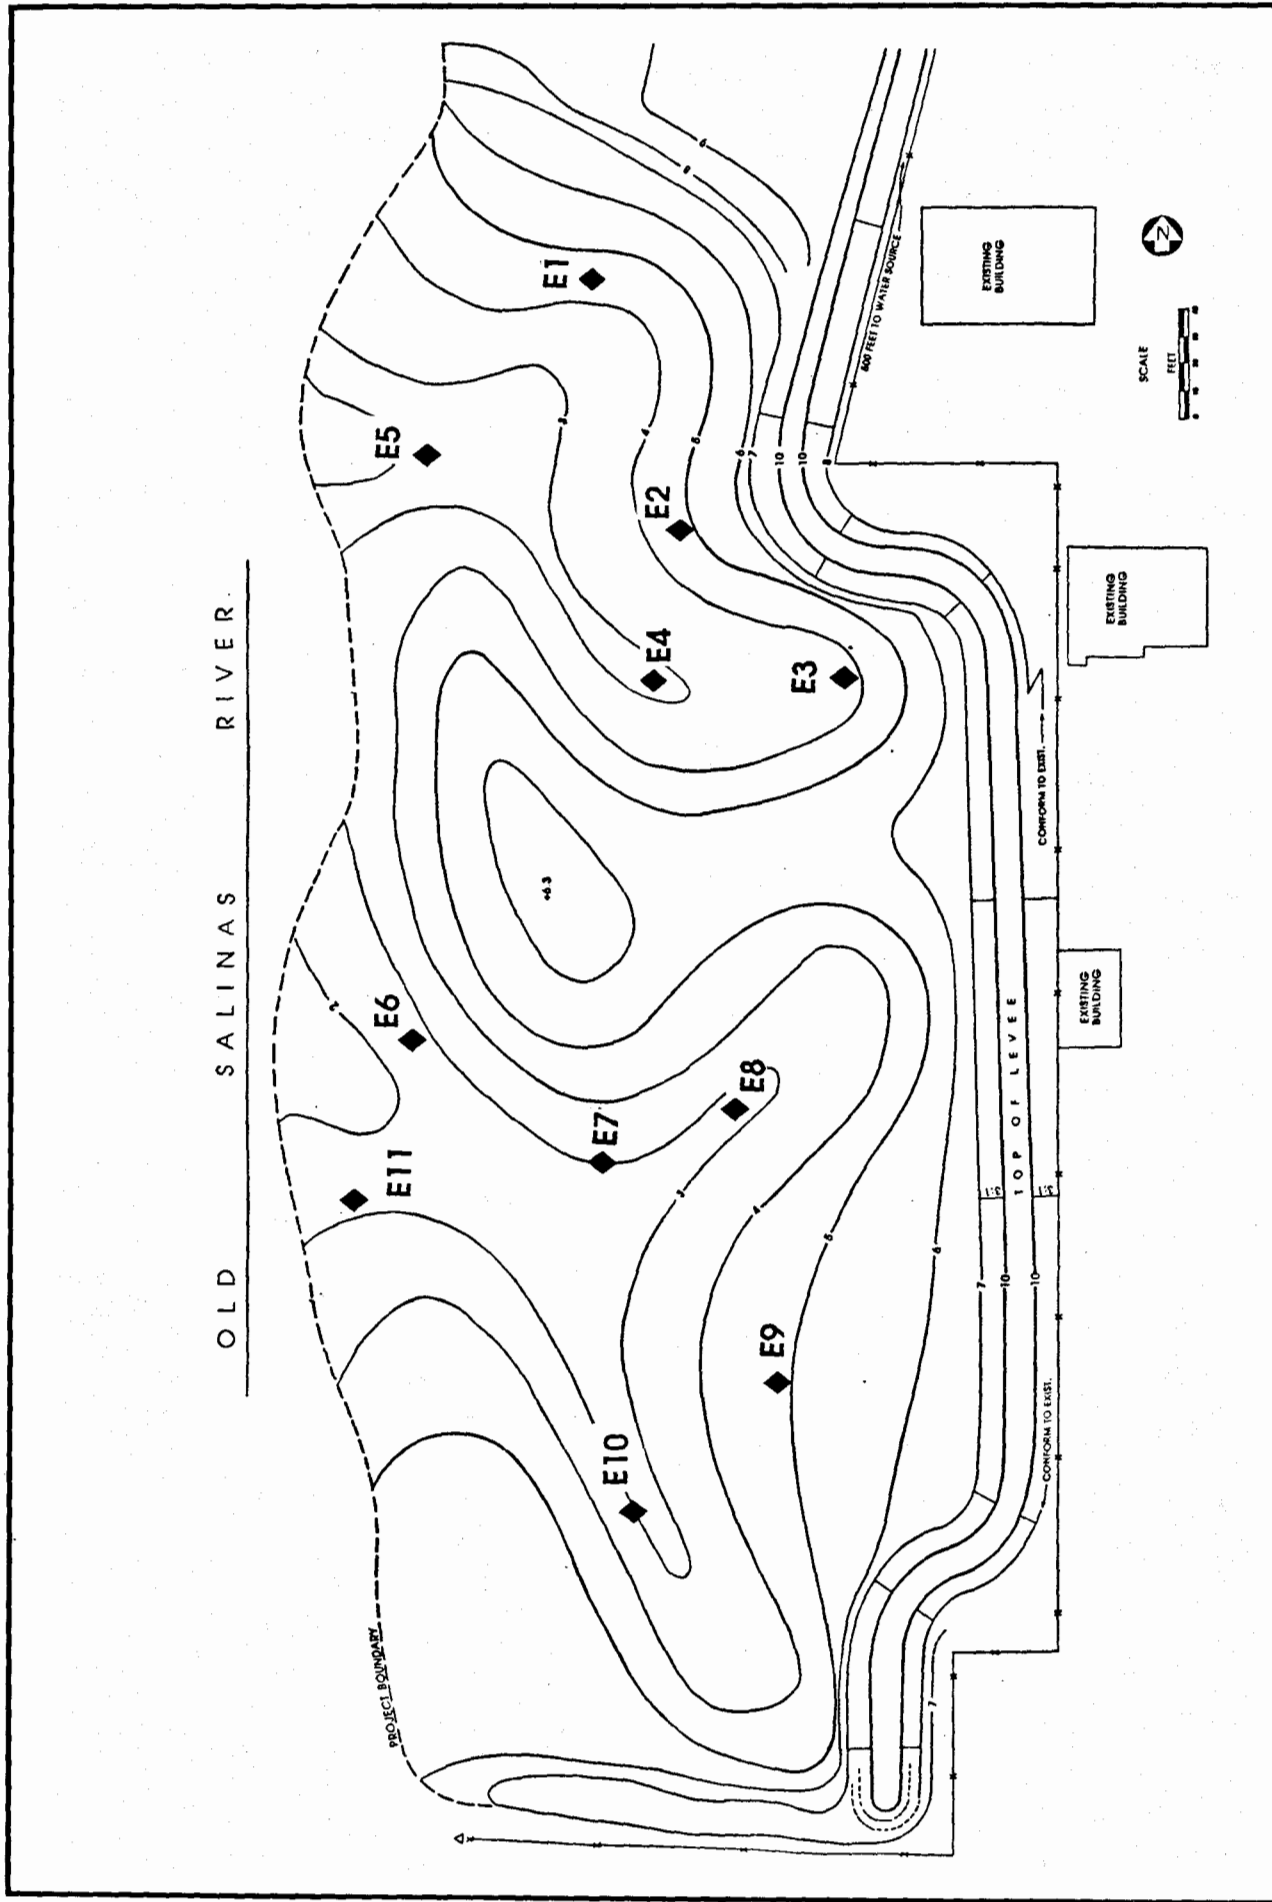
Figure 7

MOSS LANDING HARBOR
 Location of elevation stakes to monitor
 depositional/transportational/erosional processes.

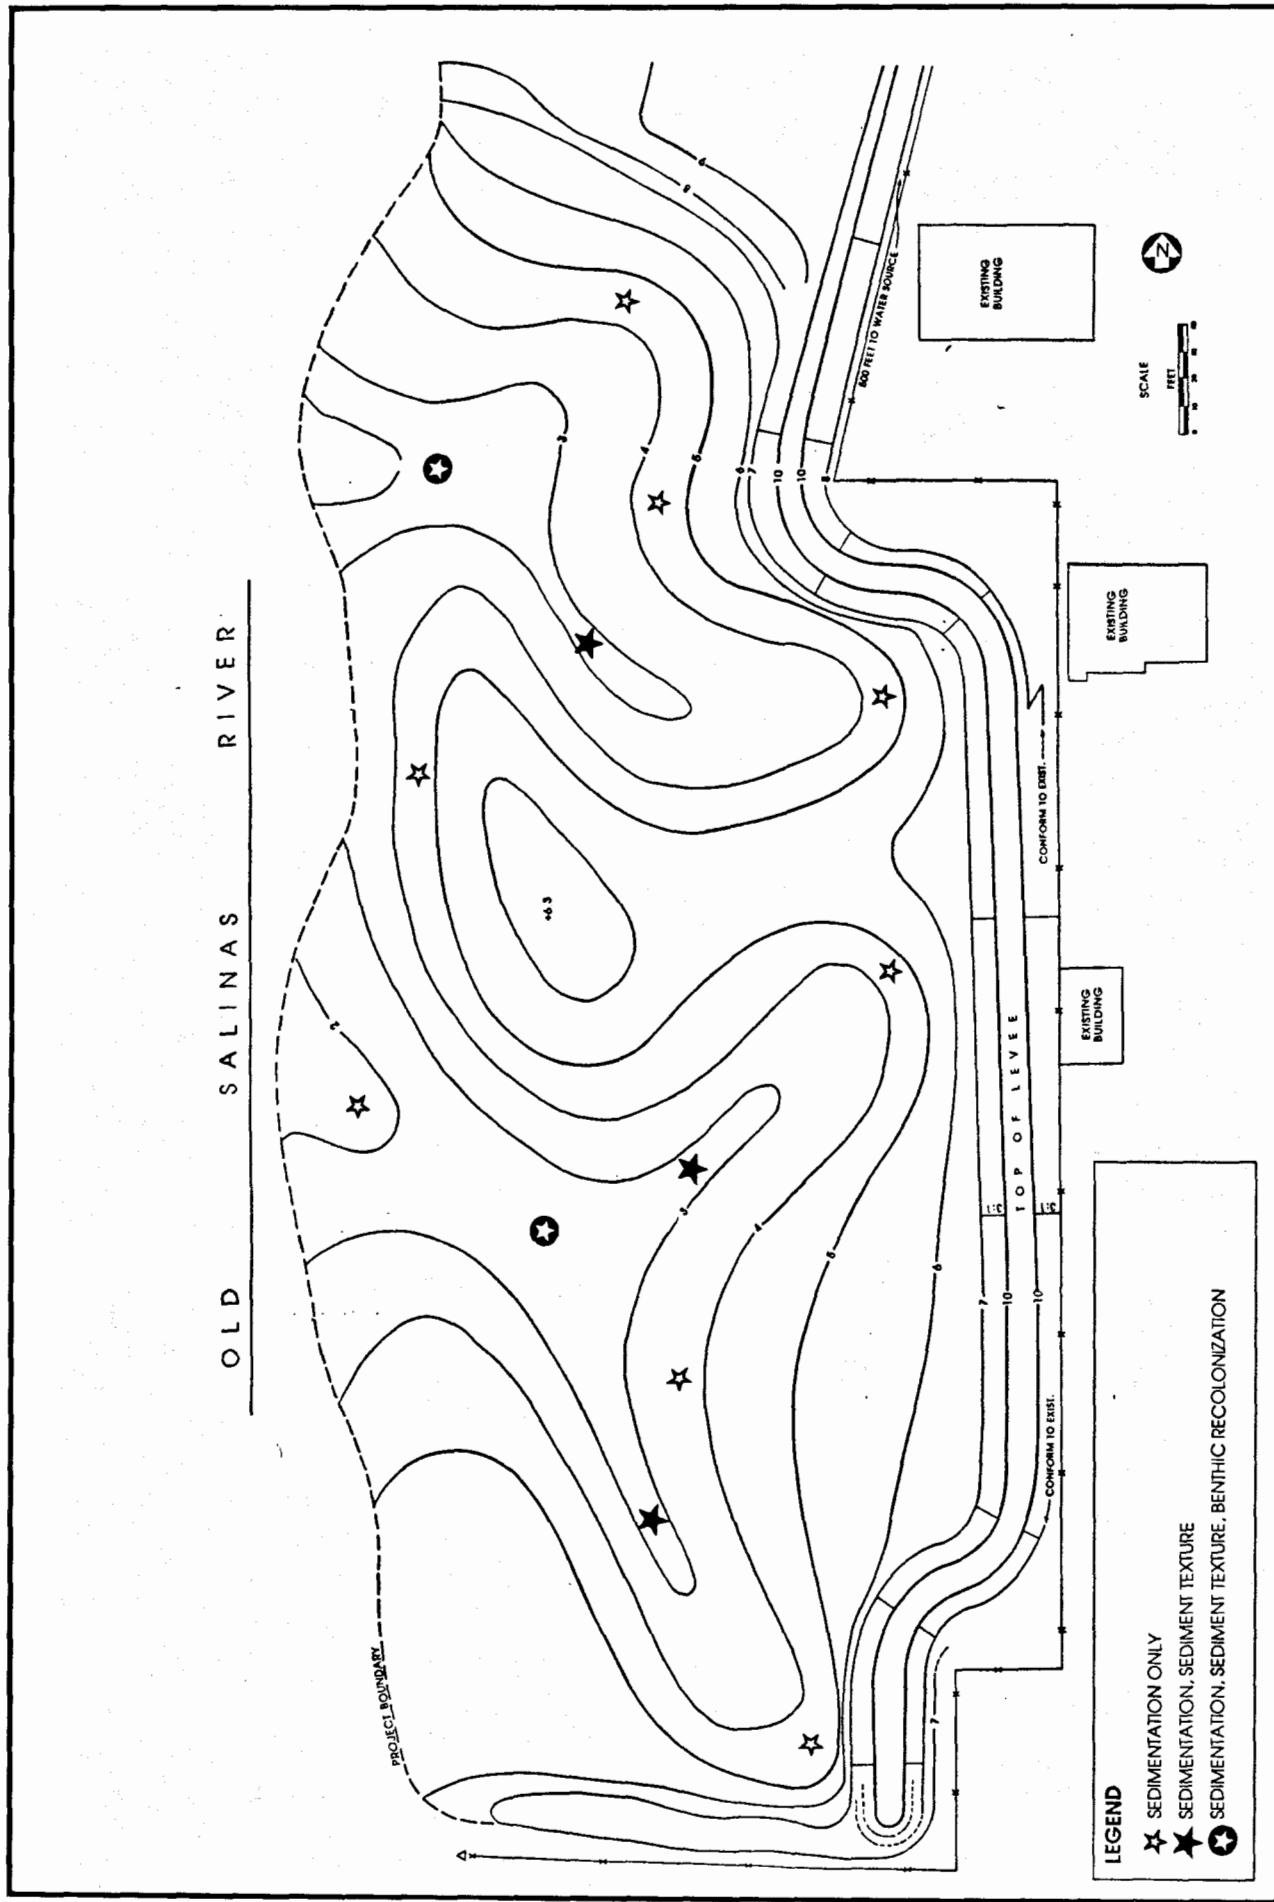
Figure 8

MOSS LANDING HARBOR
 Proposed sampling stations for sedimentation, sediment texture, and benthic recolonization.

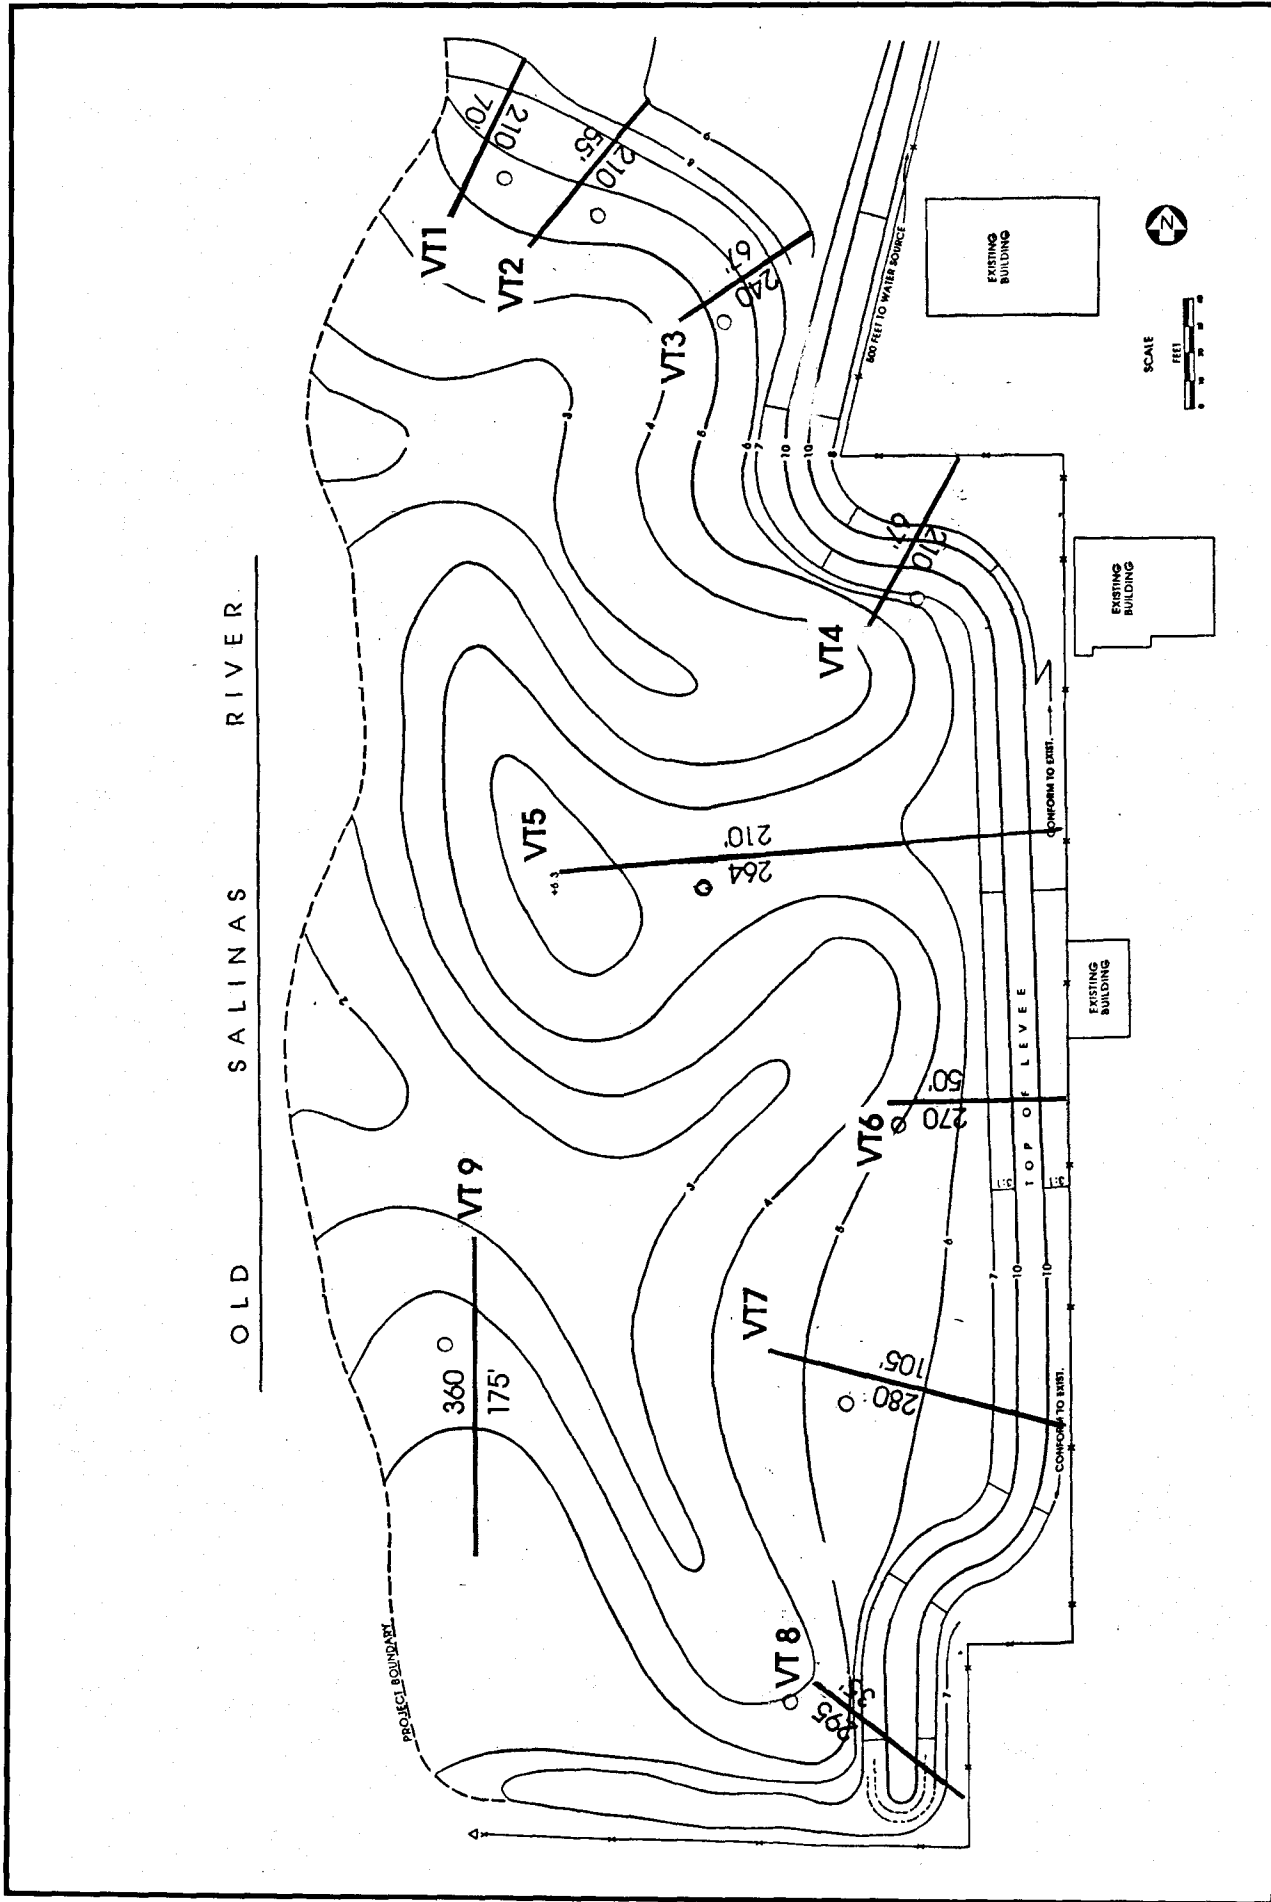
MOSS LANDING HARBOR
 Station location of vegetation transects
 for salt marsh and peripheral upland.

Ten fixed transects will be established across the pickleweed and upland periphery plains (above elevations 3.5') as depicted on Figure #4. Each transect will be staked so that elevation changes are noted in each transect. Permanent one-meter square quadrats will then be established along the transect lines. A minimum of one quadrat per elevation of one foot will be established. Quadrat numbers in each transects will be set in the field during the first monitoring. Quadrats will be alternated from one side of the transects to the other.

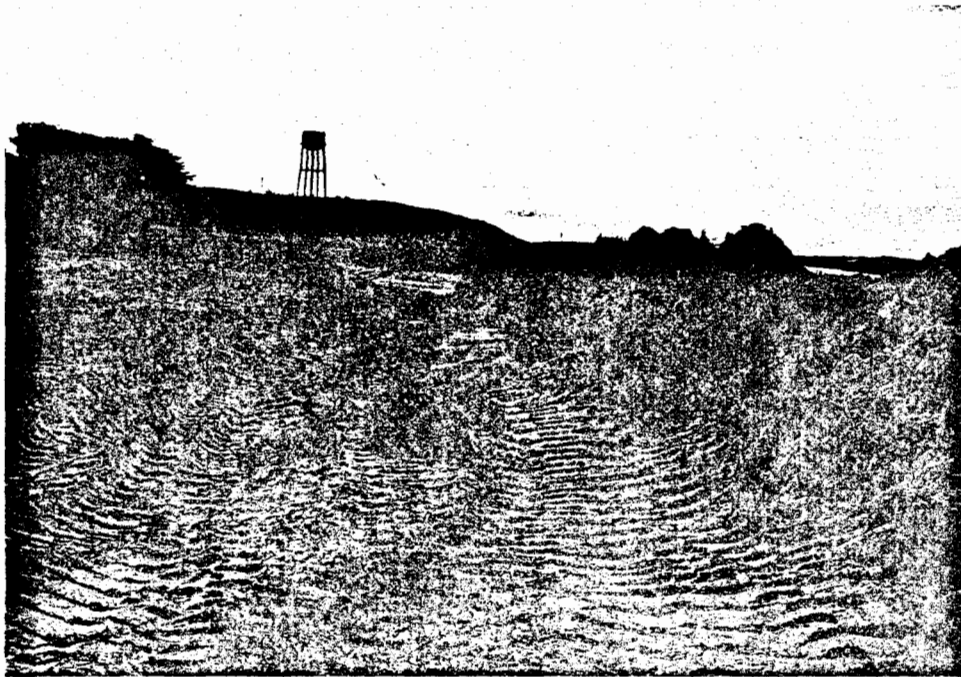
CONSTRUCTION OF THE MARSH PLAIN AND MUDFLAT
PRIOR TO BREACHING OF THE EXISTING LEVEE.

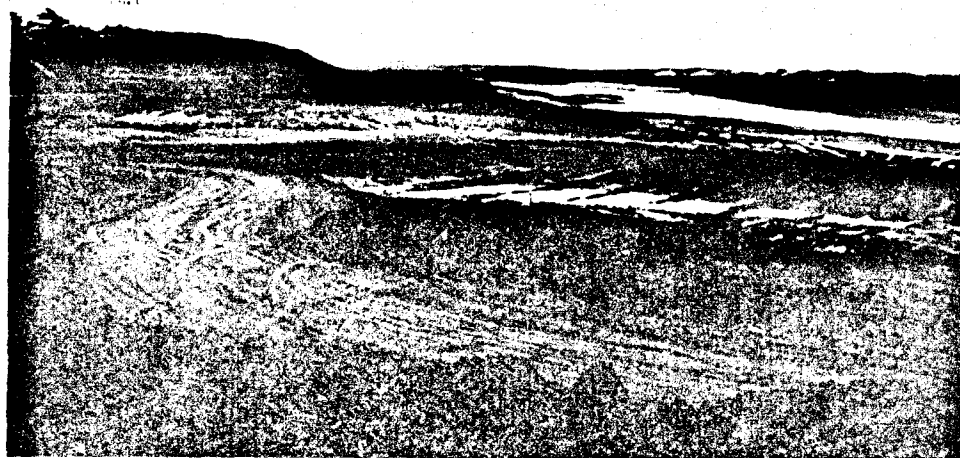
THE NEWLY CONSTRUCTED LEVEE, SHOWING THE NEW MARSH
PLAIN, SLOUGH AND MUDFLAT AREAS.

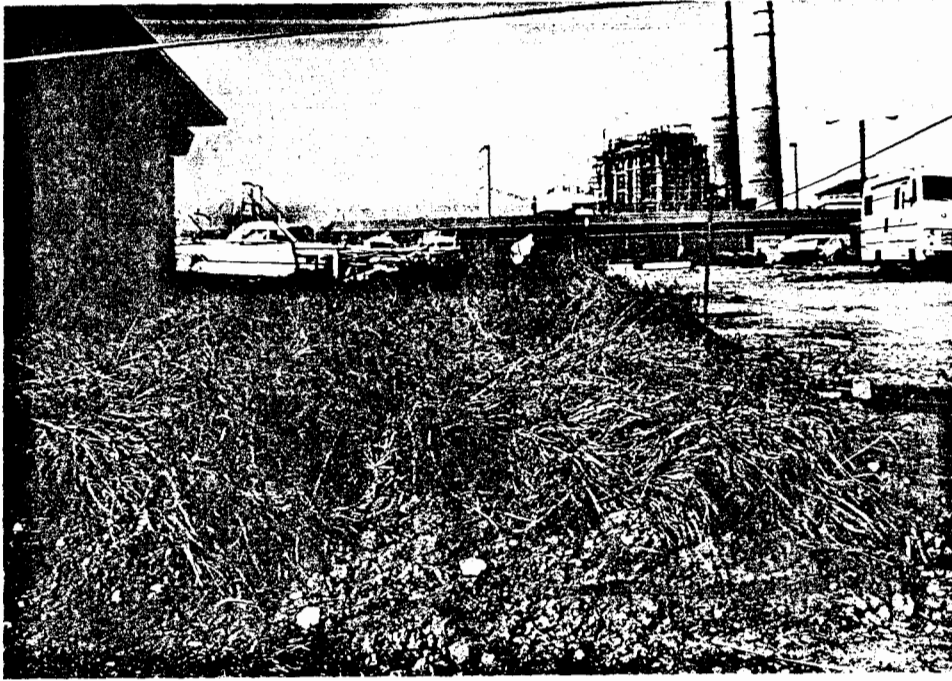
THE TEMPORARY NURSERY AREA.

Prior to the implementation of the salvage operation, a temporary nursery area was established at the dry storage area of the Moss Landing Harbor District. This area is located across Sandholdt Road, on the north side of the project site. Available plant materials were salvaged and transported to this temporary nursery site.

The nursery area was fenced off by driving stakes around the perimeter and using flagging tapes. This area received a topsoil layer of a few inches to facilitate a "heeling in" process of the root systems of salvaged plants. The root surfaces of salvaged plant materials were kept moist during the salvage and transportation. A simple hand-held hose and nozzle spray was used at the nursery to water the plants. During the grading operation and while the plants awaited installation, all salvaged and nursery-grown plant materials were maintained at the temporary nursery site.

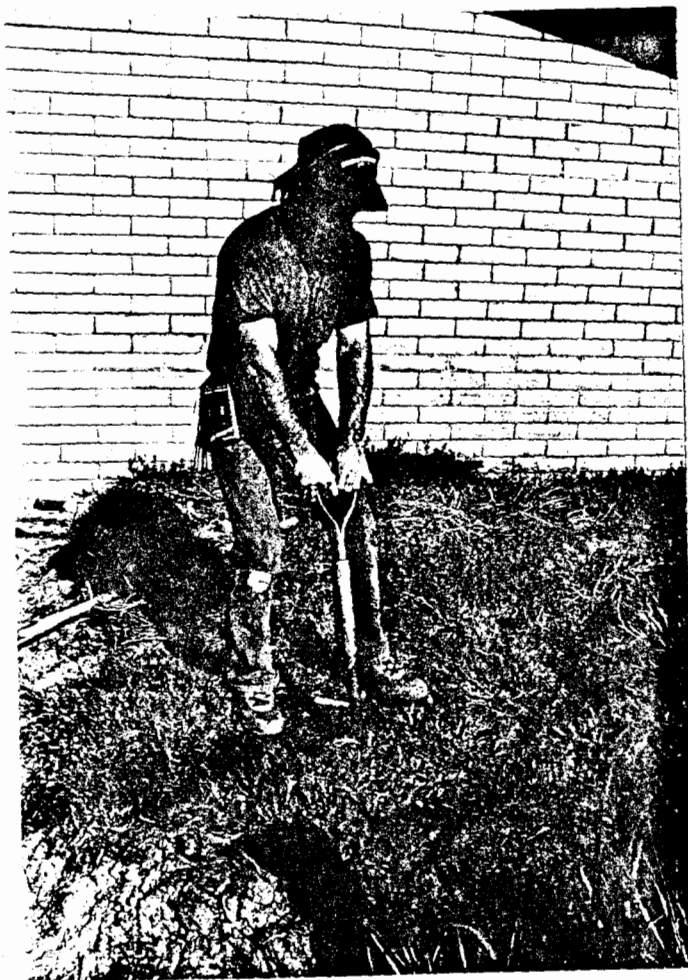
**SALVAGED *Spergularia macrotheca* SOD SECTION
PREPARED AND CUT FOR REPLANTING.**

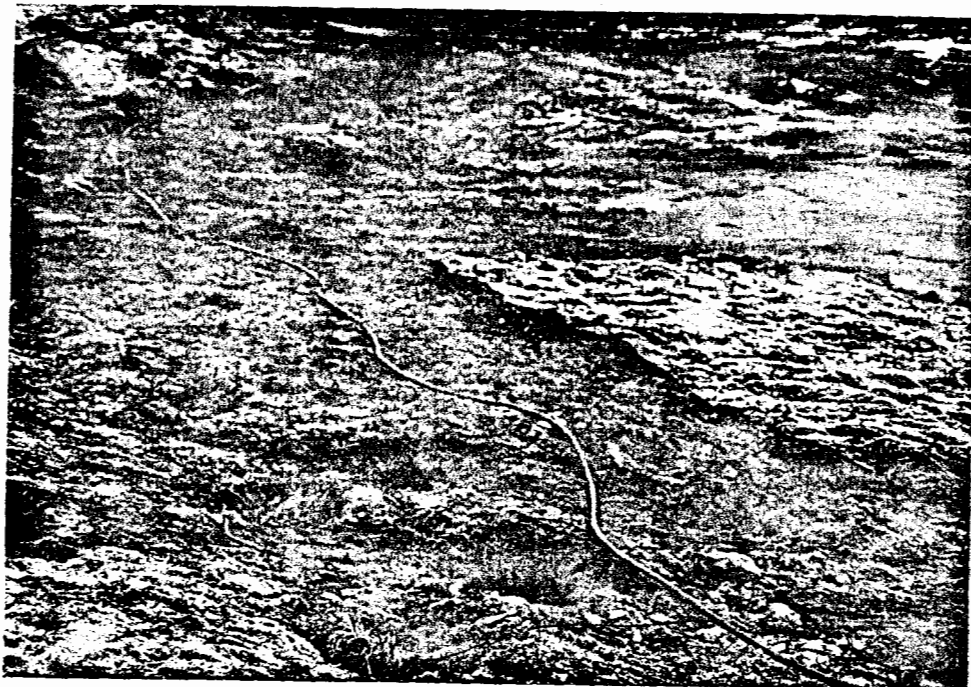
REPLANTED LEVEE SHOWING PLANTING BASINS WITH
SALTGRASS SOD SECTIONS AND DRIP IRRIGATION SYSTEM.

All sod section plants installed at the project site are watered by a 0-10 GPH bubble, set at 5 gallons-per-hour, while one-gallon container plants receive irrigation water via 1 gallon-per-hour emitters.

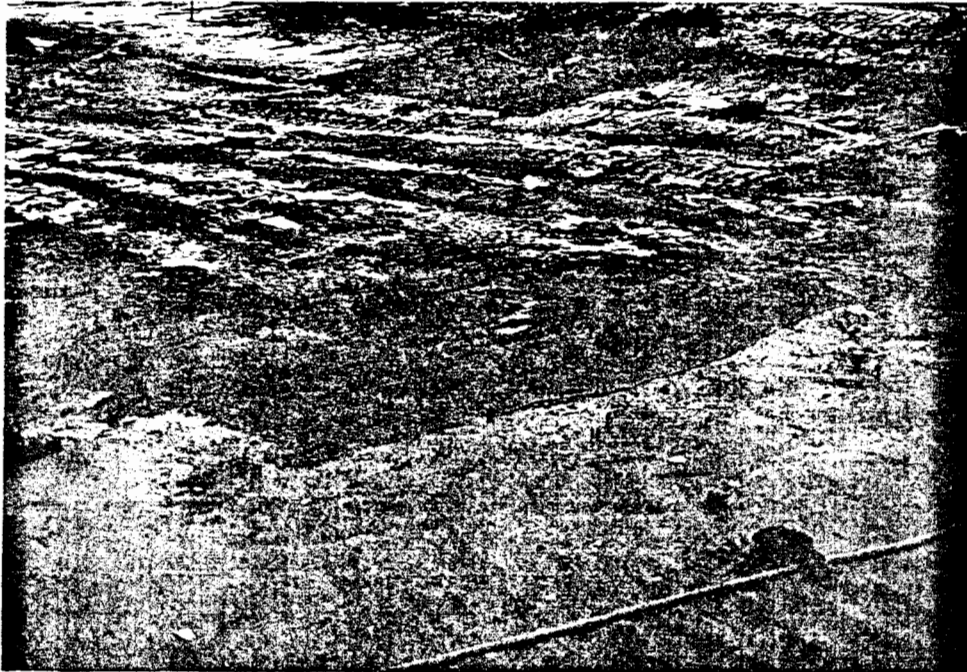
**PROPAGULES OF PICKLEWEED ASSOCIATION PLANTS
FOUND IN SALVAGED TOPSOIL SHOWING SIX WEEKS
OF GROWTH AFTER APPLICATION**

The salvaged topsoil contained pickleweed propagules (seeds, cuttings and rooted plants) that will re-establish themselves and speed the process of revegetation within the pickleweed marsh area. This topsoil was transported to a stockpiling area within the dry storage facilities of the Moss Landing Harbor District. A front-loader tractor and a dump truck were used to excavate, transport and stockpile the topsoil.

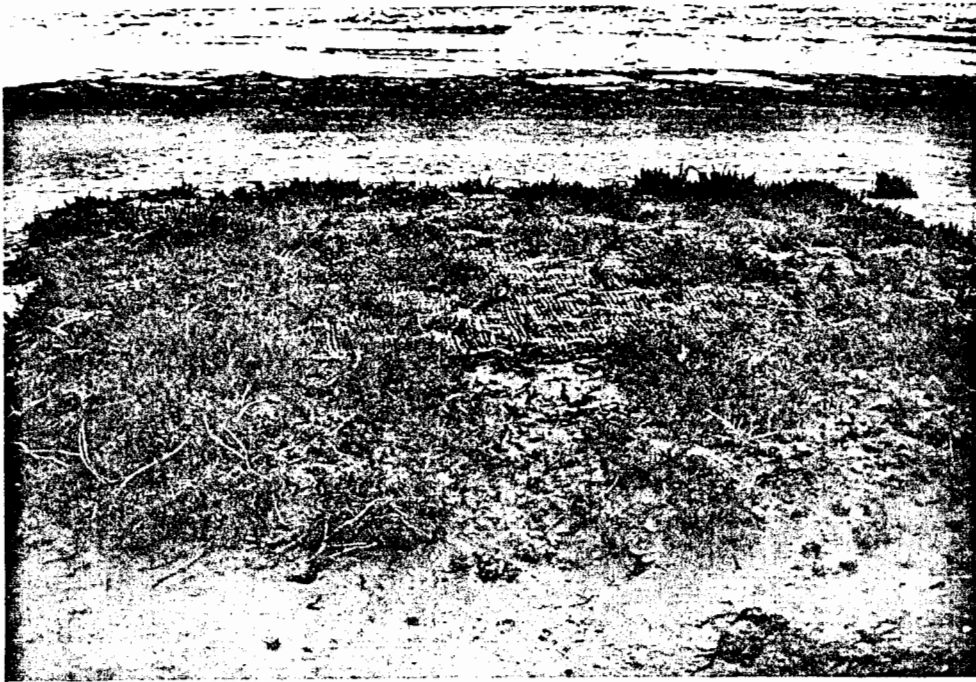
PROPAGULES IN SALVAGED TOP SOIL OF PICKLEWEED MARSH
SHOWING EIGHT WEEKS OF GROWTH AFTER APPLICATION
