# W.E.O.P.

WATERSHED ECOLOGY OUTREACH PROGRAM

TECHNICAL REPORT  
MARCH 1995

## • 1995 FLOOD •

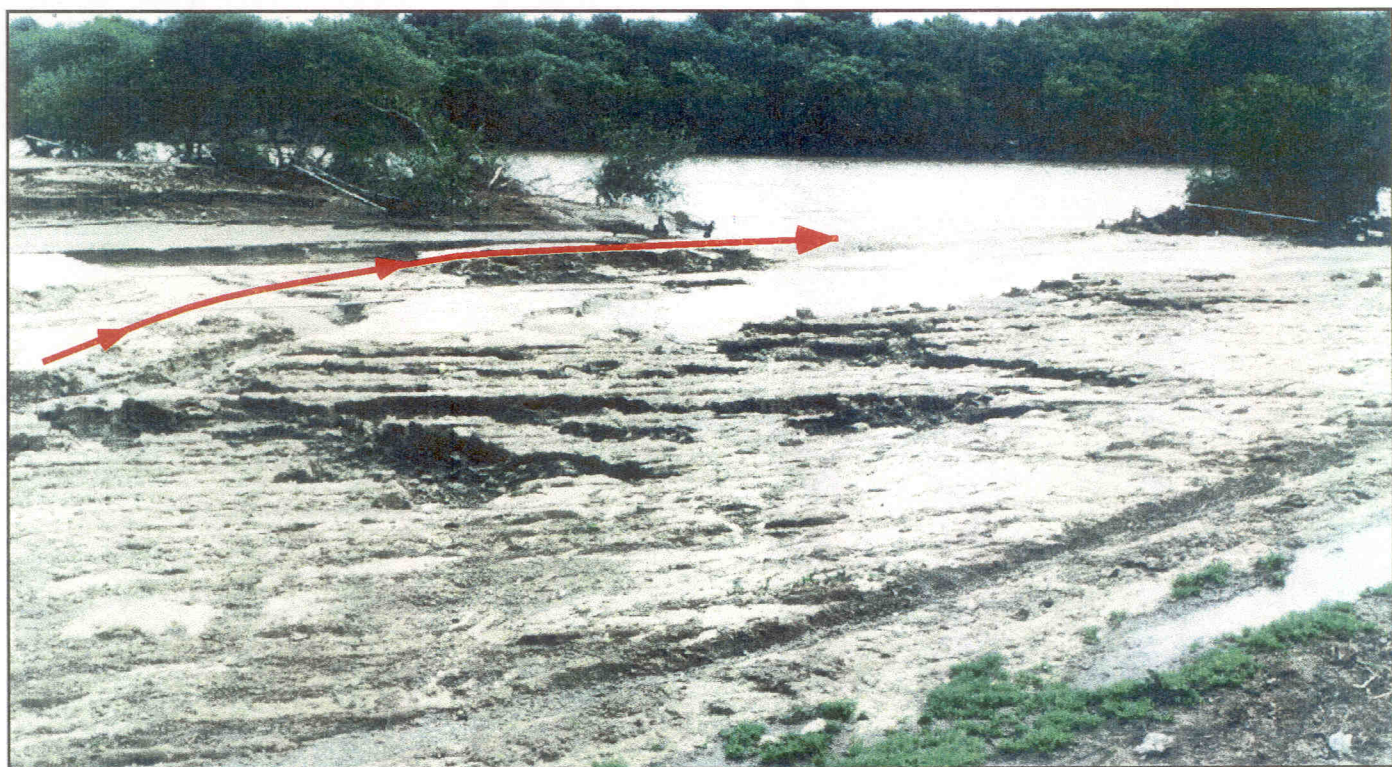
8. Ground view of the extensive erosion and deep gully formed as the flood reentered the river above the Highway 1 bridge.

The worst impacts of the flooding were caused by breaking dikes and by ponding flood water behind roads and other barriers. Dike breaks can be prevented by making gradual back slopes and protecting both the front and back dike with erosion resistant native vegetation. Barriers to flood flow outside the main river course can be avoided by diverting flood water over specific spillways where downstream flow is least impacted by barriers.
