# Final Report

## Completing the Core Objectives of the Moro Cojo Slough Management and Enhancement Plan

GRANT AGREEMENT BETWEEN:  
OCEAN PROTECTION COUNCIL & COASTAL CONSERVATION AND RESEARCH, INC.  
AGREEMENT NUMBER: P0-1-05

MARCH 2023

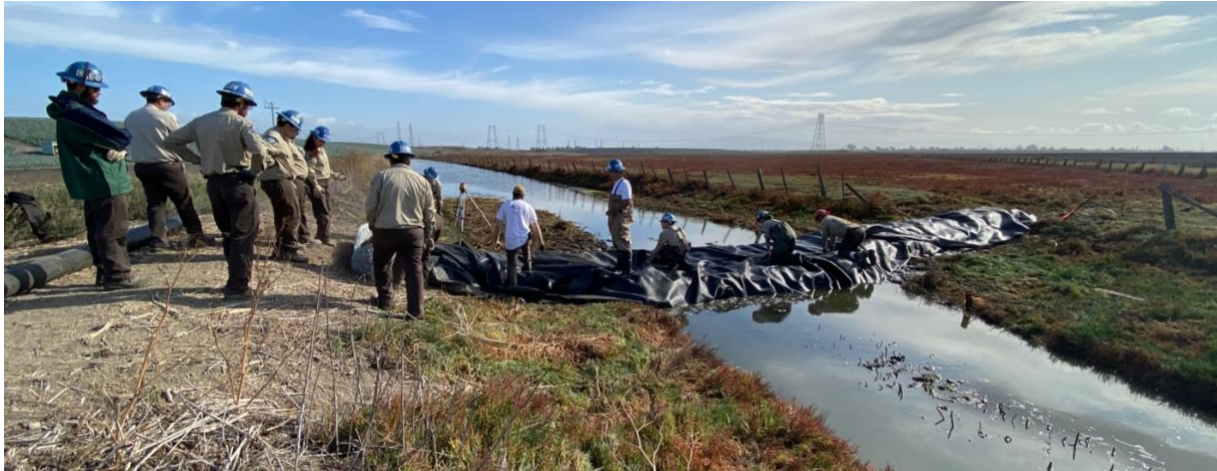
*Figure 8. California Conservation Corps crew working with CCWG on the construction of the Moro Cojo Slough weir.*

*Weir:* In November 2019 CCWG staff with support from Water Ways Consulting and the Santa Cruz RCD worked with the California Conservation Corps to construct the weir in the main channel of the Moro Cojo slough (Figure 8).

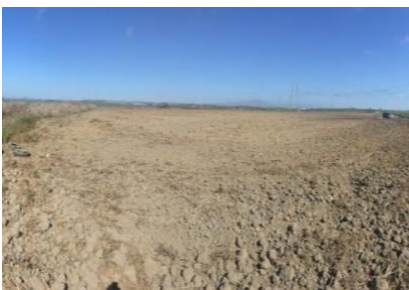
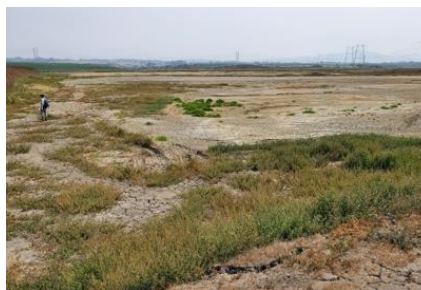
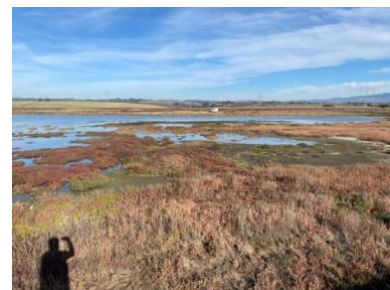
*(A) 2018-prior to construction*

*(B) 2020-initial earthmoving complete*

*(C) 2022-final earthmoving complete and wetland flooded*

*Figure 10. Photo monitoring at photo point #2 showing (A) the condition of the restoration site prior to construction, (B) following Phase 1 and (C) following phase 2 of construction with the site flooded.*

**Wetland restoration site:** Sea Mist Farms enacted Phase 1 (fall 2019) by building a berm that separates the wetland area from the farm to the south. Spoils used to build the berm were strategically taken from the areas of Ponds 3 and Pond 4. Phase 2 was completed two years later (fall 2021), when contractor Durden Construction dug the remaining ponds and built raised areas for driving access. Phases 1 and 2 were followed by seeding and planting (fall 2021 through spring 2023). Each phase involved grading the site with tractors to create the ponds, followed by invasive plant management via herbicide application and mowing, and native seeding and planting (Figure 10 and 11).

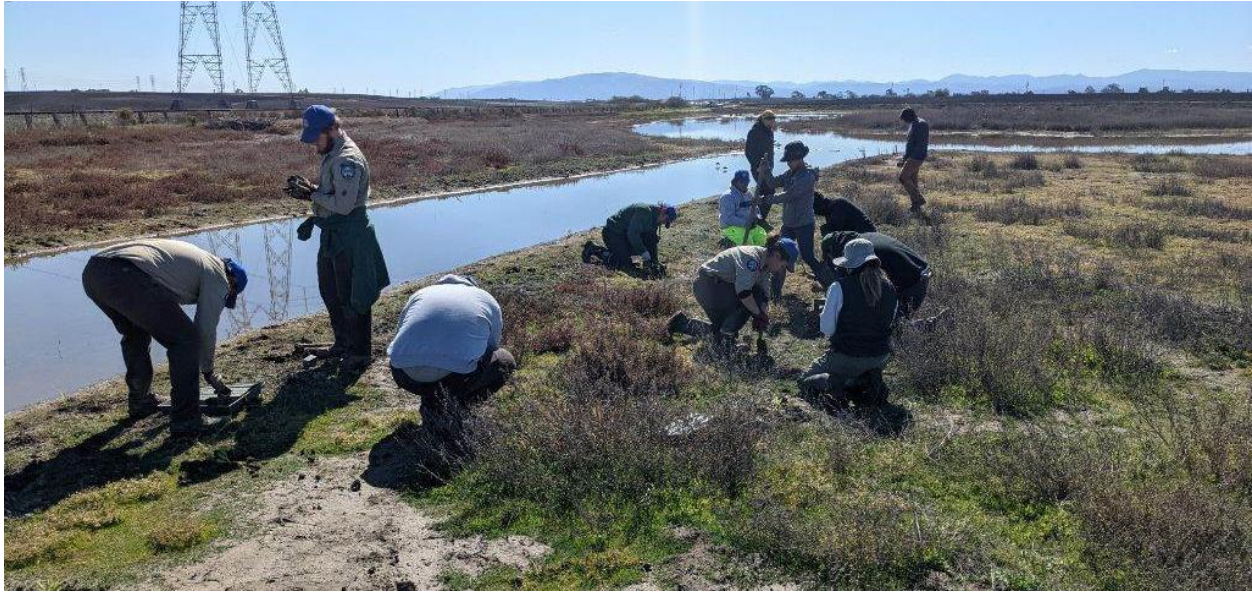
*Figure 11. California Conservation Corps crew working with CC&R on the planting of the Tottino II restoration site.*
