Update to  
Natividad Creek Park Restoration Plan

**Water Reuse and Flood Protection around  
V.R. Barton School and Laurel Lake**

## EXTENDING RESTORATION ALONG NATIVIDAD CREEK

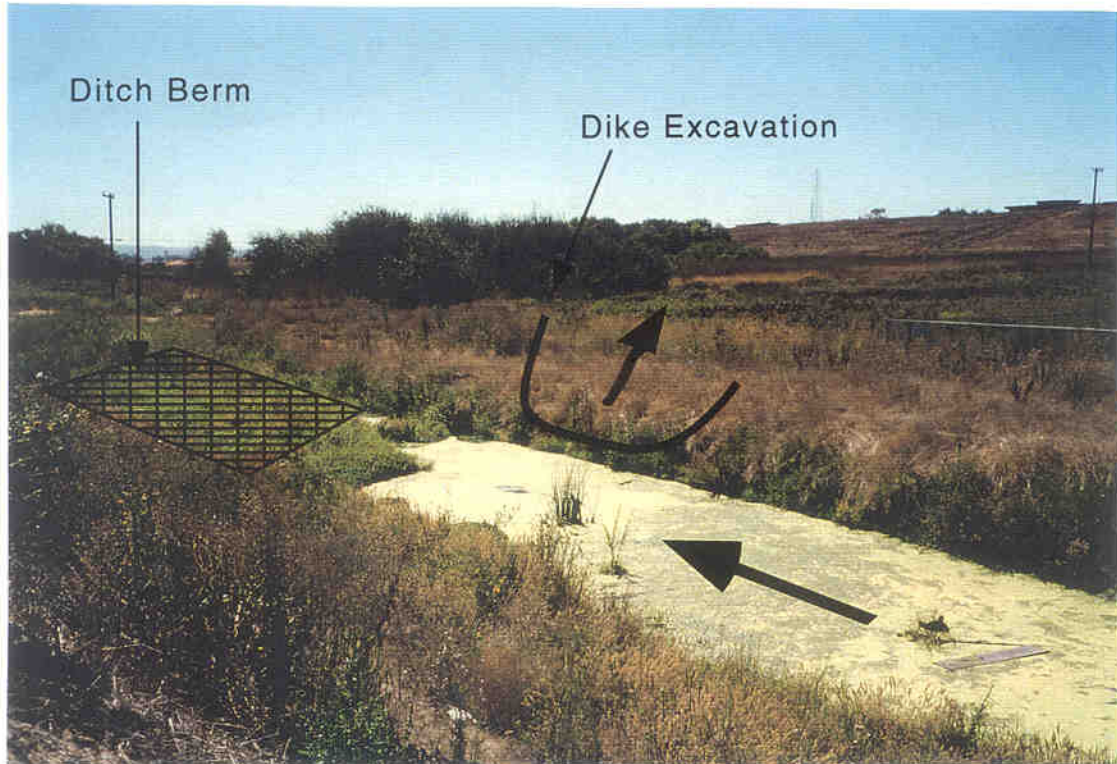
Photographs 3 and 4. Turning water from Natividad Creek ditch and spreading it over the historical marsh. Thick arrows indicate water flow direction.

Photograph 3 shows the landform changes in this restoration unit. The main ditch channel will be closed with an ecologically engineered berm. The core of the berm will be soil excavated from the adjacent dike; the core will be covered with hay bales to prevent erosion and accelerate native plant establishment. A 25 foot section of dike bank will be excavated with a backhoe directly upstream of the berm to return water flow into the V.R. Barton School Marsh (photograph 4). The dike excavation will be 3-4 feet below the berm elevation, at 2-3 feet below the dike top. Native plants under the berm will be removed and replanted on the front and back sides of the berm and between hay bales. These are primarily bull rush, which is easily transplanted.

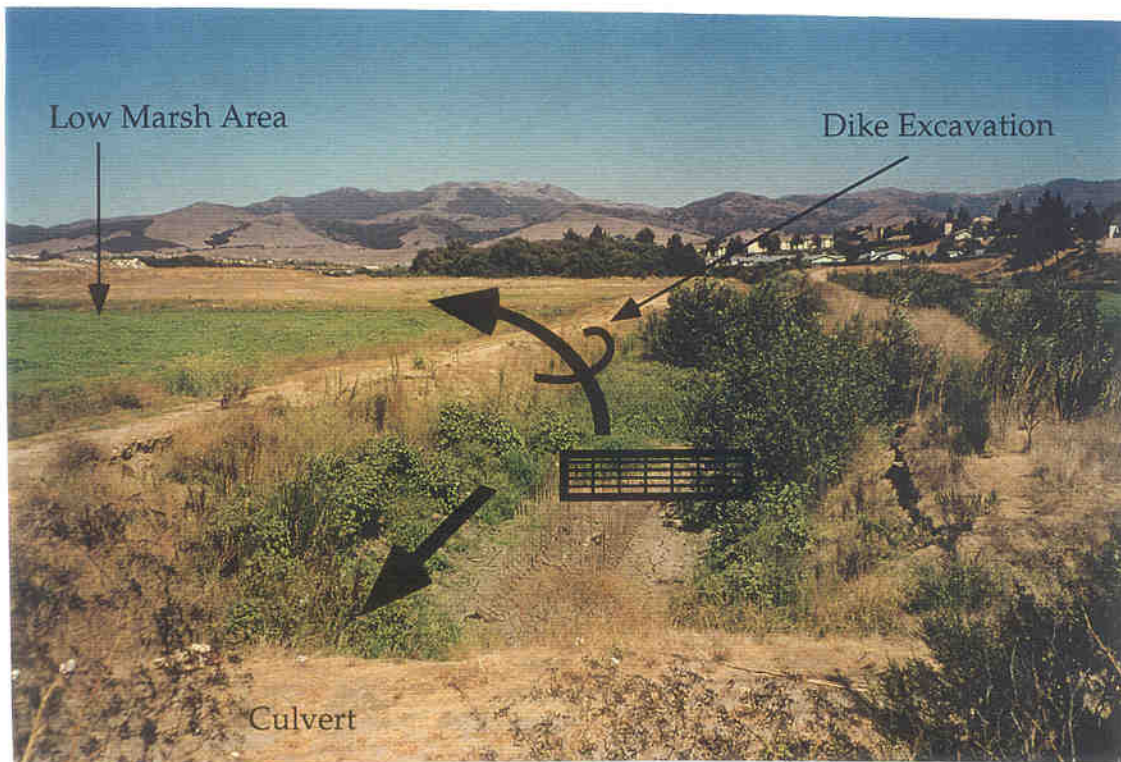
Photograph 8. Ponding also permits water to enter the low marsh next to Laurel Lake through a low area excavated in the ditch dike. Thick arrows indicate water flow.

to send water through a dike opening and into the low marsh (photograph 8). This will increase flood storage and create a dense wetland filter for cleaning drainage water.

A 25 foot opening will be excavated in the ditch dike as shown in photograph 8. This will be done in the same manner described for restoration unit 2.
